The East Harbour Stormwater Catchment

Model Build Report

This modelling study has been undertaken by Wellington Water Limited (Wellington Water Ltd) to assist management of stormwater in the catchment. The model is to be used for the generation of flood hazard maps and may subsequently be used to assess options for upgrading the stormwater system to mitigate flooding in the catchment.

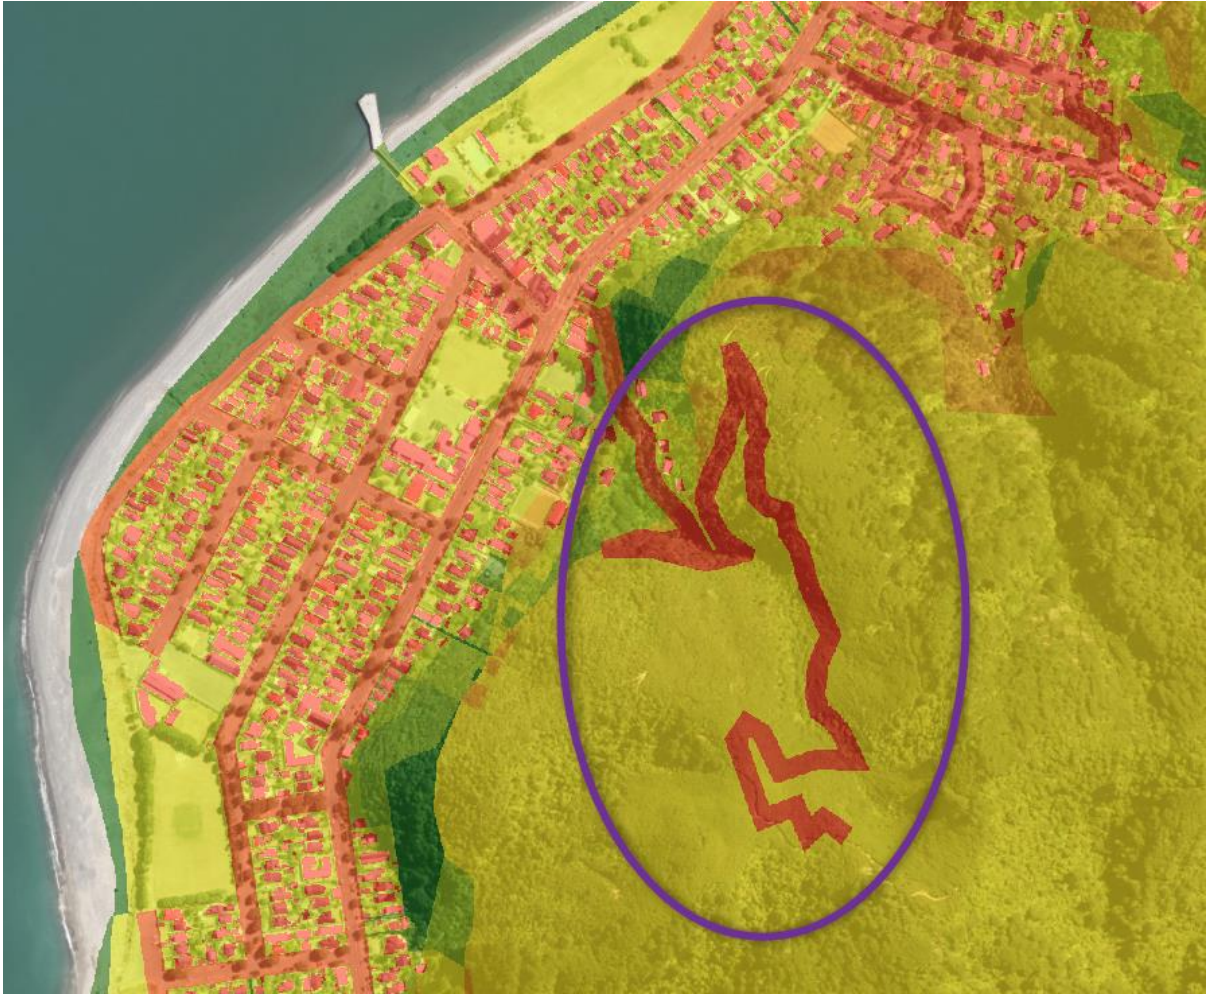
Figure 4 Non existent road with CN value of 91

Land use designation, curve numbers and surface roughness layers were available at Wellington Water Ltd for use in the model. These layers were spot checked and found to be reasonably sound. One exception that was identified is a paper road extending from MacKenzie Road into the upper hillside (Figure 4) which is recorded as almost impervious with CN value of 91. As this road does not exist, the composite CN value of the delineated subcatchment was greater than it is. The CN value for the subcatchment was revised from 67.81 to 63, to be consistent with CN value of the area at large.

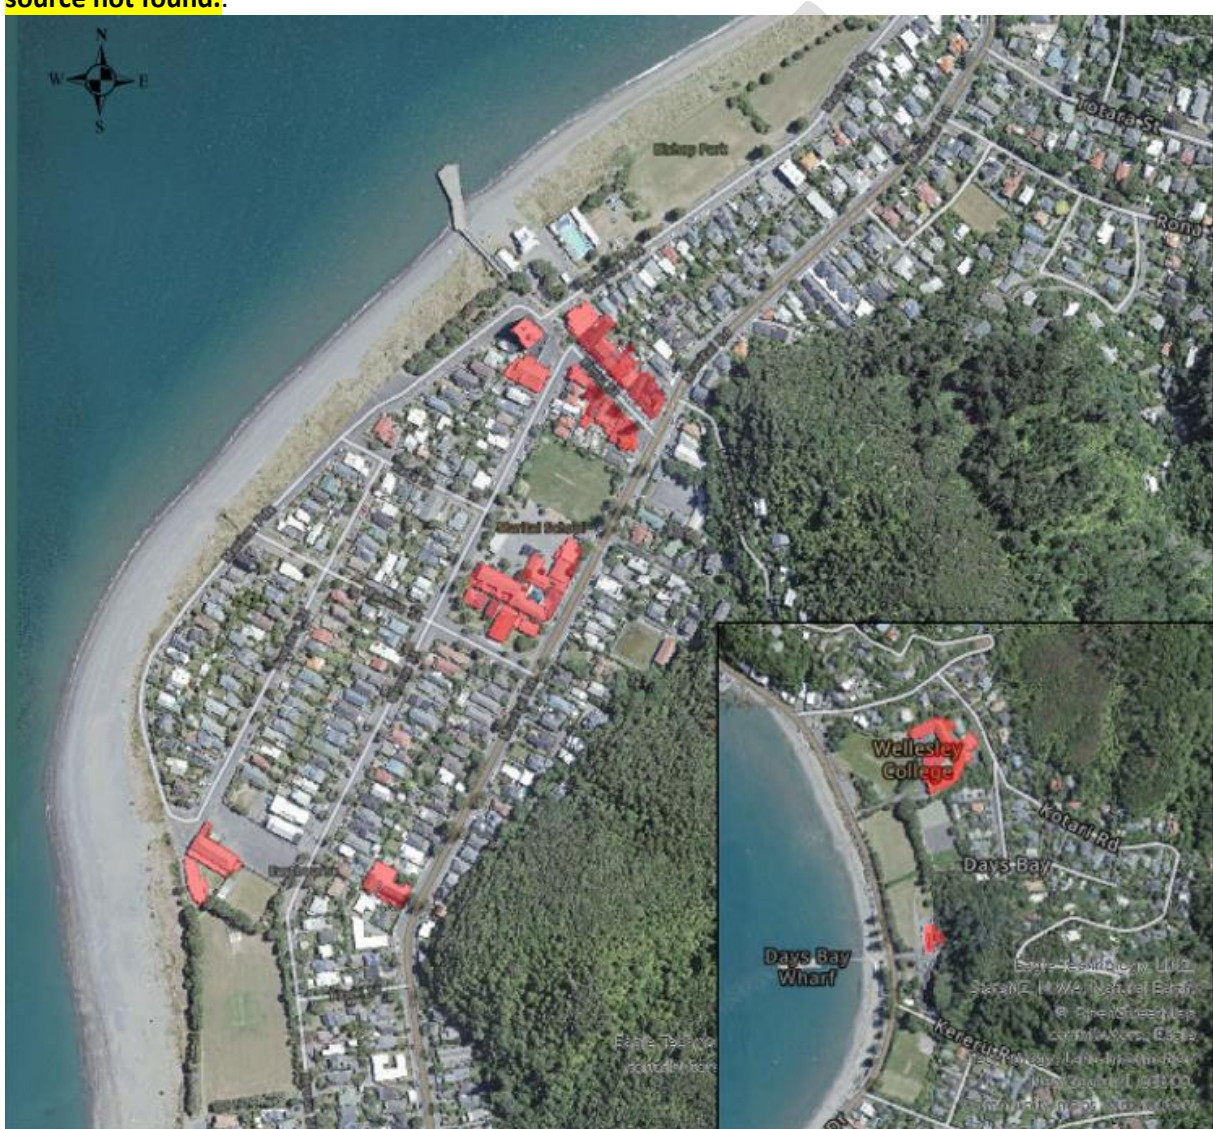
Figure 9 Building Voids layer

Some large commercial buildings in Eastbourne and Days Bay assessed to be a barrier to overland flow paths and prevent surface flows from passing through, were excluded from the 2-D surface model by modelling them as voids. The final building voids used are shown in **Error! Reference source not found.**

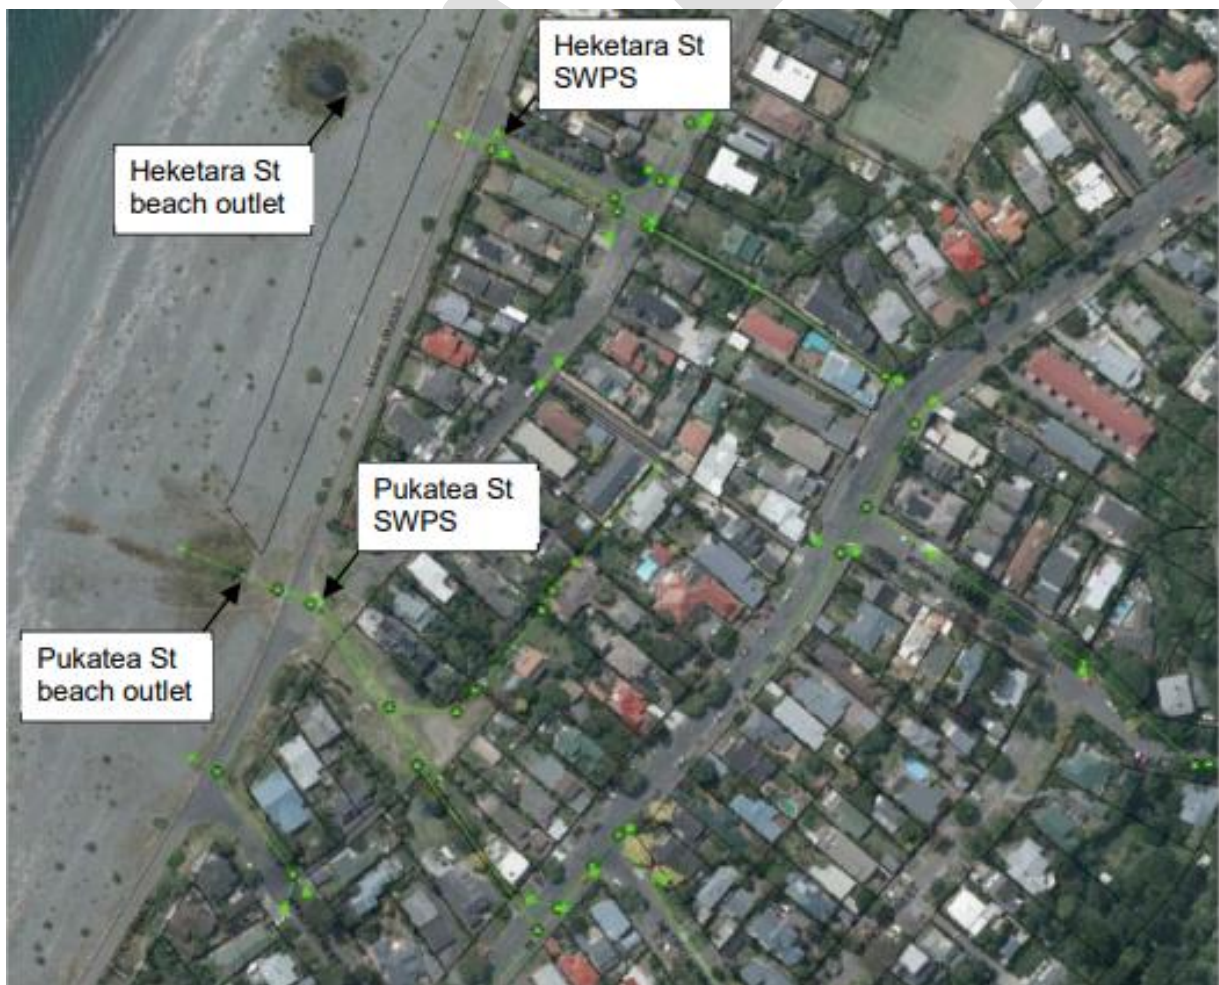
Figure 12 Overall Site Layout

There are two stormwater pumping stations in the East Harbour area and both have been included in the model as 1D model components. The two pump stations are referred to as Heketara Street and Pukatea Street and are indicated in Figure 12.

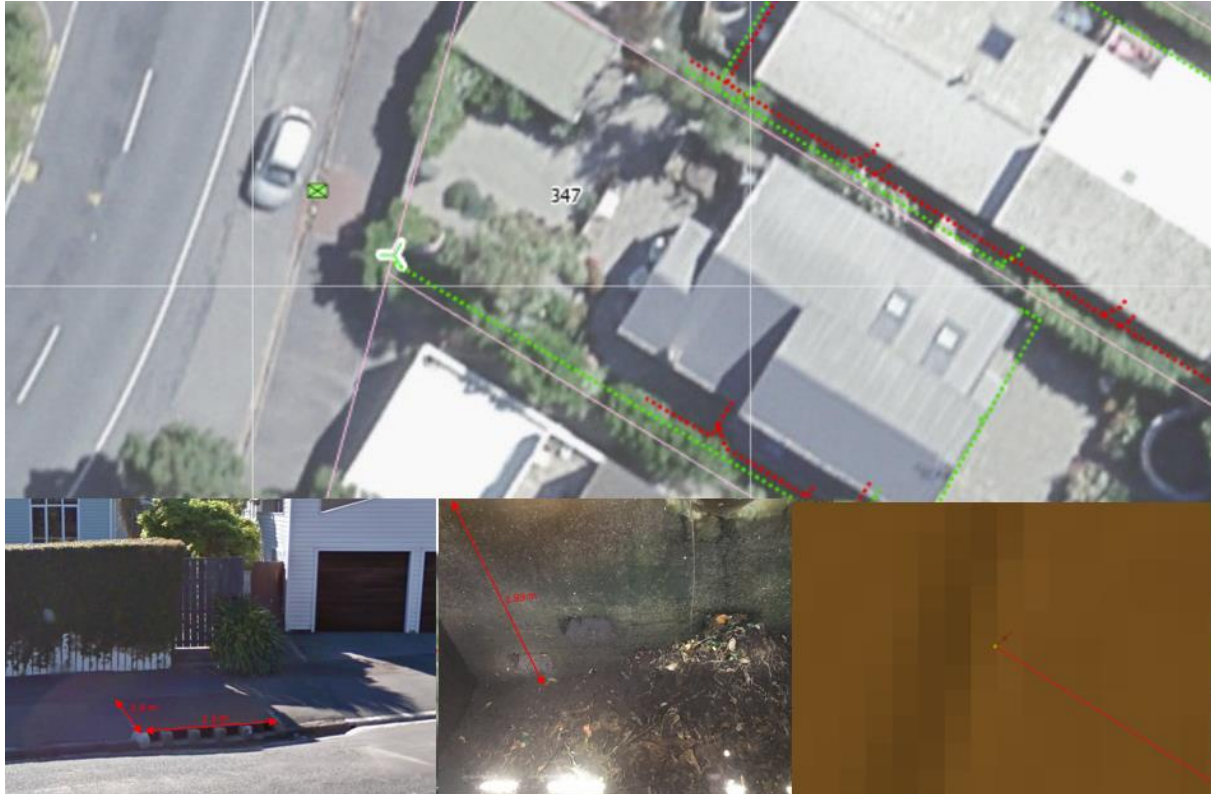
Figure 13 Soakage Chamber at 347 Muritai Rd

Adjacent to 347 Muritai Rd, there is a chamber unconnected to stormwater network. The dimensions of the chamber are indicated in Figures 13 below. The chamber receives runoff from the neighboring properties but its soakage capacity is unknown.

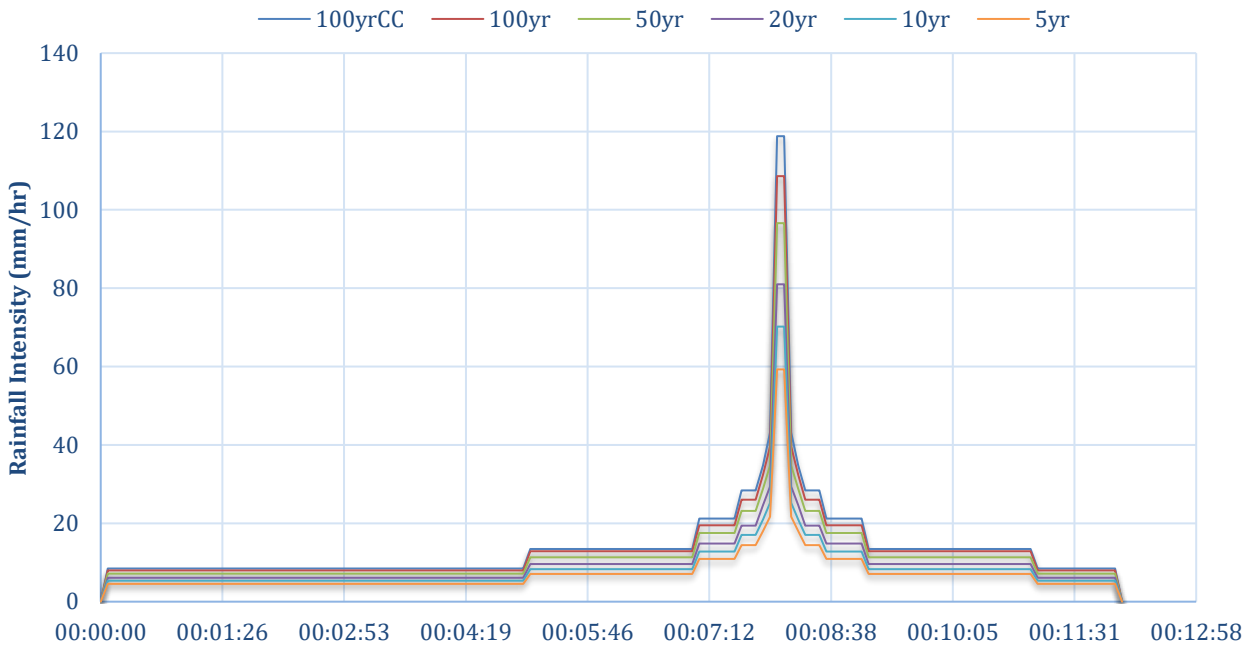
Figure 15 Nested storm events used in the model

To have a full understanding of modelled catchments response to the entire spectrum of rainfall durations, using above rainfall data, nested storm profiles were created as shown in Figure 15 below. The use of a nested storm means that one simulation event can represent a range of response times, including performance in different sub catchments as well as across the entire catchment.

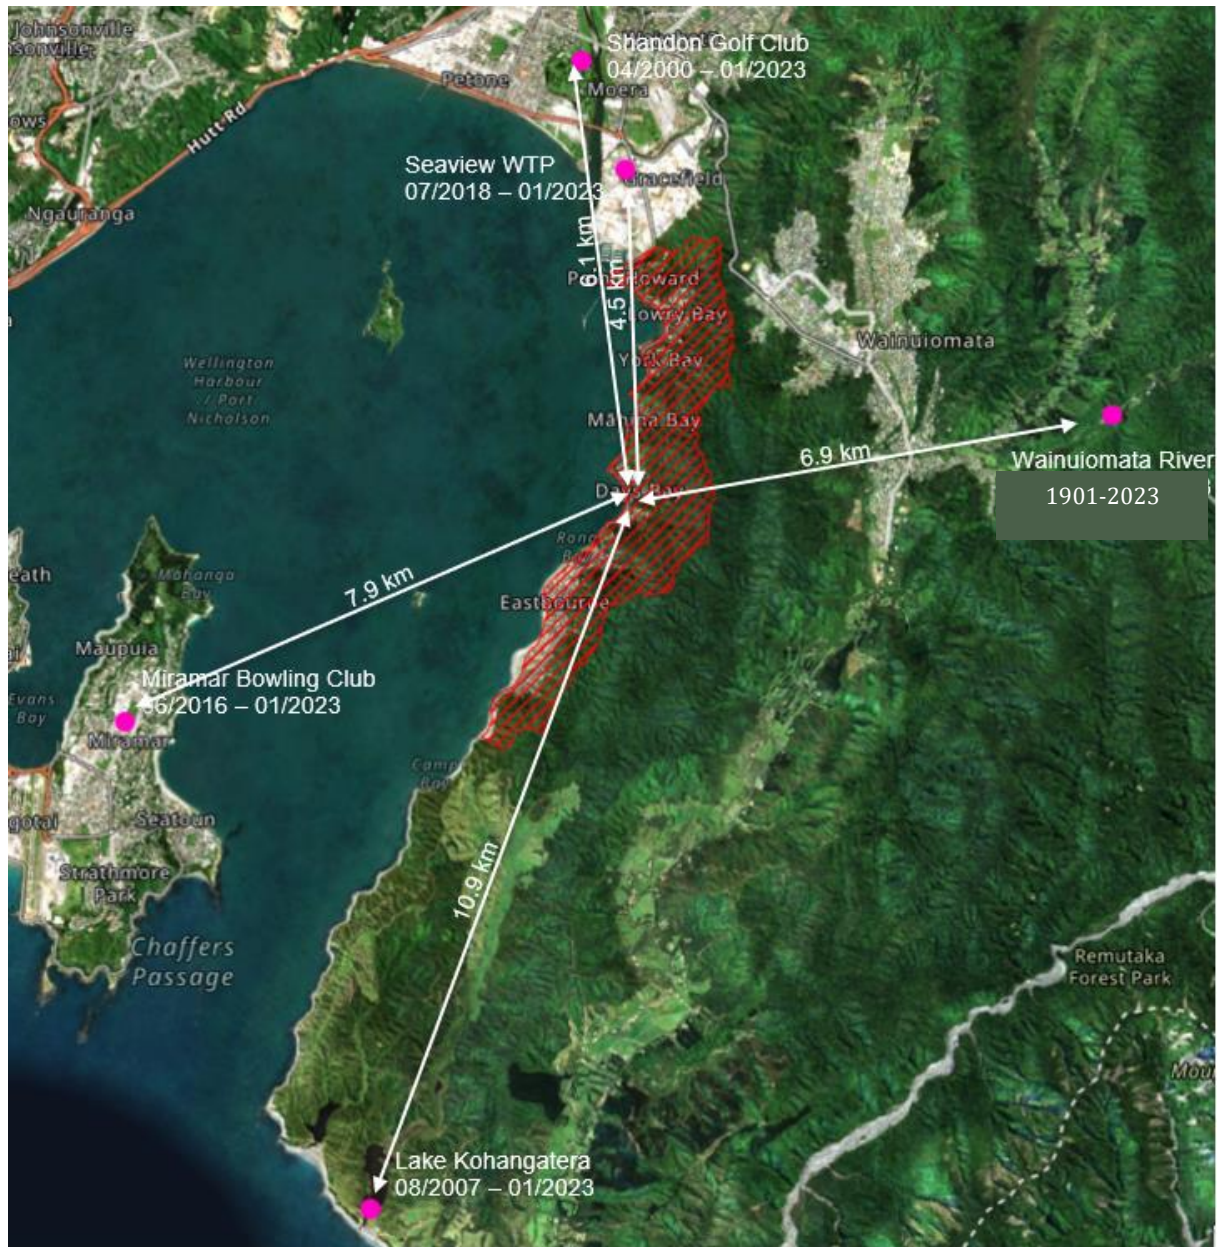
Figure 17 Rainfall gauge locations nearest to the study area

There are no rainfall gauges within East Harbour catchment itself for validation use. There are five adjacent active rainfall gauges of which Seaview WTP and Shandon Golf Club are the nearest. **Error! Reference source not found.** shows the location of the rainfall gauges in relation to the study area, while **Error! Reference source not found.** shows the rainfall records available at each site:

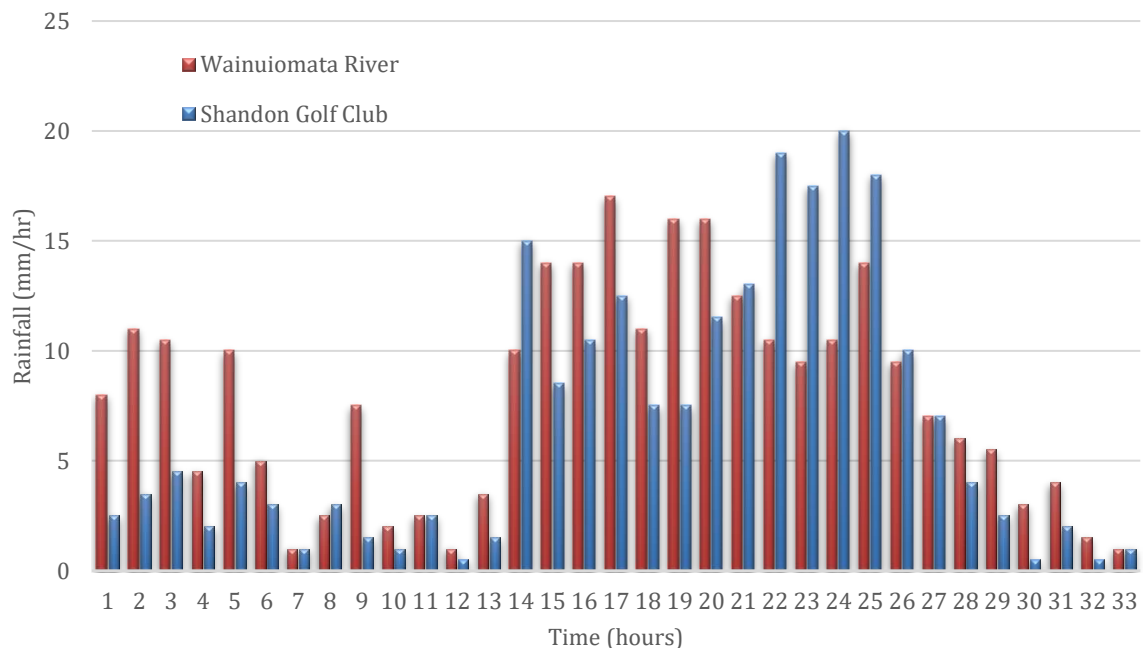
Figure 18 Temporal Pattern of 16 Feb 2004 Event Observed at Wainuio mata River and Shandon Golf Club Sites

16 February 2004: Error! Reference source not found. shows that the rainfall depth observed for the 24 hours over the 15-17 February 2004 at Shandon Golf Club and Wainuio mata River sites was similar at between 192-211 mm (80 yr ARI storm over 12 hrs). For the purposes of validation, Wainuio mata River rainfall data was employed.

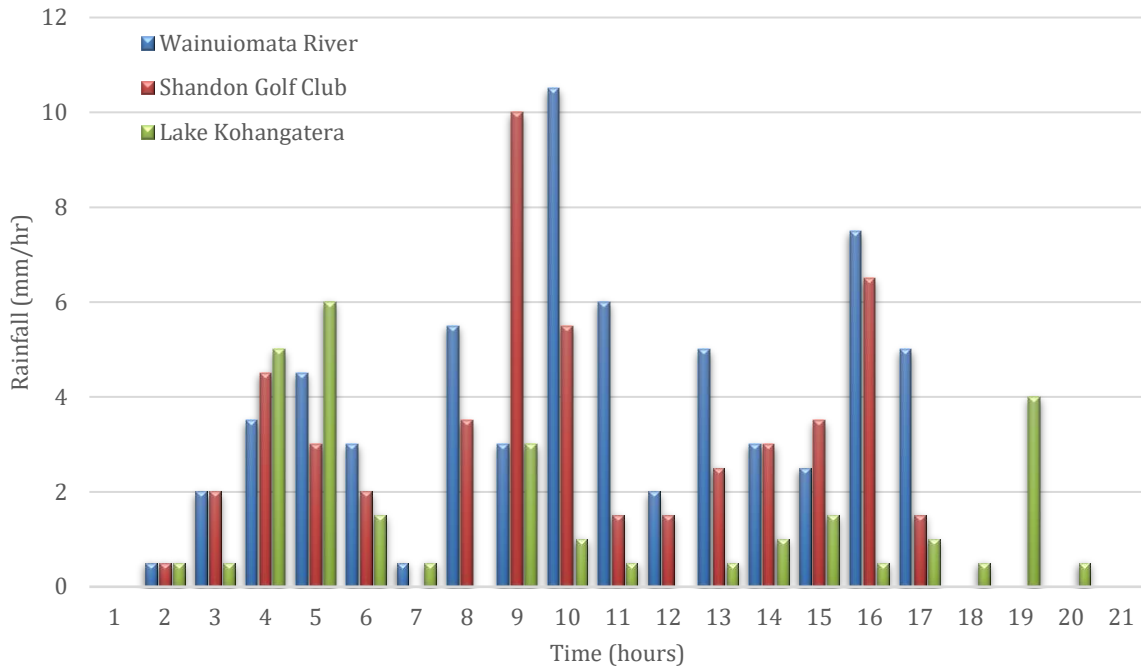
Figure 19 Temporal Pattern of 16 October 2009 Event Observed at Different Gauging Sites

16 October 2009: A rainfall depth of 58 mm over 12 hrs was observed at Wainuiomata river rainfall gauge for the 16 October 2009 event. This was a highest recording of all the gauges and can be categorised as less than 1.58 yr ARI storm. Temporal rainfall pattern of this event observed at Wainuiomata River was employed.

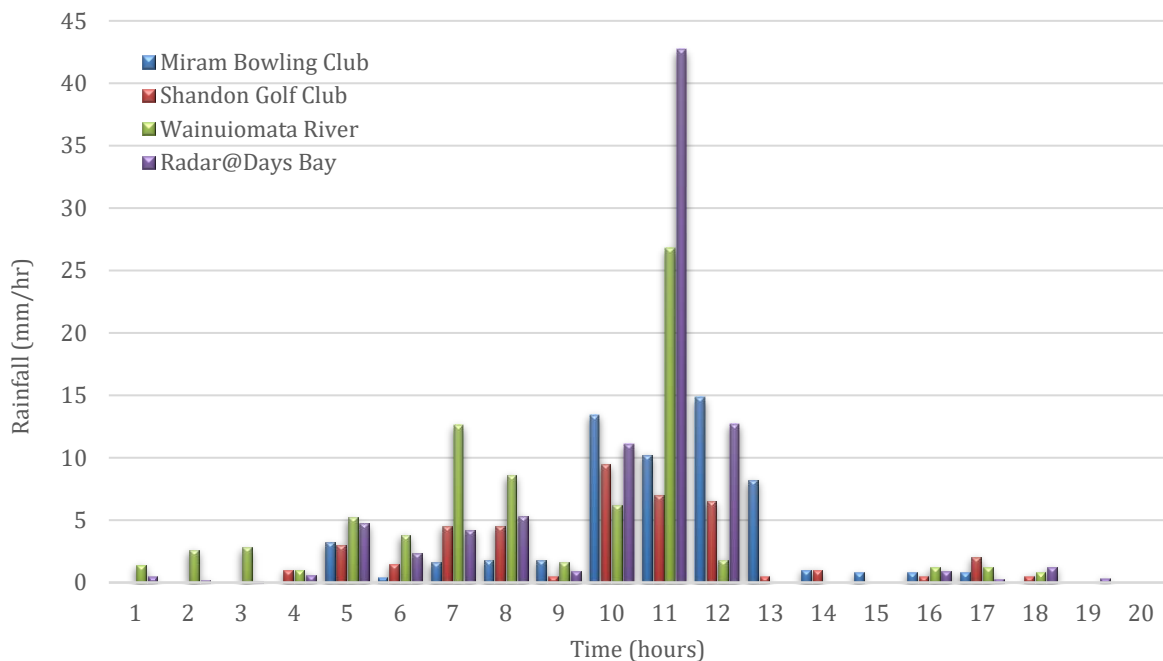
Figure 20 Temporal Pattern of 7 April 2019 Event Observed at Different Gauging Sites

7 April 2019 : For the 7 April 2019 event all the rain gauges with exception of Wainuiomata river indicated a minor event of less than 1.58 yr ARI. Wainuiomata river gauge with one hour maximum of 27 mm is categorised as 10 yr ARI storm. The rain radar data available for the East Harbour catchment estimates rainfall depth of 42.7 mm over a period of one hour. If this estimate is correct, then this event can be categorised as 100 yr ARI storm.

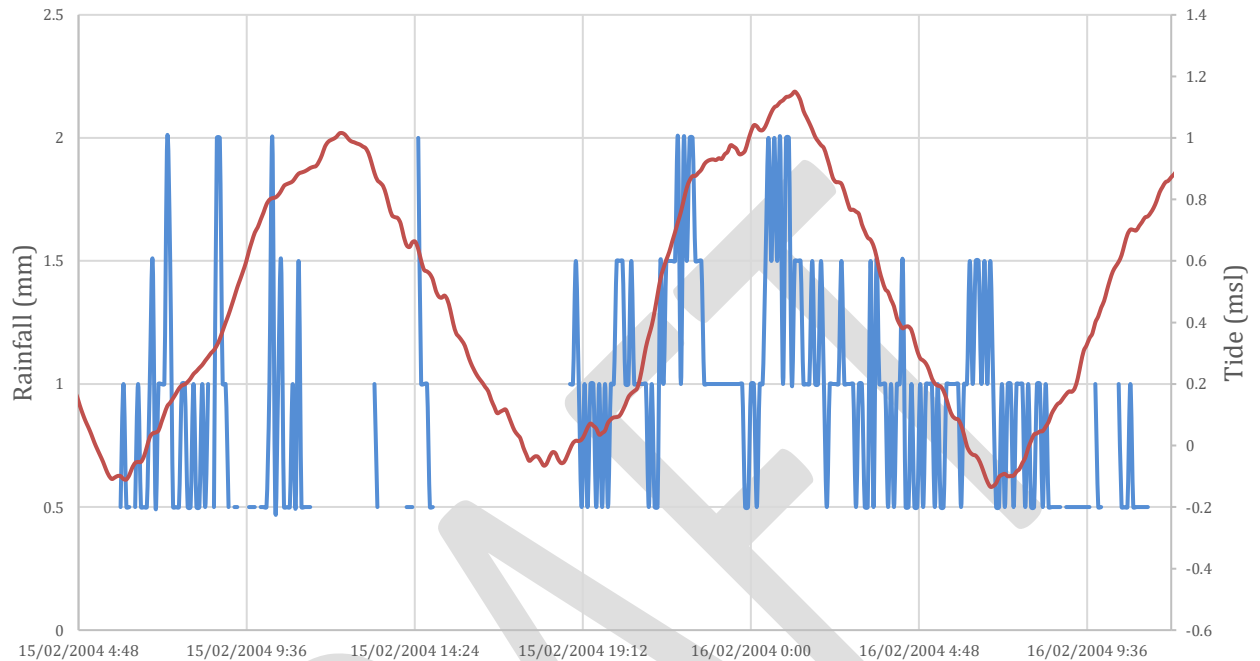
Figure 21 Validation Boundary Conditions (16th February 2004)

For the validation runs a dynamic tidal boundary was applied to the downstream tidal boundary of the model, based on the recorded levels in Wellington Harbour at Queens Wharf tidal gauge. Some smoothing of the raw data was carried out to reduce the instability at the downstream end of the model. Figures 21, 22 and 23 present rainfall and corresponding tide data for February 2004, October 2009 and April 2019 events respectively.

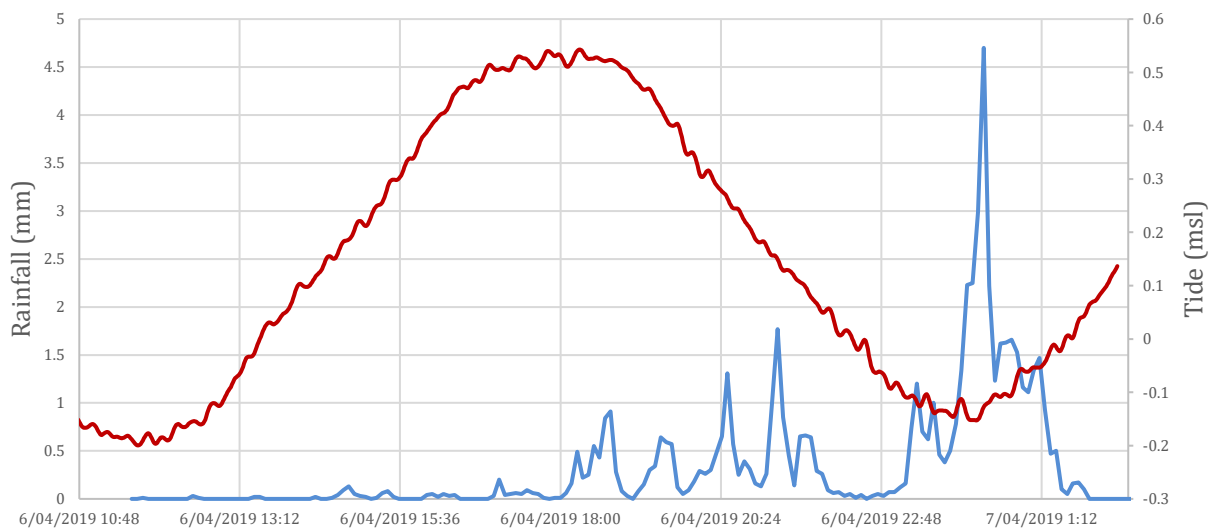
Figure 23 Validation Boundary Conditions (7th April 2019)

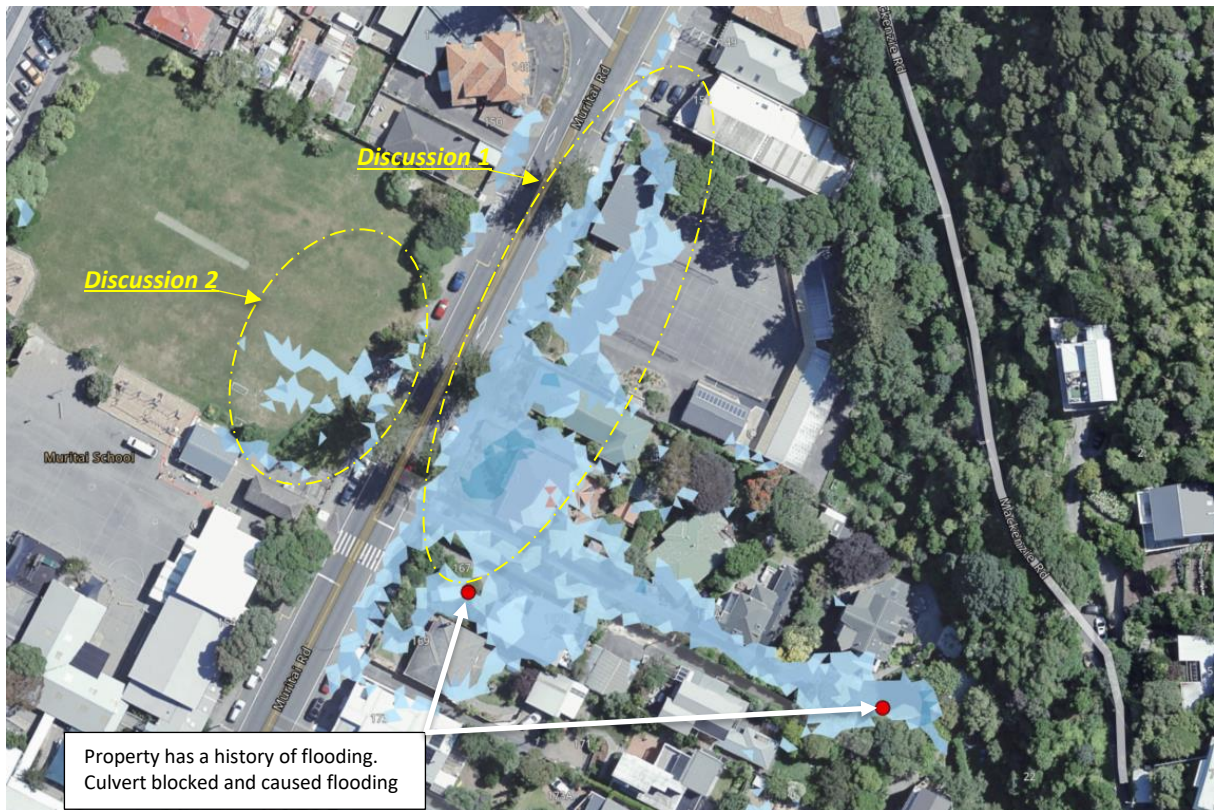
Figure 29 Flooding at 153 to 167 Muritai Rd and Muritai School in October 2009 – Modelled and Observed

Hutt City records indicate that properties at 165 and 167 Muritai Rd have history of flooding. It can't be positively confirmed whether the cause of the flooding is due to blockage of culvert as indicated in the council records or due to insufficient capacity as appears to be the case based on the model prediction.

The flood extent predicted by the model for 153 to 167 Muritai Rd appears to be accurate and is corroborated by the image in the top right corner in Figure 29 where it shows flooding extend to around half of school grounds.

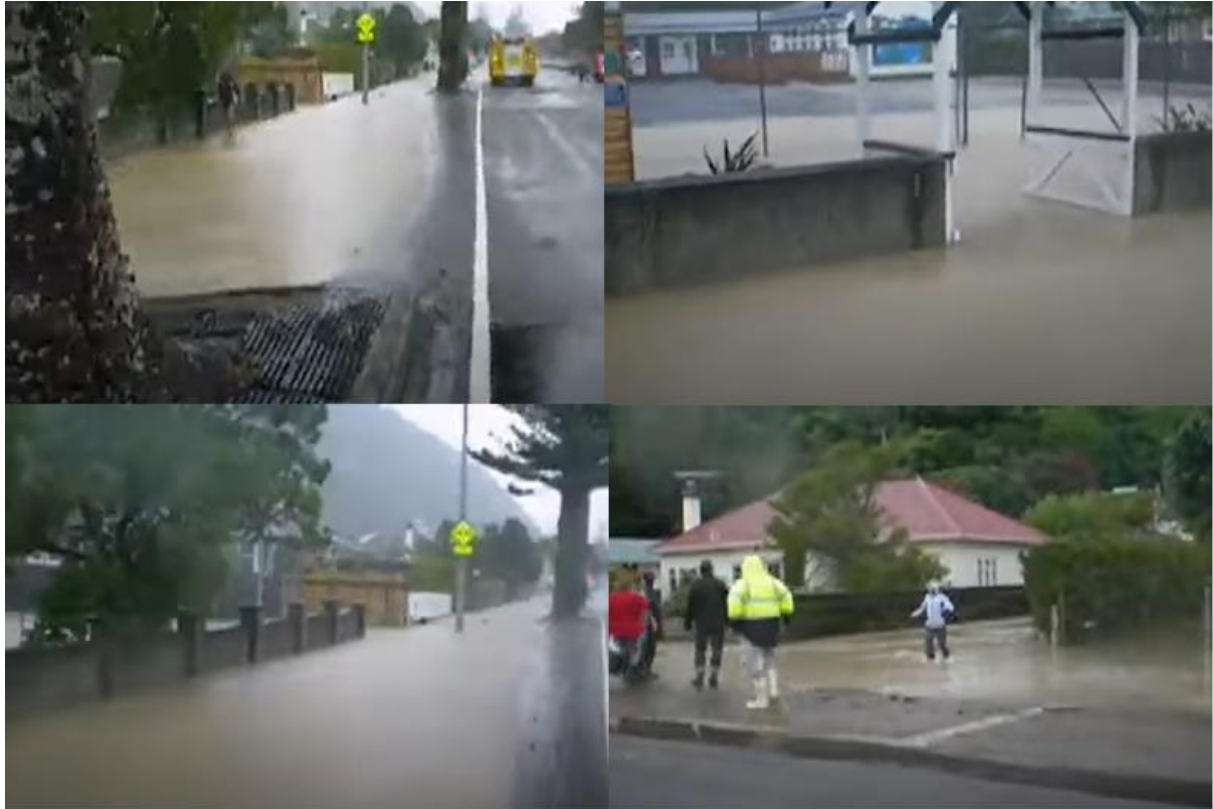
Figure 30 Flooding at 153 to 167 Muritai Rd during 16 October 2009 storm event

Model prediction for flooding at Muritai School grounds appears to match the video evidence from the event as can be seen in Figure 30.

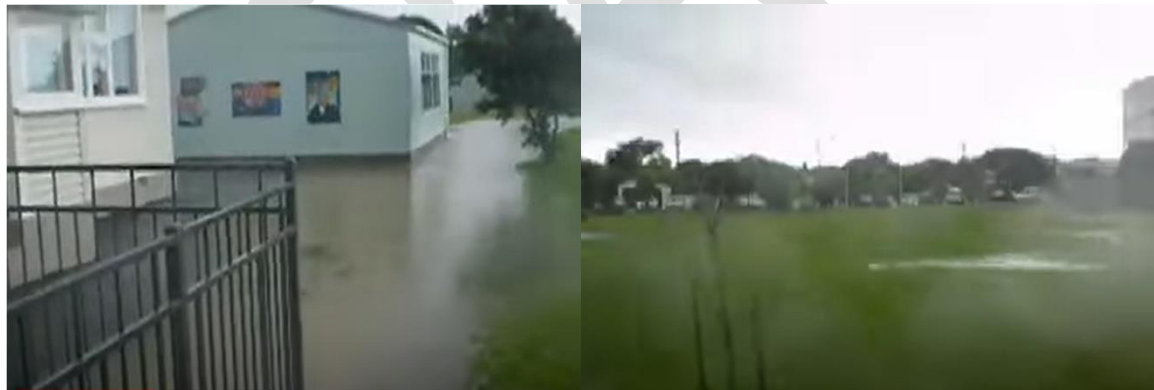
Figure 31 Flooding at Muritai School during 16 October 2009 storm event

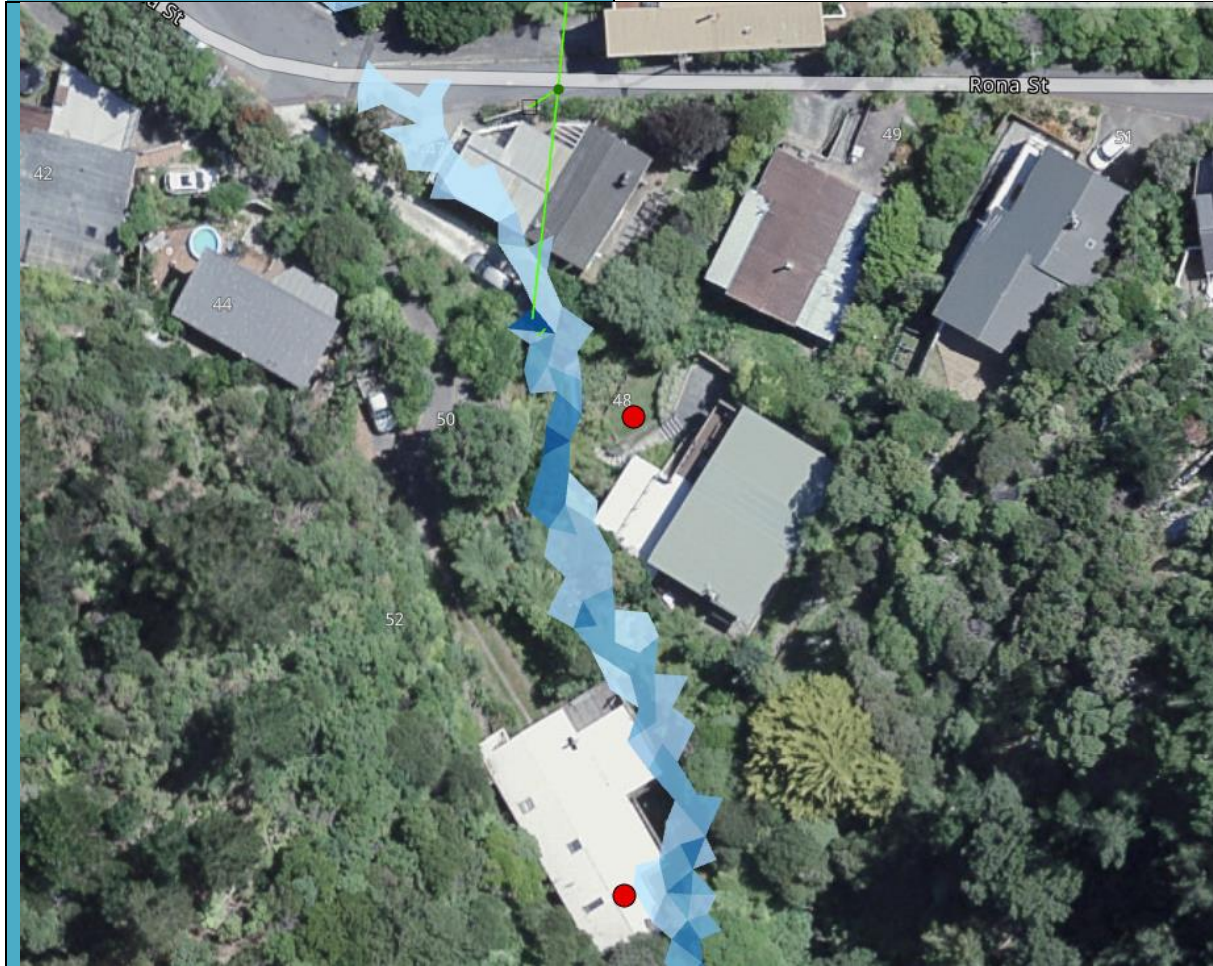
| Description of flooding from Social Pinpoint/HCC database | House flooded, caused by channel behind house overtopping. Stream burst banks and flooded multiple properties |
| Description of flooding from model | The model potential flooding at this location. The severity of it would depend on the stormwater network inlet conditions. If it was blocked, the flooding could be significantly more obvious. |

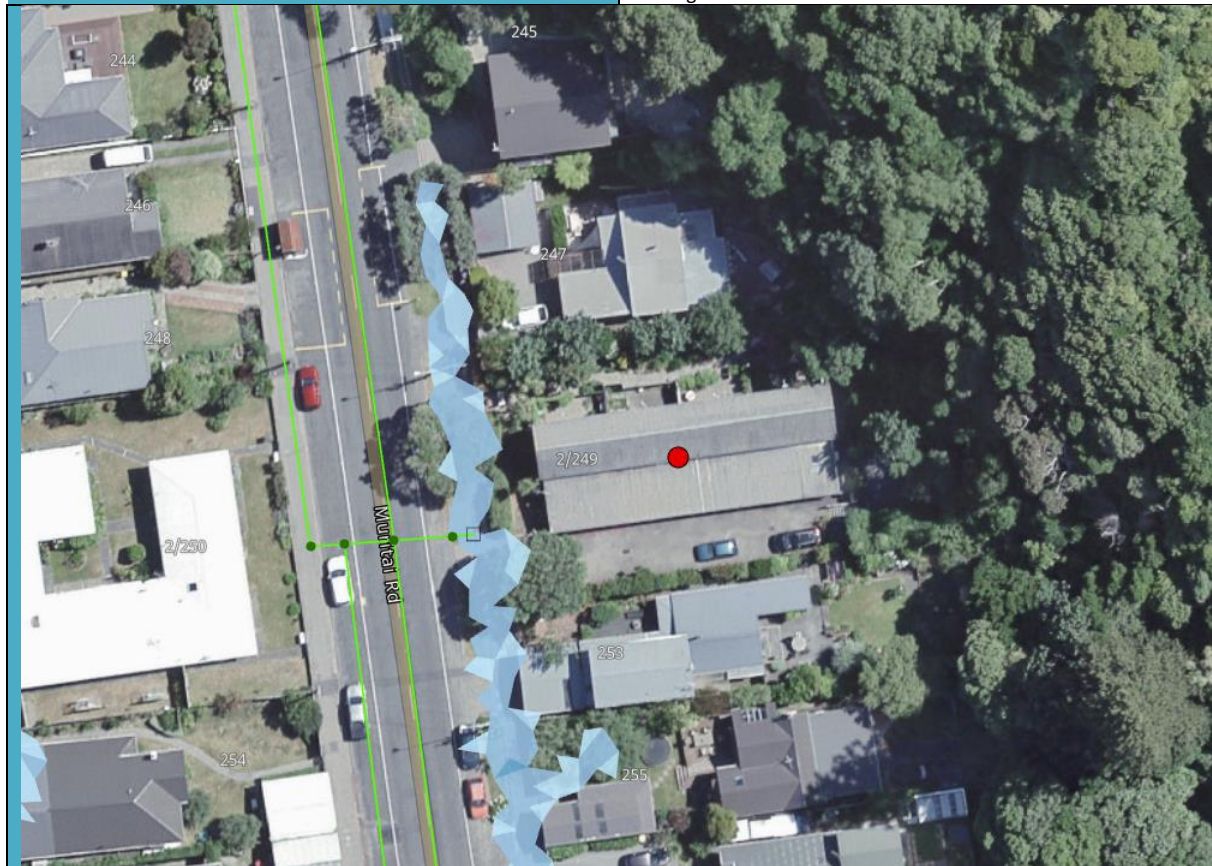
| Description of flooding from Social Pinpoint/HCC database | Flooding from large 2004 rainfall event. Several properties at the base of the hills could potentially be at risk of flooding |
| Description of flooding from model | The model does predict flooding at this location during Feb 2004 event however flooding is predicted at the front of the property as the hill sub-catchments discharge to the curb drain. Rain on grid results do indicate shallow runoff over this properties flowing towards the road. |

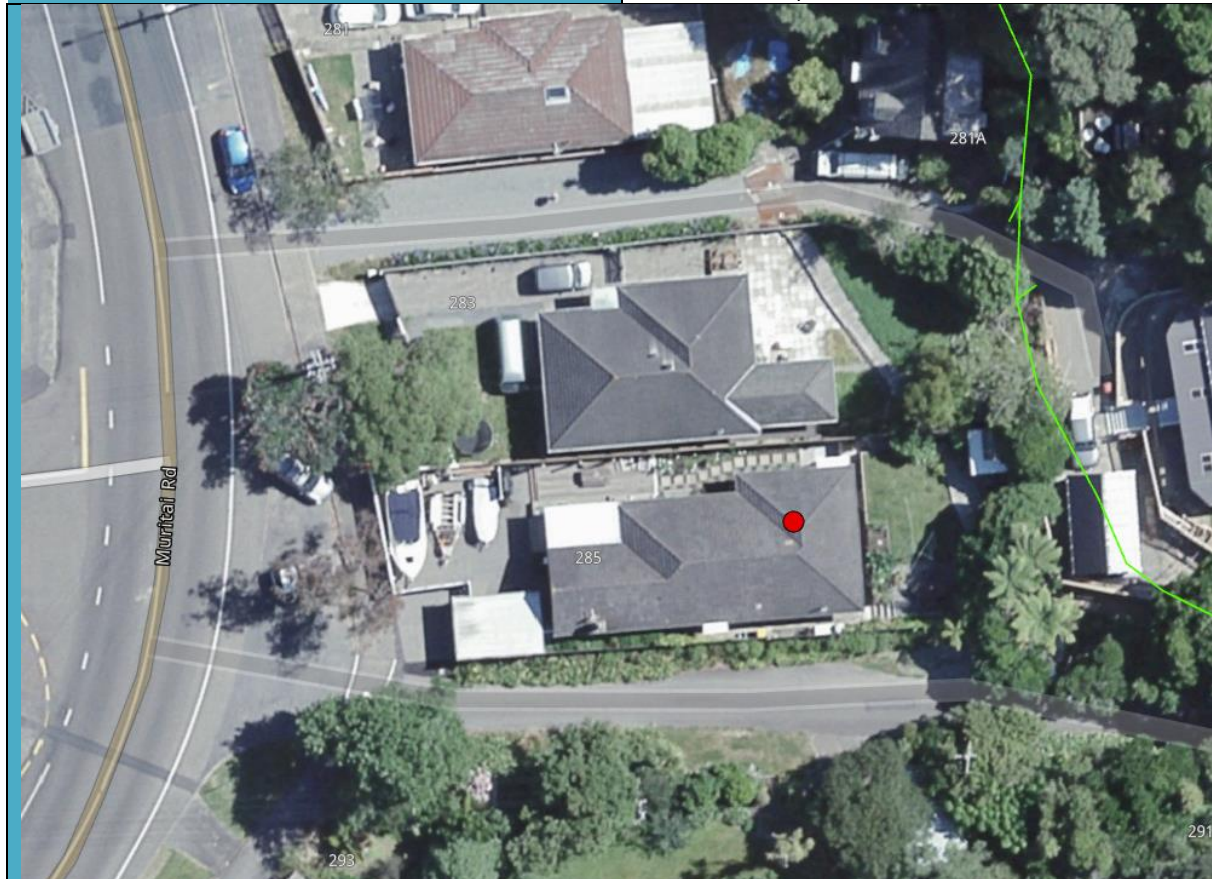
| Description of flooding from Social Pinpoint/HCC database | Flooding from large 2004 rainfall event. Several properties at the base of the hills could potentially be at risk of flooding |
| Description of flooding from model | The model does not predict flooding at this location during Feb 2004 event however it does predict flooding here for April 2019 event and for 100 yr ARI storm events. |

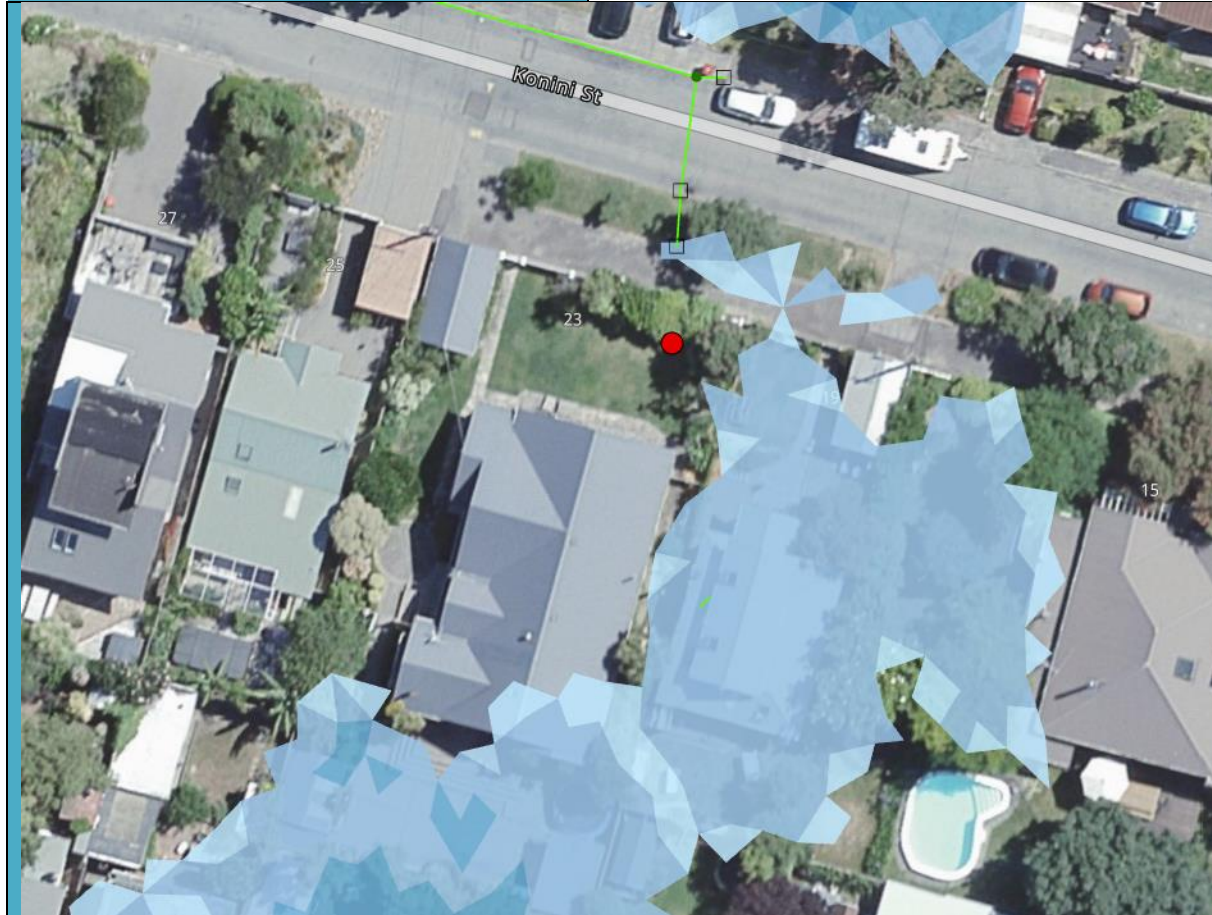
| Description of flooding from Social Pinpoint/HCC database | Floods the drain outside#23 every time there is decent/moderate rain. The flooding ranges from about 2m radius around the drain to covering the footpath. This is the only drain on the south side of the street |
| Description of flooding from model | Depression area. Does not easily drain. The model predicts flooding here for most events. |

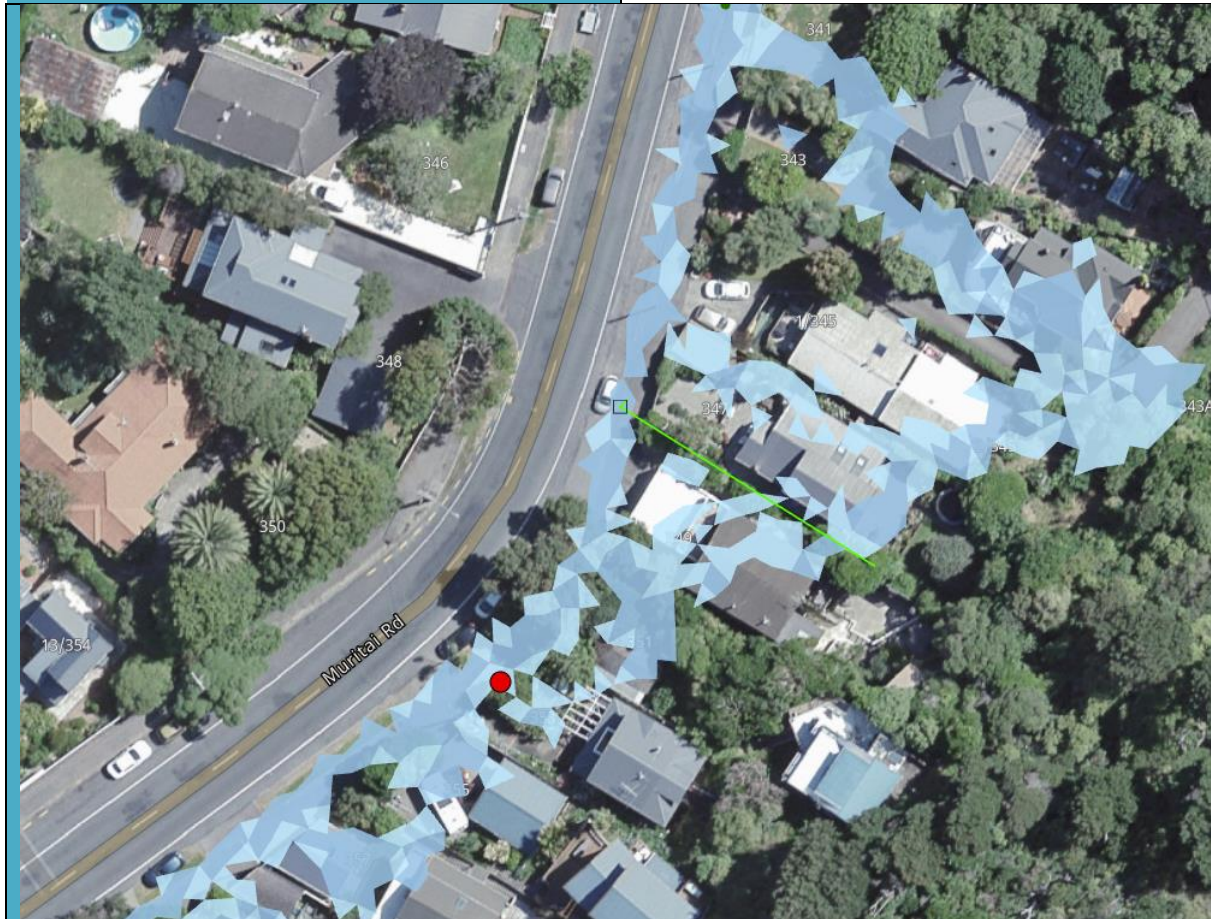
| Description of flooding from Social Pinpoint/HCC database | Flooding from large 2004 rainfall event. Flooding as a result of runoff from Hills. A number of properties at the base of the hills could potentially be at risk of flooding |
| Description of flooding from model | The model does not predict flooding at this location for Feb 2004 event. |

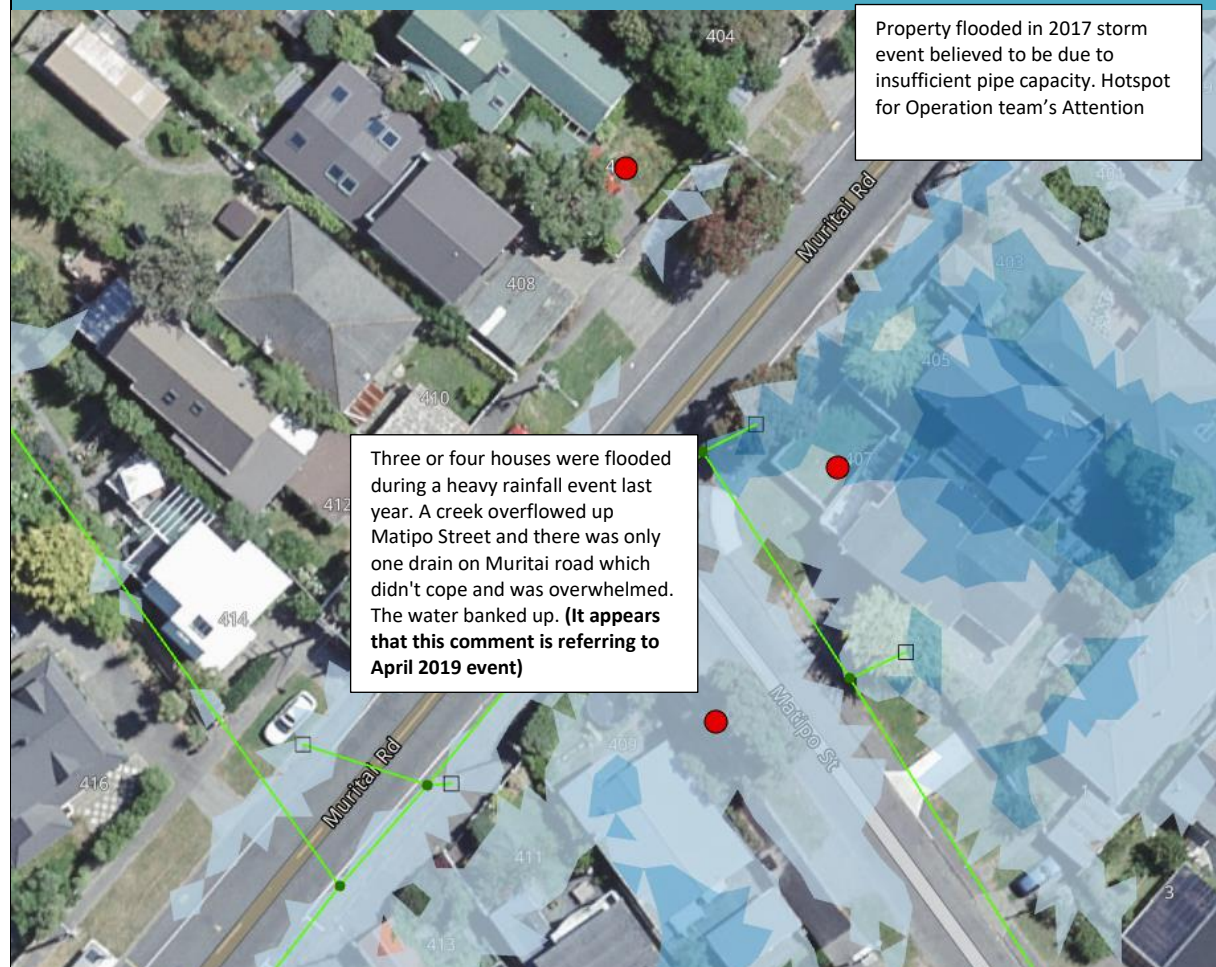
| Description of flooding from model | Rainfall associated with an event that generated flooding at several locations throughout Wellington in 2017 did not produce flooding consistent with what was reported in this catchment. There could be many reasons why this is so including outlet blockage etc. This is not known. One of the comments appears to be referring to 2019 event. The model does predict flooding at this location for 2019 storm. |

Property flooded in 2017 storm event believed to be due to insufficient pipe capacity.
