The East Harbour Stormwater Catchment

Model Build Report

This modelling study has been undertaken by Wellington Water Limited (Wellington Water Ltd) to assist management of stormwater in the catchment. The model is to be used for the generation of flood hazard maps and may subsequently be used to assess options for upgrading the stormwater system to mitigate flooding in the catchment.

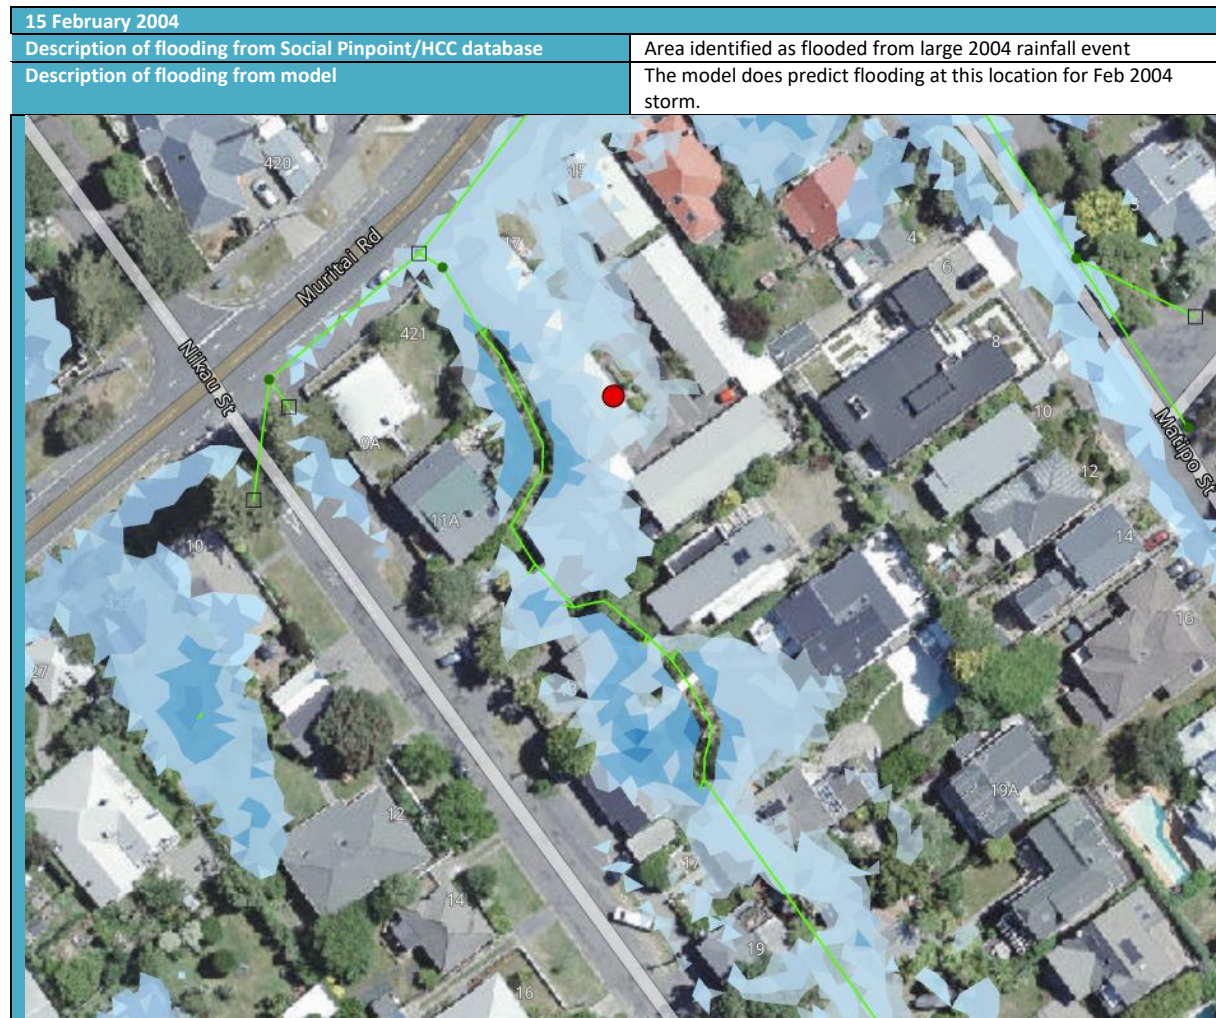
Muritai Rd and Nikau St intersection, Eastbourne

Property flooded in 2017 storm event believed to be due to insufficient pipe capacity. Hotspot for Operation team's Attention

Three or four houses were flooded during a heavy rainfall event last year. A creek overflowed up Matipo Street and there was only one drain on Muritai road which didn't cope and was overwhelmed. The water banked up. **(It appears that this comment is referring to April 2019 event)**

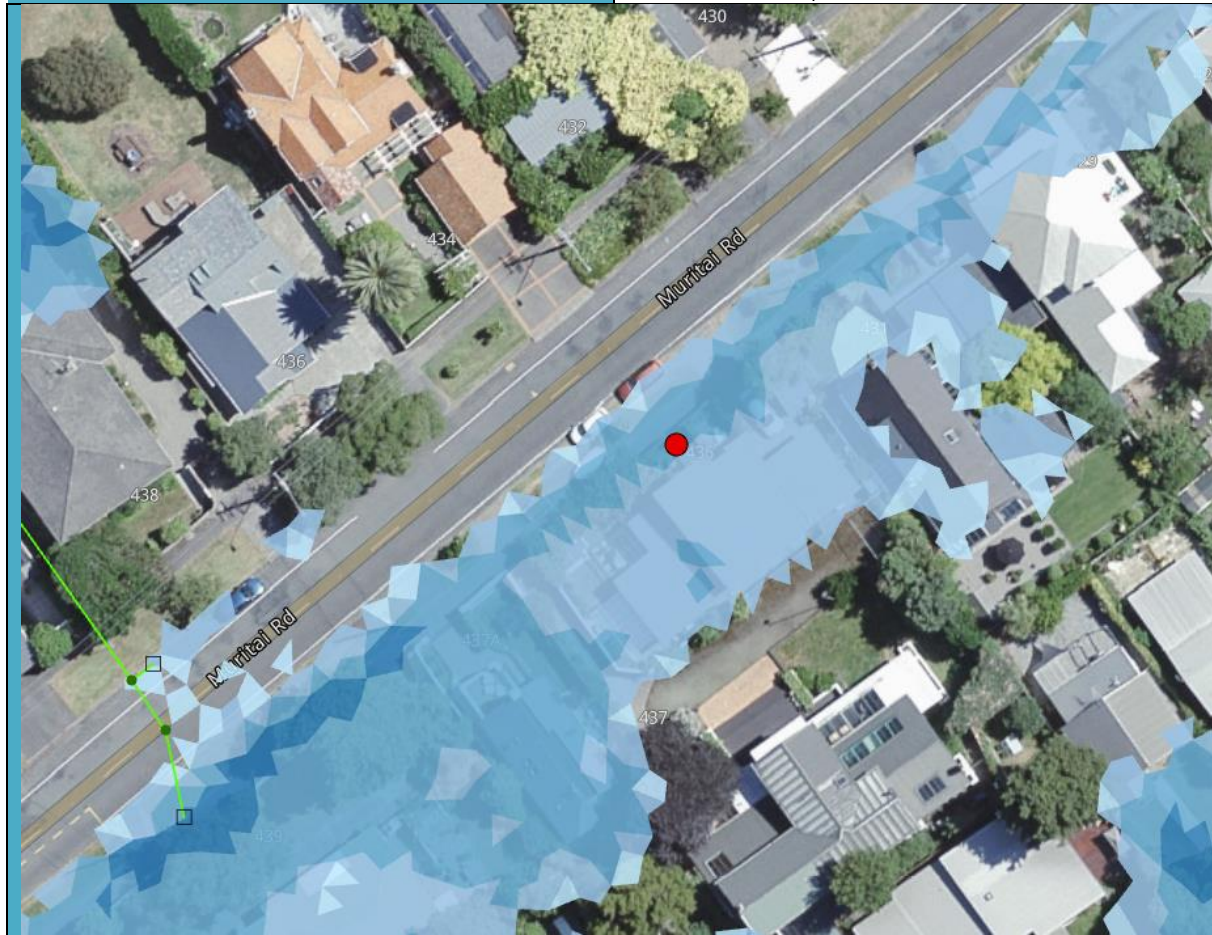
| Description of flooding from Social Pinpoint/HCC database | Surface flooding on the street/gutter during heavy rainfall. Our front garden also fills up with rain during heavy rainfall events and can flood up to about 3 or 4 inches deep. |
| Description of flooding from model | The description does not mention the event when flooding occurred. The model does predict flooding at this location for Feb 2004 event but not April 2019 event. |

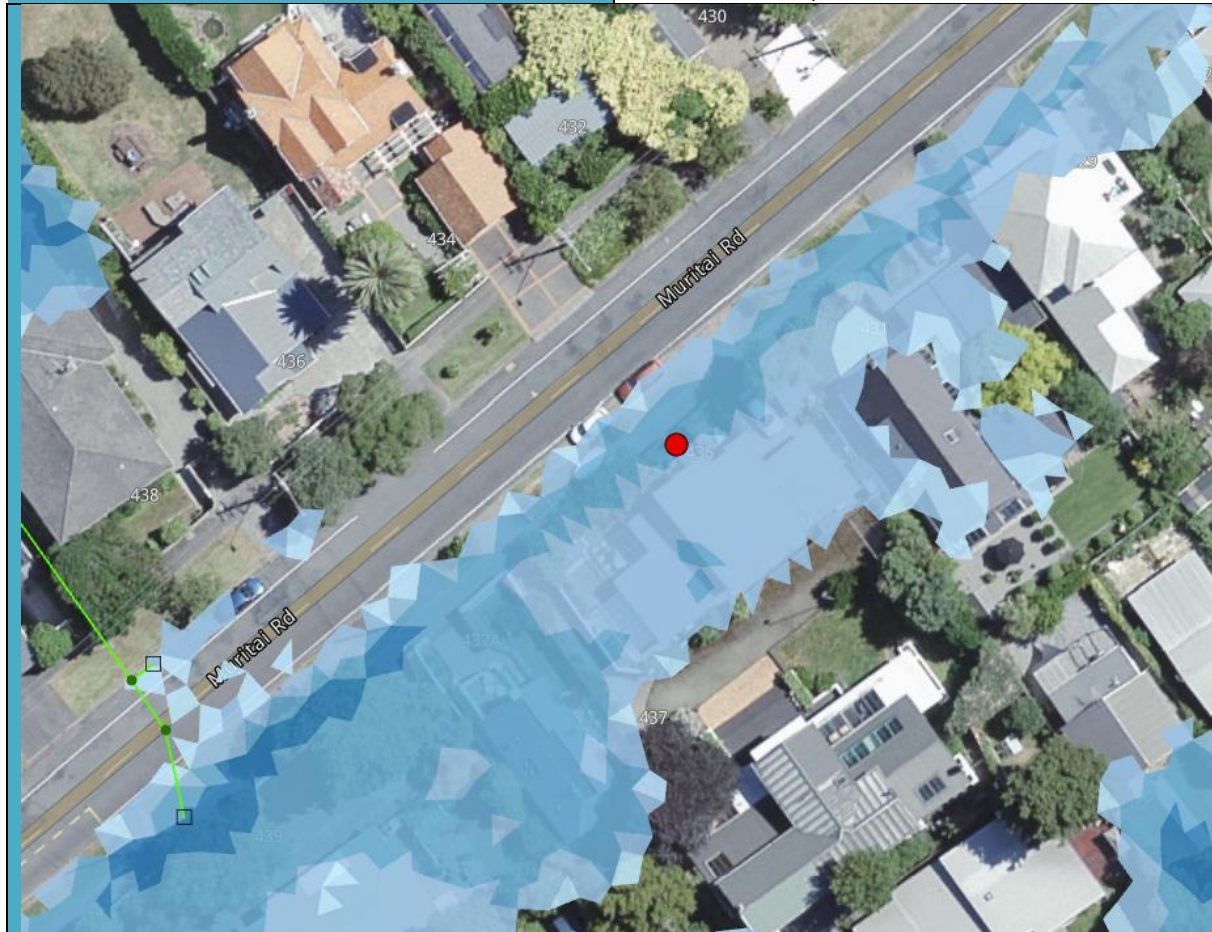
| Description of flooding from Social Pinpoint/HCC database | Surface flooding on the street/gutter during heavy rainfall. Our front garden also fills up with rain during heavy rainfall events and can flood up to about 3 or 4 inches deep. |
| Description of flooding from model | The description does not mention the event when flooding occurred. The model does predict flooding at this location for Feb 2004 event but not April 2019 event. |

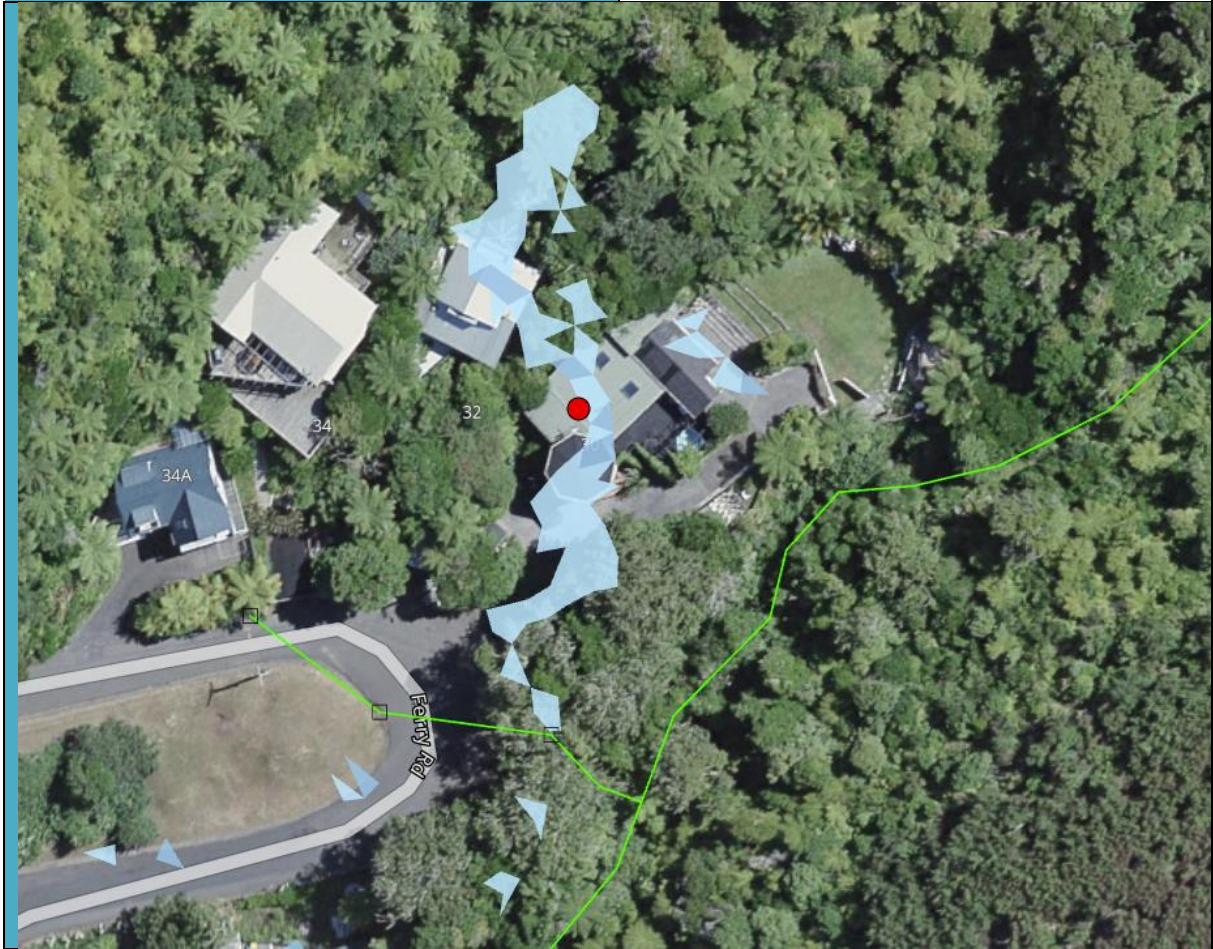
| Description of flooding from Social Pinpoint/HCC database | Internal flooding at No 30 Ferry Road Feb 2004, Problems at 28A August 2004, Located at base of hillside catchment |
| Description of flooding from model | The model does predict flooding at this location for Feb 2004 event. |

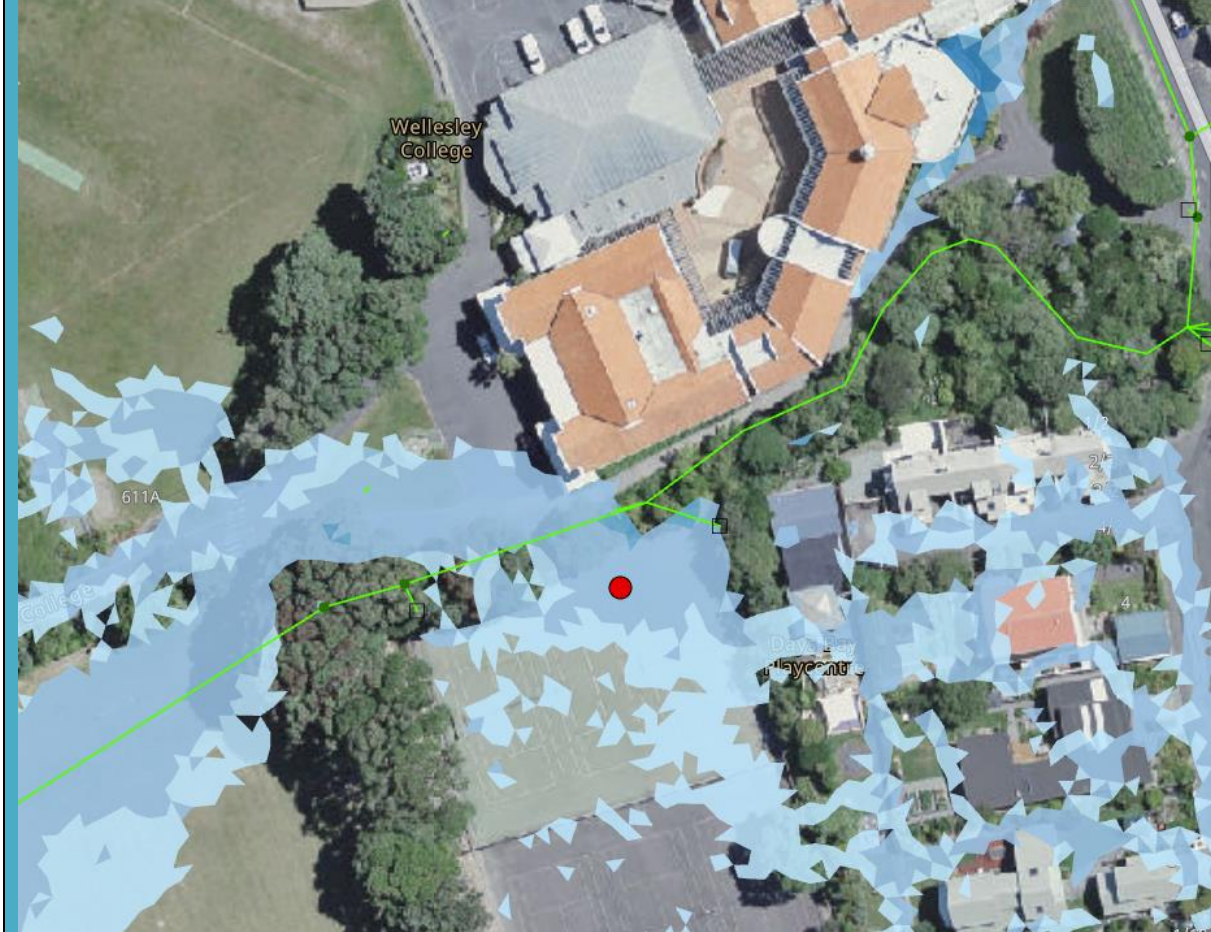
| Description of flooding from Social Pinpoint/HCC database | Washout and debris at entrance of pipe on the edge of sports field at Wellesley College. |
| Description of flooding from model | The comment does not specify the event when flooding occurred. The model does predict flooding at this location for Feb 2004 event. |

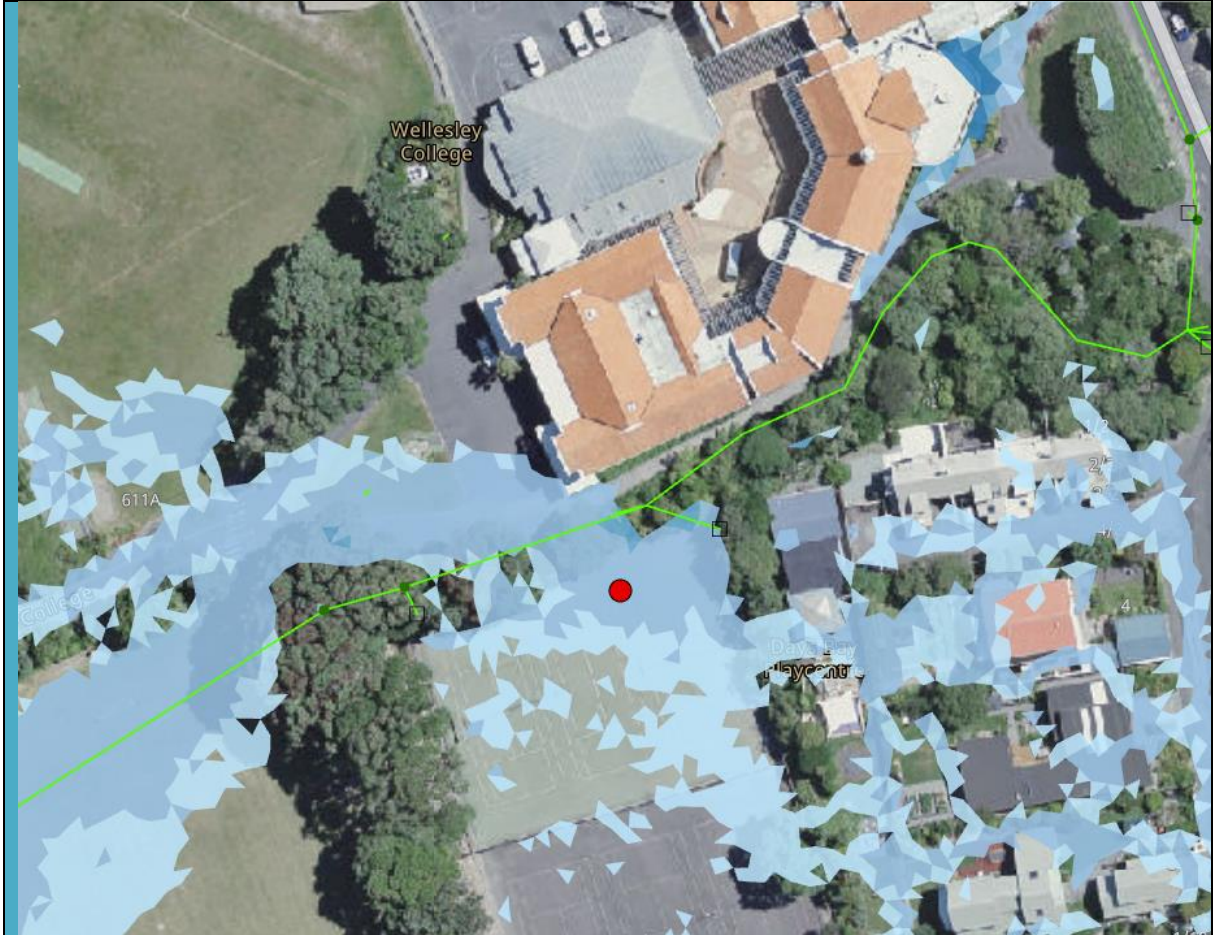
| Description of flooding from Social Pinpoint/HCC database | Washout and debris at entrance of pipe on the edge of sports field at Wellesley College. |
| Description of flooding from model | The comment does not specify the event when flooding occurred. The model does predict flooding at this location for Feb 2004 event. |

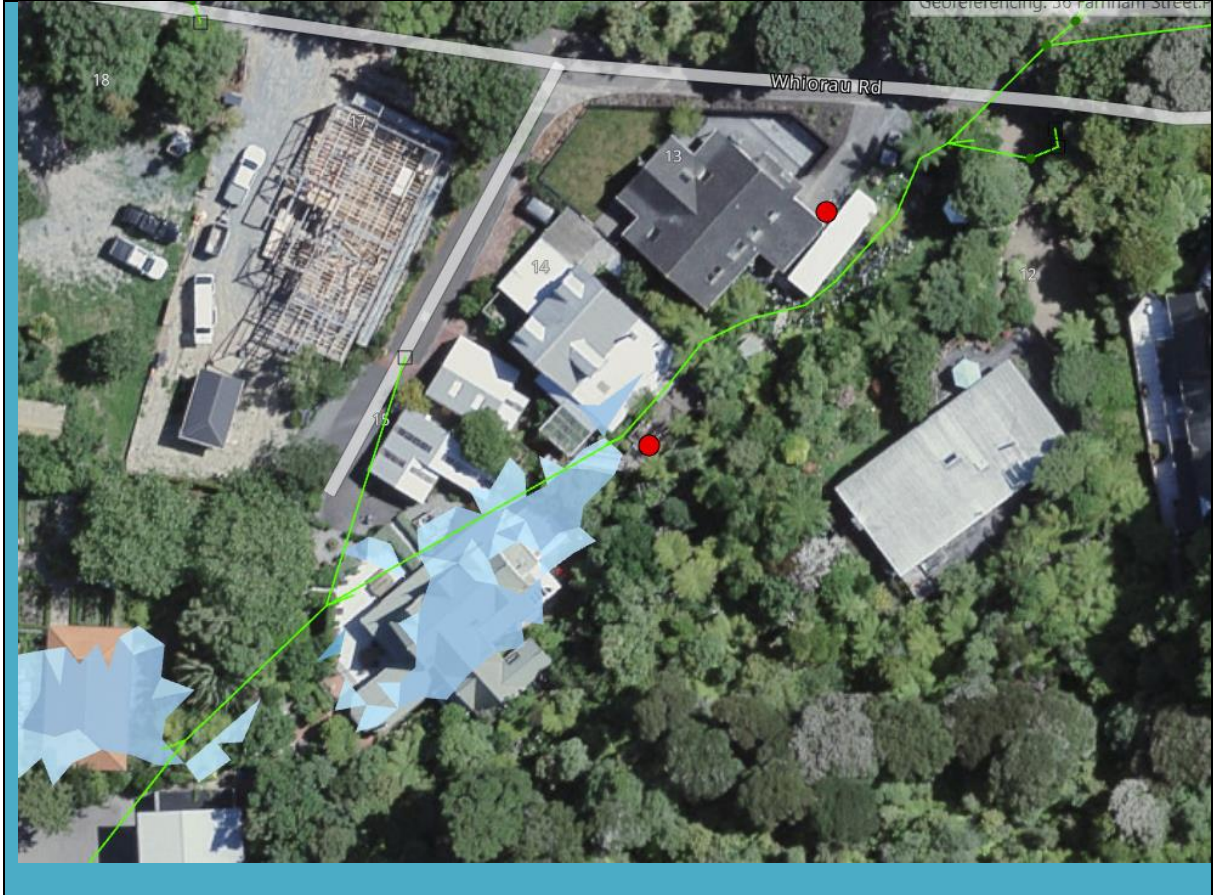
| Description of flooding from Social Pinpoint/HCC database | Flooding problems reported in February and August 2004 rainfall events. Likely due to blocked intake |
| Description of flooding from model | The model does predict flooding at this location but seemingly of less severity. It is not clear what is meant by blocked intake in the comment. |
