SUBJECT Modelled Flooding at 23 Pomare Rd, Tirohanga

To assess model predictions for flooding at 23 Pomare Rd, Tirohanga, considering modelled topographic discrepancies between the model data input and actual ground topography.

SUBJECT Modelled Flooding at 23 Pomare Rd, Tirohanga - Update

To investigate the gully draining beside the boundary between 23 Pomare Rd and 760 Western Hutt Rd and assess its impact on the model predictions for flooding.

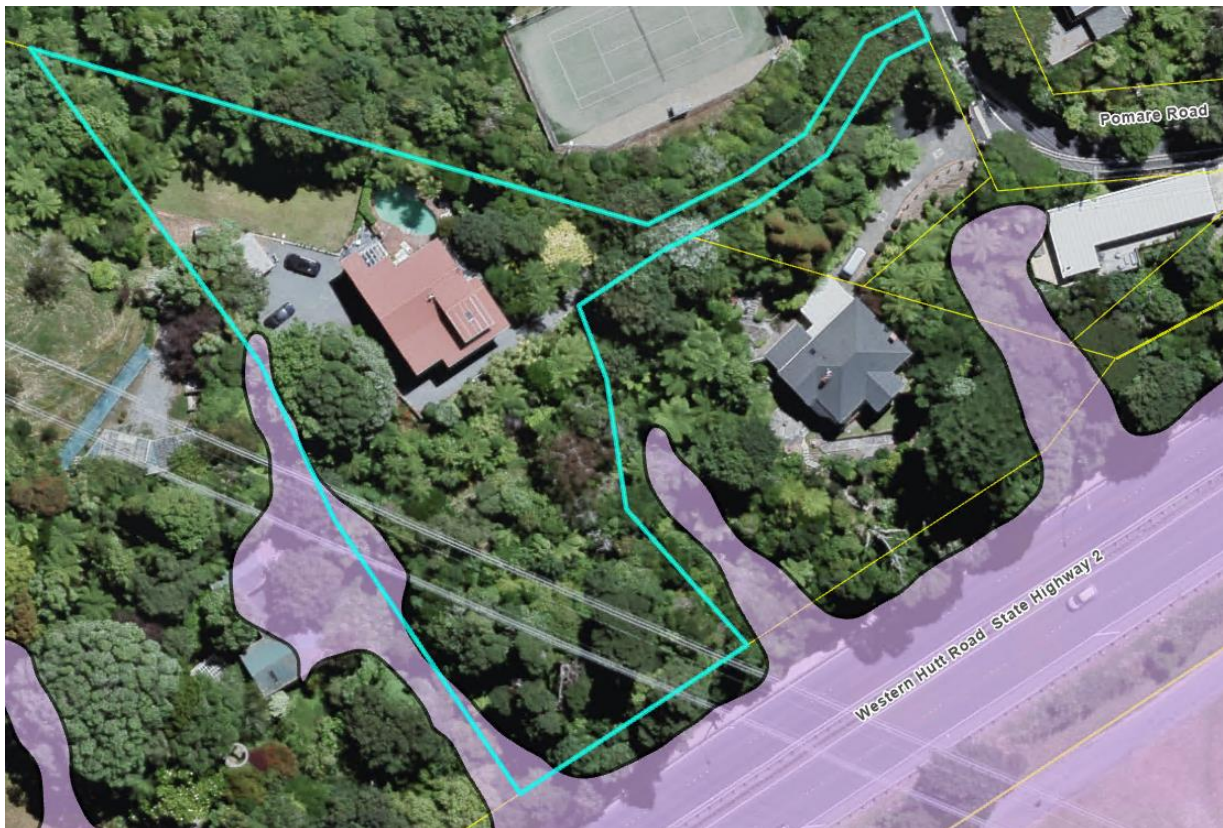
Wellington Water is still working through the updated hazard mapping for the Petone stormwater model (covering Tirohanga) into which this work will be incorporated and do not have a final hazard layer available at this time. However, Figure 9 below shows the expected extent of the updated flood hazard mapping in the vicinity of 23 Pomare Rd.

**Figure 9:** Updated flood hazard extents in the vicinity of 23 Pomare Rd

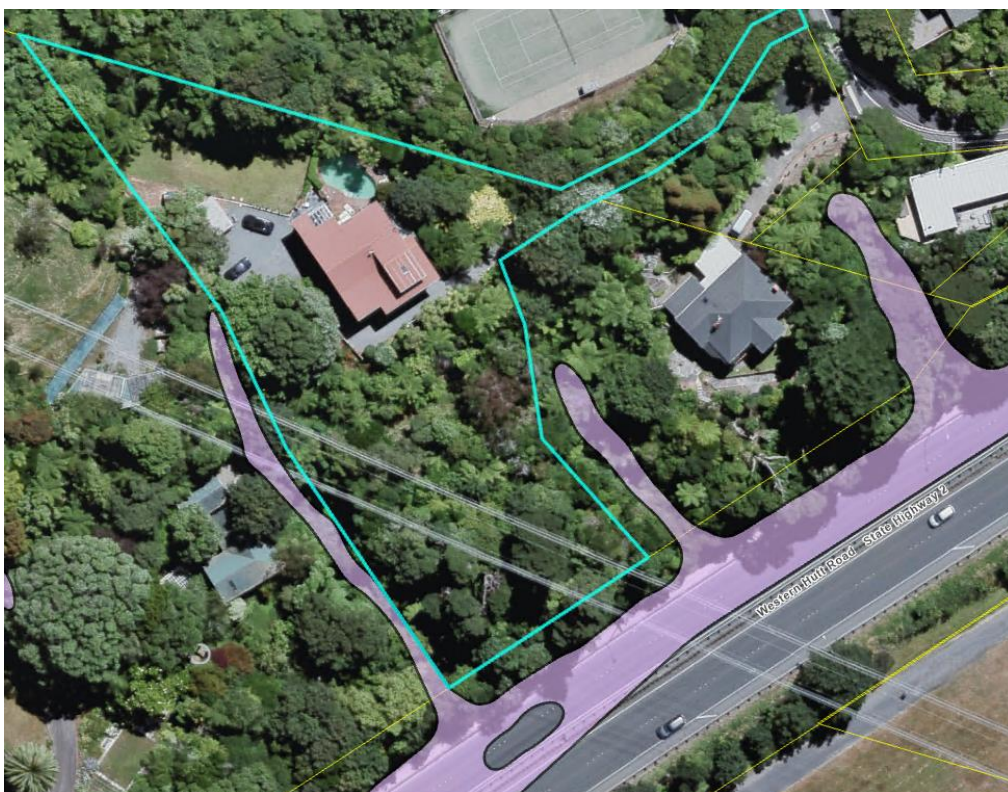
As part of the additional analysis undertaken by Wellington Water, the flood hazard maps that will be applied by Hutt City Council in the upcoming notified Proposed District Plan have been updated to reflect this updated modelling. Figure 4 below shows the extent of the updated flood hazard mapping in the vicinity of 23 Pomare Rd. The updated mapping shows there is no longer a modelled flood hazard on the property.

**Figure 4:** Updated flood hazard extents in the vicinity of 23 Pomare Rd
