Coast Road River Erosion Mitigation Works

- Approximately 2.5km south of the WGC entrance
- River Berm Excavation
- Retaining Wall Construction

8/4/2022

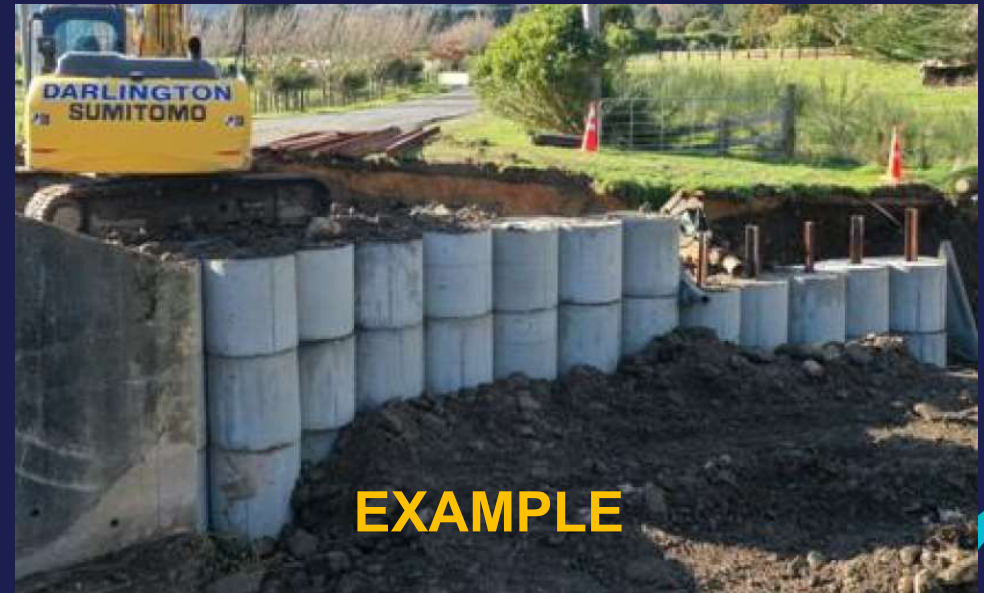
Approved Design:

New Retaining Wall Structures to reinforce/reinstate the riverbank below Coast Road

Construction of parallel driven rail-iron and concrete bollard retaining walls

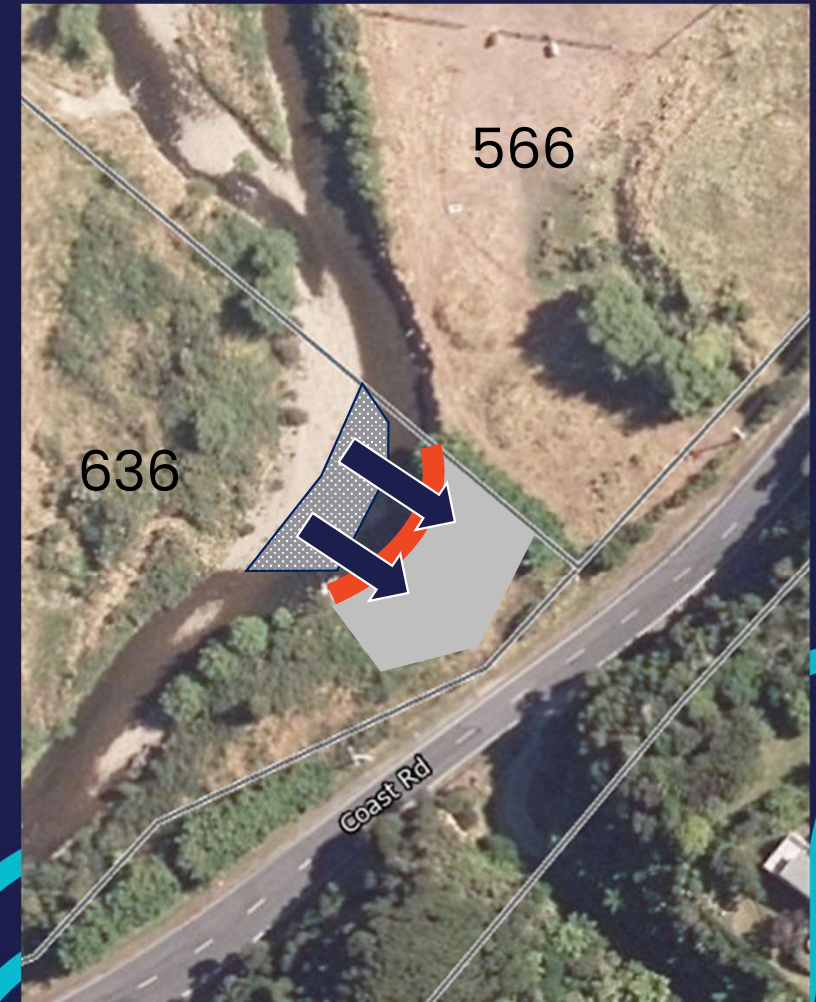
Rip-rap footing

Construction Stage 1:

Install rip-rap footing,
backfill with excavated
beach material to form
a working platform for
retaining wall
construction activities

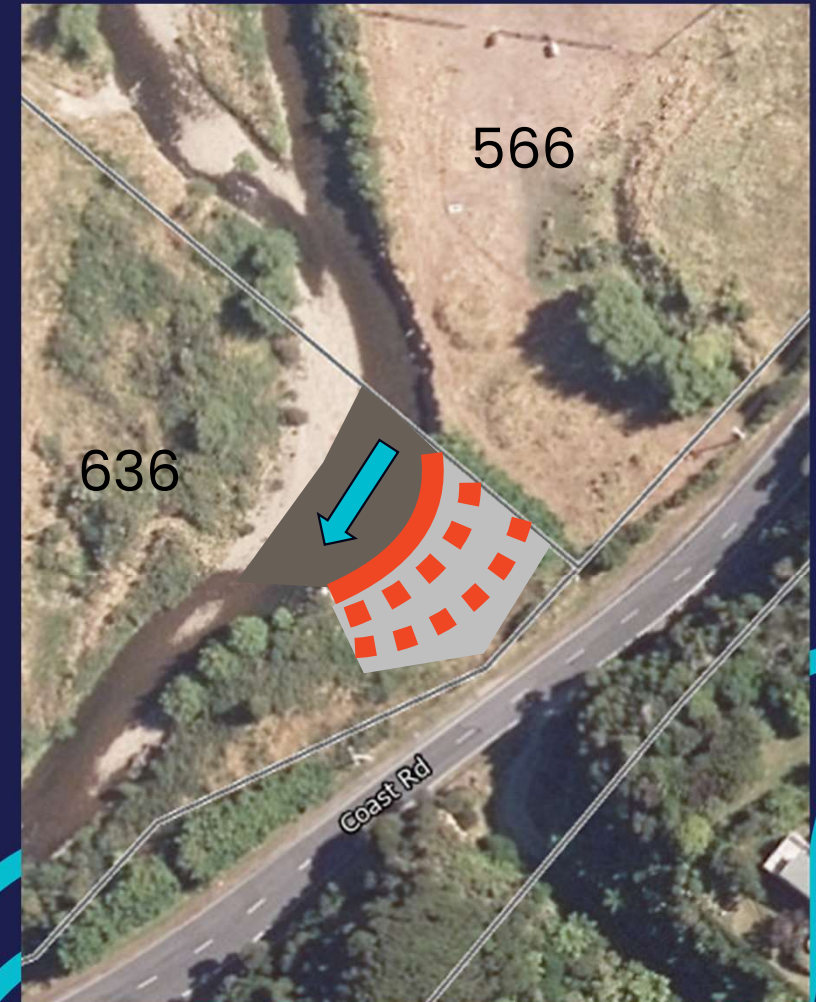
Construction Stage 2:

Construct Retaining Wall then backfill with locally sourced material

- Protects the riverbank against further erosion

Driven rail-iron and concrete bollard retaining walls

Rip-rap footing
