Executive summary

We have now completed an Initial Seismic Assessment (ISA) of the Eastbourne Library at 38 Rimu Street, Eastbourne using the Initial Evaluation Procedure (IEP). The assessment was carried out after completing a site visit and a review of limited architectural drawings of the building obtained from the Hutt City Council.

Initial Evaluation Procedure (IEP) Assessment - Completed for Hutt City Council

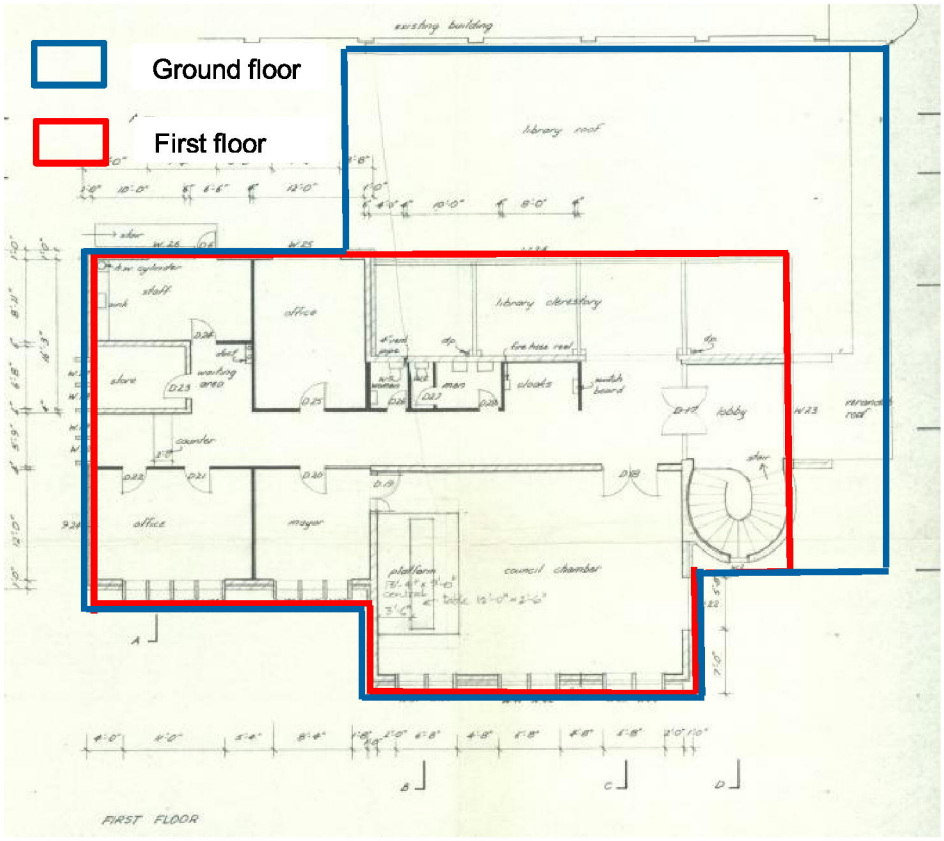
Figure 2 Floor plan of the building

The building is a two-storey blockwork shear wall structure with a lightweight timber-framed roof and steel sheet roof cladding. The upper level floor structure is comprised of timber joists and flooring supported on steel beams. The steel beams are in turn supported on blockwork pilasters. The building foundation is comprised of a concrete slab-on-grade.

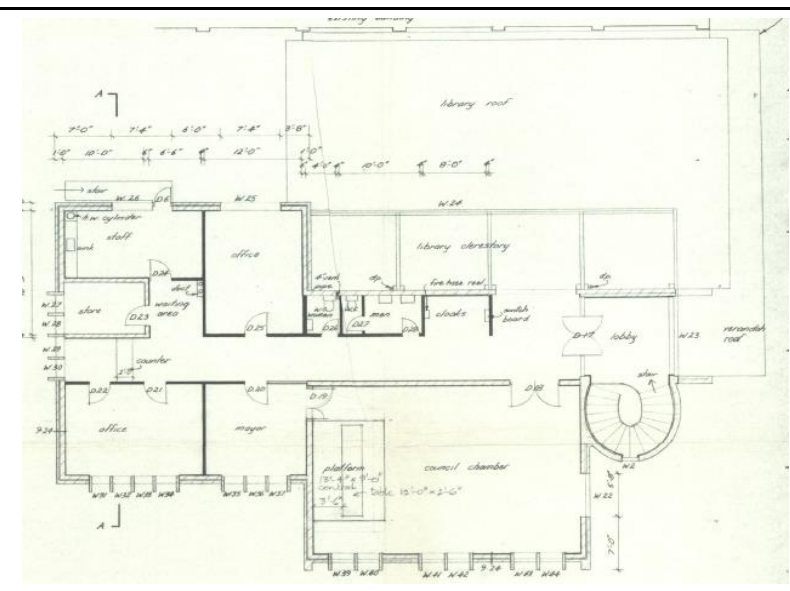
First Floor Plan

The first floor partially occupies an eccentric portion of the total floor footprint, so the roof is lighter than the floor below. According to NZS1170.5, this situation needs not be considered in the determination of irregularity.
