Executive summary

We have now completed an Initial Seismic Assessment (ISA) of Wainuiomata Library at Queen Street, Wainuiomata using the Initial Evaluation Procedure (IEP). The assessment was carried out after completing a site visit and an inspection of the building consent documentation.

Wainuiomata Library was designed and built circa 1983. This library is a single-storey timber-framed building with Pryda-speedbrace wall bracing panels. The building is currently used as a library and office space. This building has been subject to an Initial Seismic Assessment (ISA).

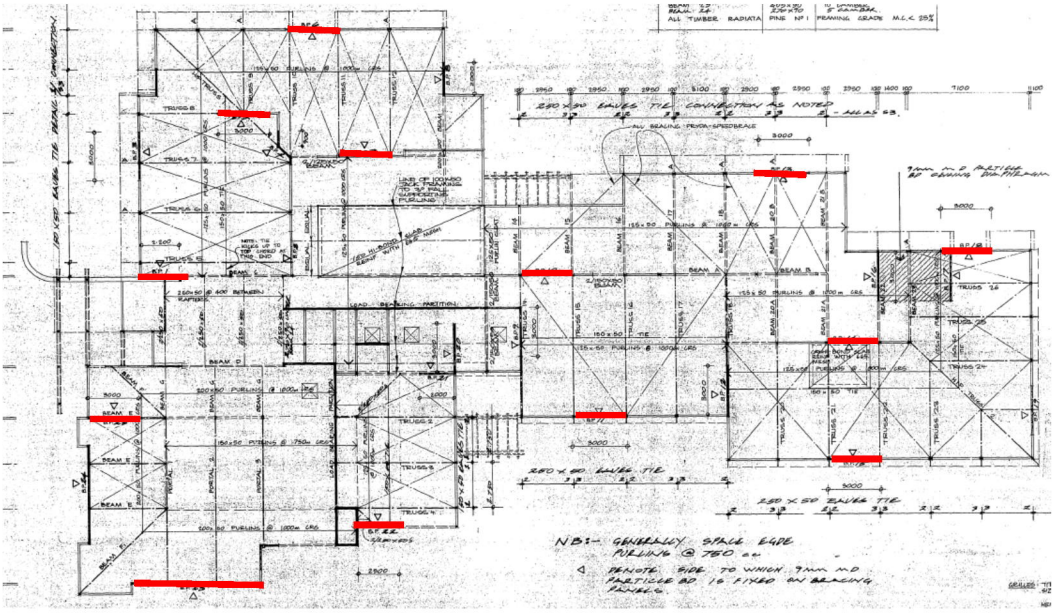
Figure 2 Location of the timber shear walls in the longitudinal direction

When the structure is subjected to seismic action, the inertial loads from the roof and walls are transferred through the timber shear walls down to the foundation. The in-plane shear walls resist these loads through bending and yielding of the nail fixings around the perimeter of the wall. The locations of shear walls (parallel to the direction of seismic action) are shown in Figure 2 and 3 below.

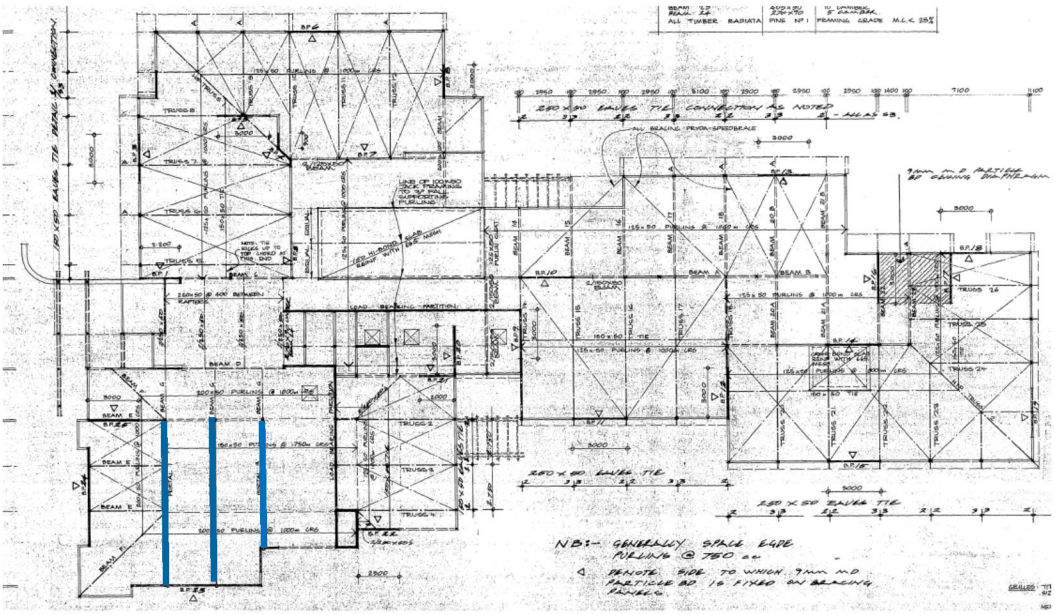
Figure 4 Location of steel portal frames

Three Steel portal frames are located in the council chamber in the South-West corner of the building to provide resistance in the transverse direction. Refer to Figure 4 for the location of the portal frames.

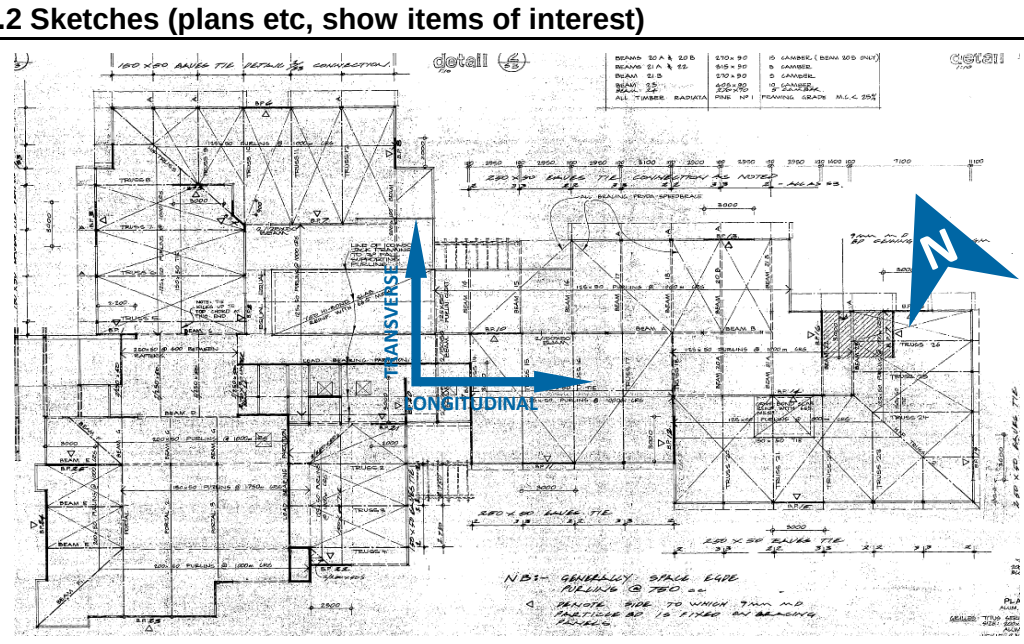
1.2 Sketches (plans etc, show items of interest)

The Wainuiomata library is a single-storey timber-framed building, which was designed and constructed circa 1983. The building foundation is comprised of a concrete slab-on-grade. The external wall cladding is a combination of fibre-cement sheet cladding and brick veneer.

Alterations to the internal layout of the building were carried out in 1995 and 2015. The 1995 alteration included the construction of the ramp to improve the accessibility to the building and the removal of a number of timber walls (these were replaced with lintels and SHS columns). The 2015 alteration included adding a small lobby to the north-east side of the library.
