Initial Evaluation Procedure (IEP) Assessment - Completed for Hutt City Council

Street Number & Name:	**17 Maire Street**	**Job No.:**	**5-C3957.00**
AKA:		**By:**	**GSF**
Name of building:	**Eastbourne Community Hall**	**Date:**	**23/08/2019**
City:	**Eastbourne, Hutt City**	**Revision No.:**	**0**

Table IEP-1 Initial Evaluation Procedure Step 1

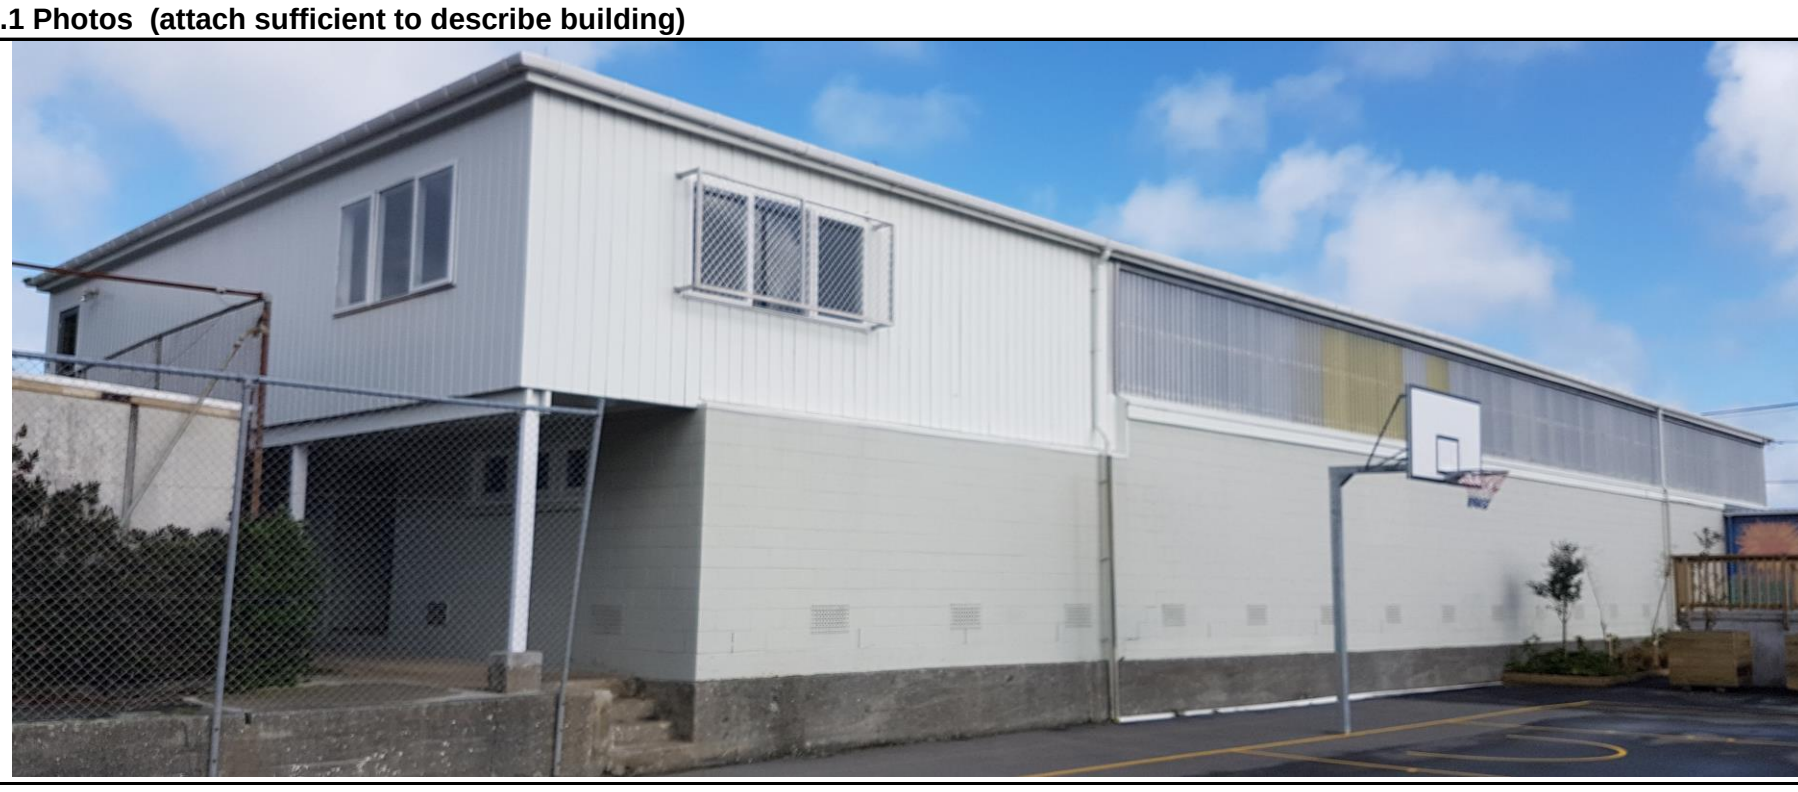
1.1 Photos (attach sufficient to describe building)

Structure: Steel portal frames with tie rod bracing. Reinforced masonry block walls, 12mm bars @ 600mm vertically with mid and full height reinforced bond beams
Foundations: Concrete slab on grade with foundation beams
Roof: Steel Portal with lightweight cladding
