Richard Prouse Park Changing Rooms and Toilets
87A Hine Road, Wainuiomata

Initial Seismic Assessment

for
Hutt City Council

Project 9792

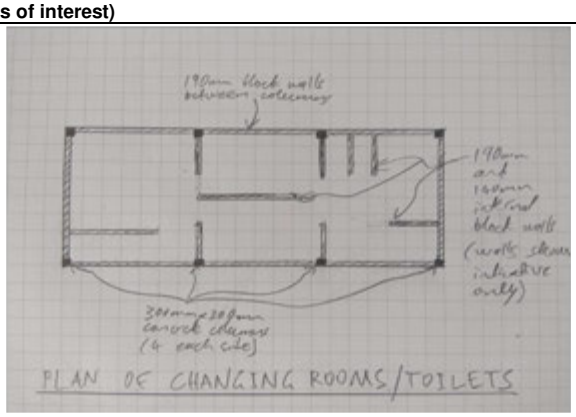
1.2 Sketches (plans etc, show items of interest)

The building is single storey and appears to have been constructed in 1969.

The roof is monoslope, with corrugated iron supported on timber purlins, which in turn are supported by steel I-beams. The steel I-beams span the width of the building and are supported by 300mm x 300mm concrete columns. There are eight columns in total - four on each side of the building. At the high side of the building, the columns cantilever approximately 800mm above the top of the block walls and there are clerestorey windows above the block walls between the columns.

The external walls are 190mm thick blockwork between the concrete columns. The internal walls are a mix of 190mm and 140mm thick blockwork. Some of the block walls have returns, but others do no and are vertical cantilevers.

There is a concrete floor slab. It is assumed the foundations consist of shallow footings.
