Hutt City Council

Community Facilities Seismic Assessments

Petone Library - ISA Report

August 2018

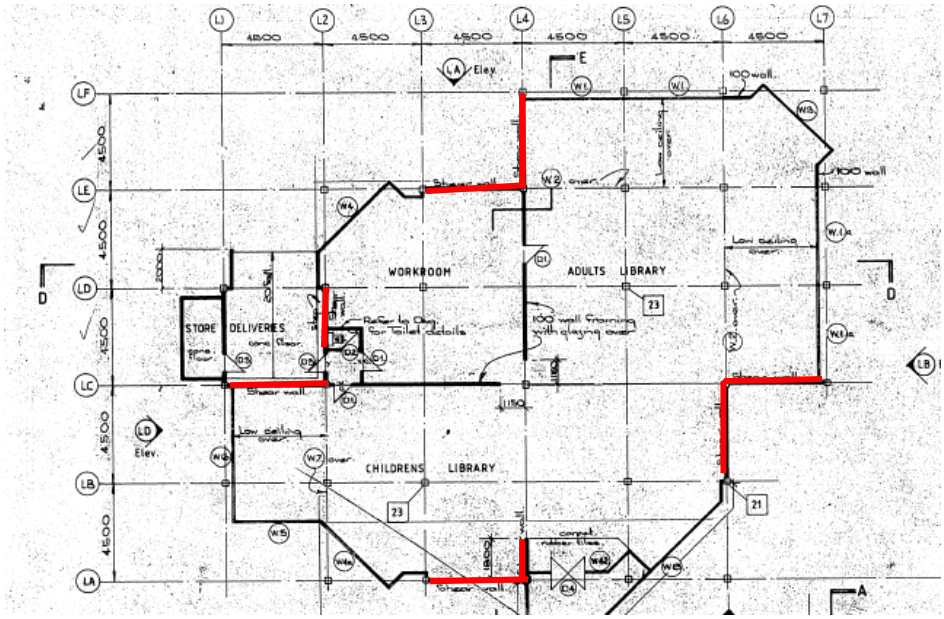
Figure 2 Location of shear walls

The building is engineered timber frame construction with shear walls in both transverse and longitudinal directions. When the structure is subjected to seismic load, the lateral loads from the roof self-weight are transferred to the timber walls. The in-plane shear walls resist these lateral loads and self-weight through shear wall action. The shear wall location is shown on Figure 2.

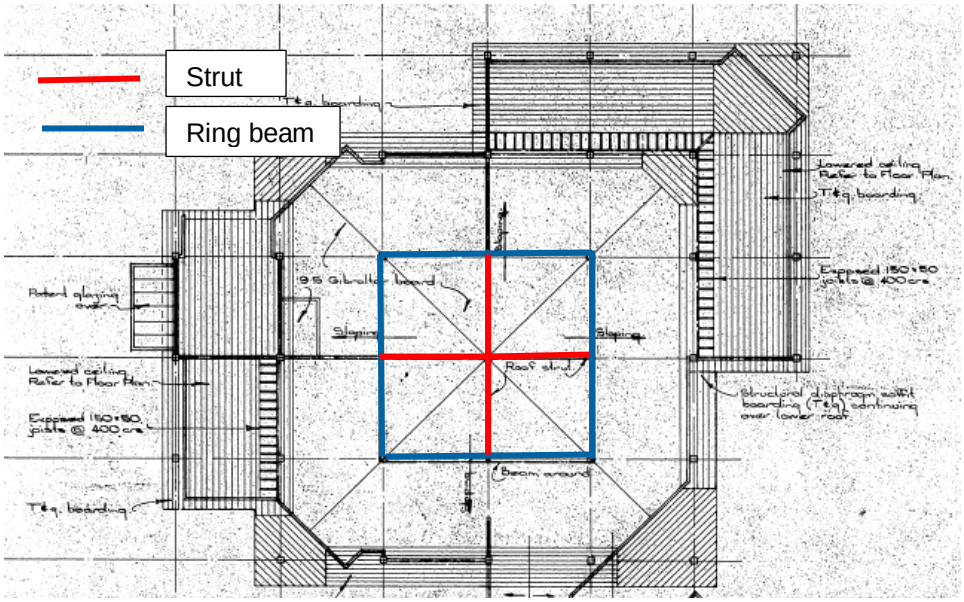
Figure 3 Location of struts and ring beams

Glulam ring beams are located beneath the mid span of the rafters to support the rafters. Refer to Figure 3 and 4 for struts and ring beams arrangement. Four twin struts perpendicularly support the ring beams, and transfer loading from roof level to the central internal timber column through bolted connection.
