Executive summary

We have now completed an Initial Seismic Assessment (ISA) of Dowse Art Museum at 45 Laings Road, Lower Hutt using the Initial Evaluation Procedure (IEP). The assessment was carried out after completing a site visit and inspection of building consent documentation.

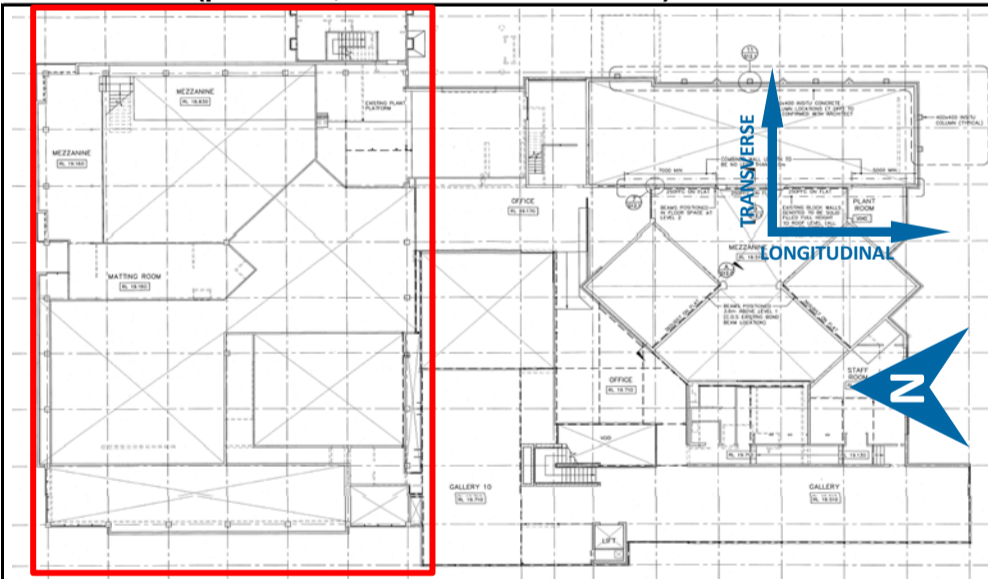
Floor plan

1. The building consists of external precast wall panels and concrete columns at the north, east, and west elevations
2. Concrete columns and concrete walls at the south elevation
3. Steel truss and timber-framed roof construction
4. Ground beams and piles foundation
5. Timber partition wall

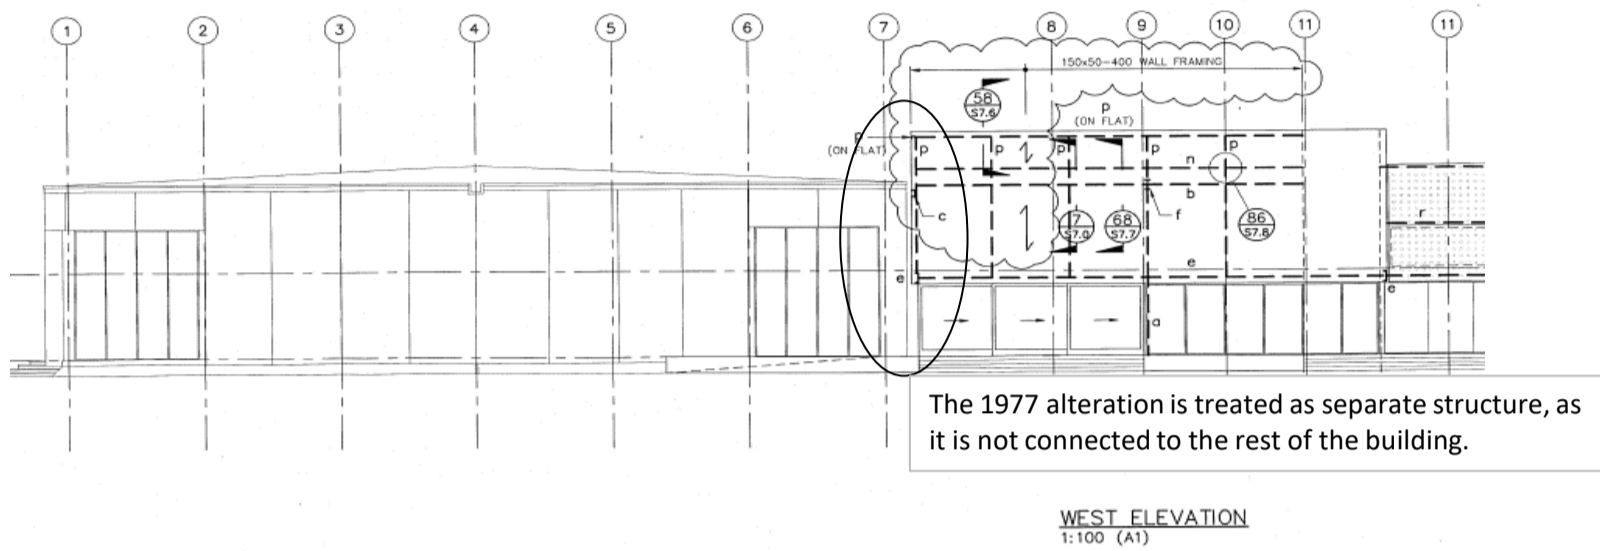
West elevation view of the 1977 alteration

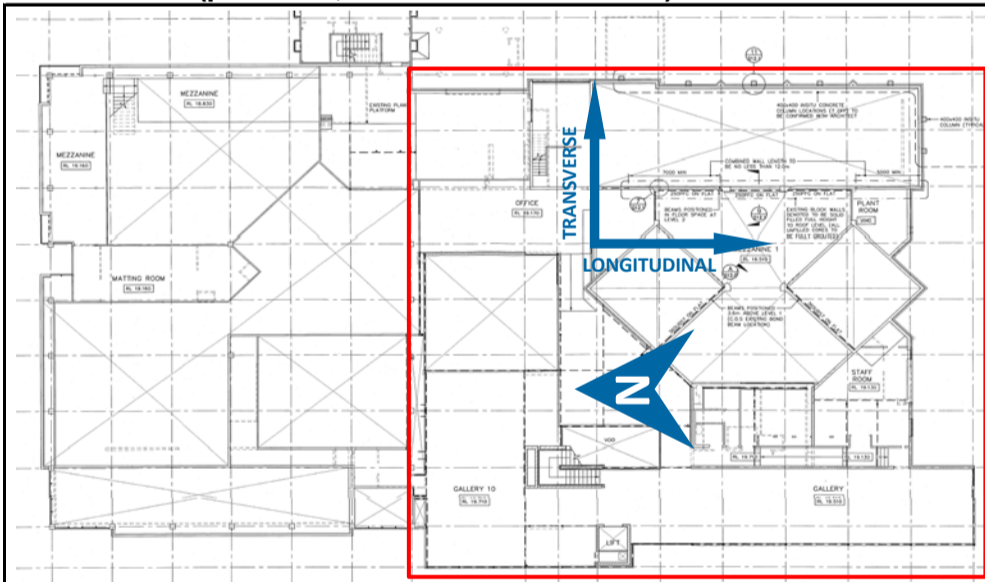
Floor plan

1. The building consists of blockwalls in both the longitudinal and the transverse directions.
2. Concrete columns at the south and east elevations strengthen the out-of-plane capacity
3. Steel portals were built in both the longitudinal and the transverse directions in 2006 in the front part of the building, forming the Cafe, Lobby area, and corresponding gallery areas in the level above.
4. Timber-framed roof construction
5. ground beams and timber driven piles foundation
6. Steel bracing was constructed in both the longitudinal and the transverse directions
