Initial Seismic Assessment Report - Naenae Library Building, 341 Cambridge Tce, Naenae

Initial Evaluation Procedure (IEP) Assessment - Completed for Hutt City Council

Street Number & Name:	341 Cambridge Terrace	Job No.:	5270911
AKA:		By:	TP
Name of building:	Naenae Library	Date:	21/03/2018
City:	Lower Hutt	Revision No.:	1

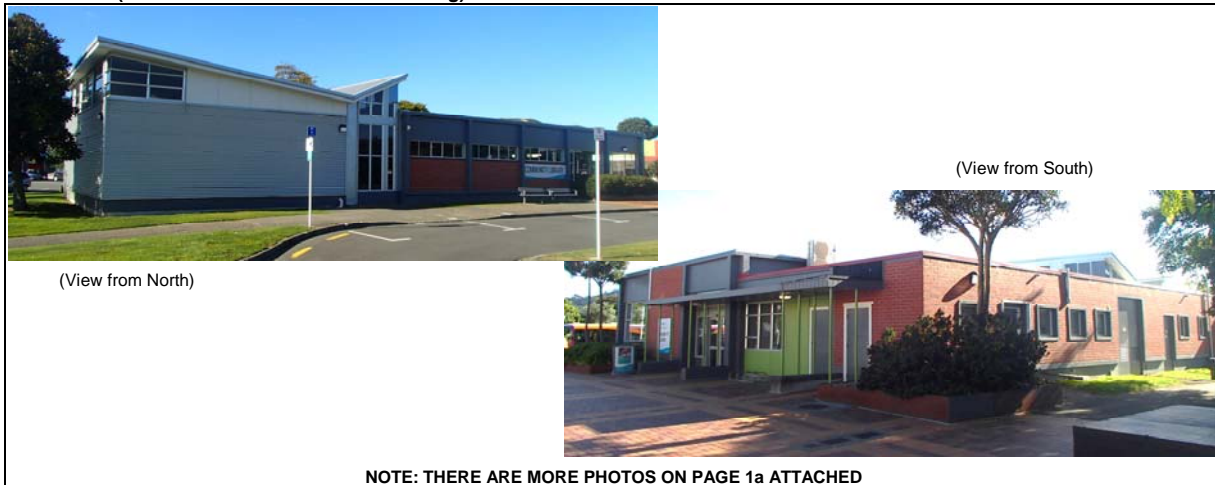
1.1 Photos (attach sufficient to describe building)

- Original building dated 1968. Extension to north east in 2000, with internal retrofit of existing. Dates based on drawings.
- This assessment is based on the older 1968 portion. Comments made are based on visual inspection and review of drawings.

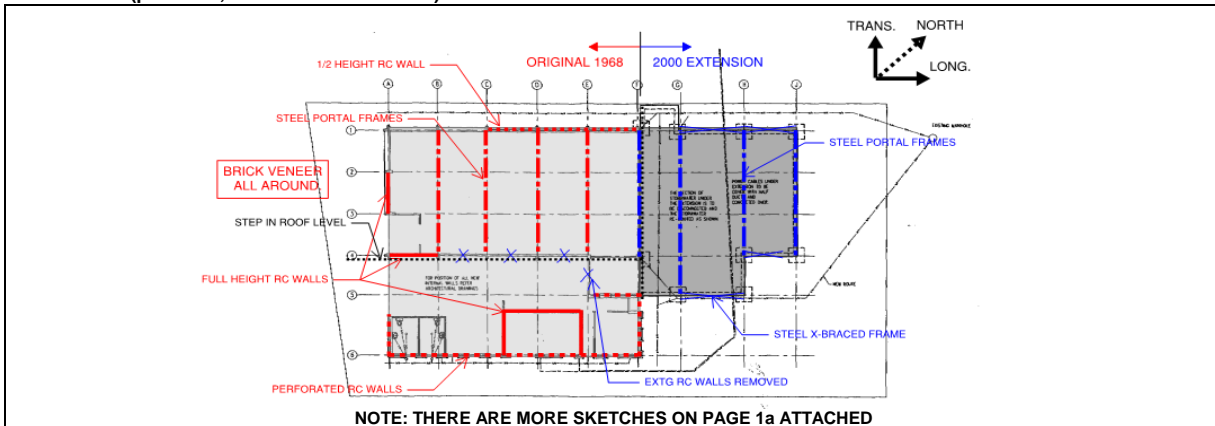
1.2 Sketches (plans etc, show items of interest)

- 2000 extension/retrofit:
 - Lightweight roof. Timber purlins with metal cladding. No apparent structural roof diaphragm (not shown on drawings or visible on site but noted in calculation sketch).

- Shallow RC pad foundations indicated on drawings.
 - Steel portal frames in transverse direction (all bays). Steel X-braced frames in longitudinal direction (each side wall). Internal RC walls in 1968 portion all removed except one bay.

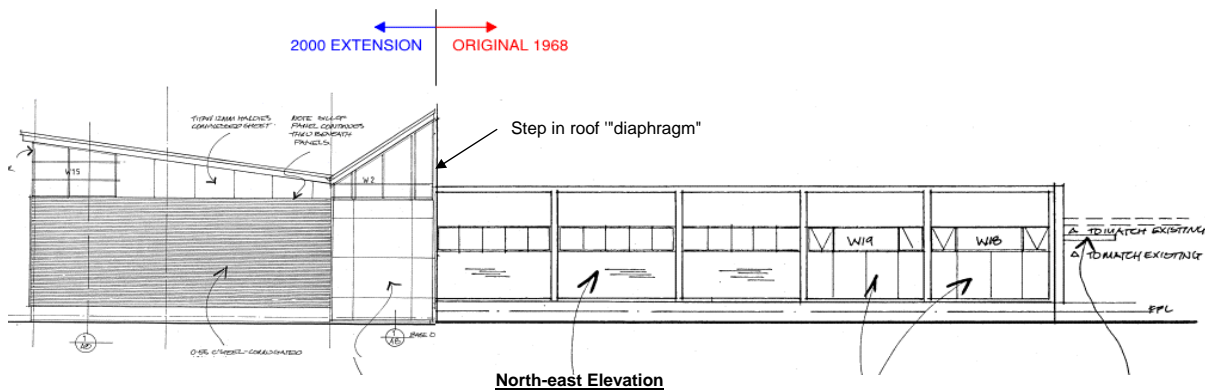
- Specification for 1968 works calls for brick veneer to have "ties of No. 8 s.w.g galvanised wire twisted loops with drip at centre set at 2' 6" centres to every sixth course of brickwork, looped around reinforcement". It also requires "all brickwork to have approved welded galvanised wire fabric bonding of correct width in every sixth course."
- Scanning was carried out on a sample of brick veneer with a Hilti PS35 ferros scanner. While the results where not conclusive, there was a vague indication of ties being present.
- Detailing of the cavity walls (see across) shows an RC capping above and below the brick veneer providing some confinement.

On the basis of the above items, the brick veneer is considered to be >34%NBS (IL2).
