# Executive summary

We have now completed an Initial Seismic Assessment (ISA) of the building at 6 Britannia Street, Petone using the Initial Evaluation Procedure (IEP). The assessment was carried out after completing a site visit and inspection of building consent documentation.

**Initial Evaluation Procedure (IEP) Assessment - Completed for Hutt City Council**

Street Number & Name:	<b>6 Britannia St</b>	Job No.:	<b>5137964</b>
AKA:		By:	<b>MF</b>
Name of building:	<b>Petone Community House</b>	Date:	<b>28/05/2019</b>
City:	<b>Lower Hutt</b>	Revision No.:

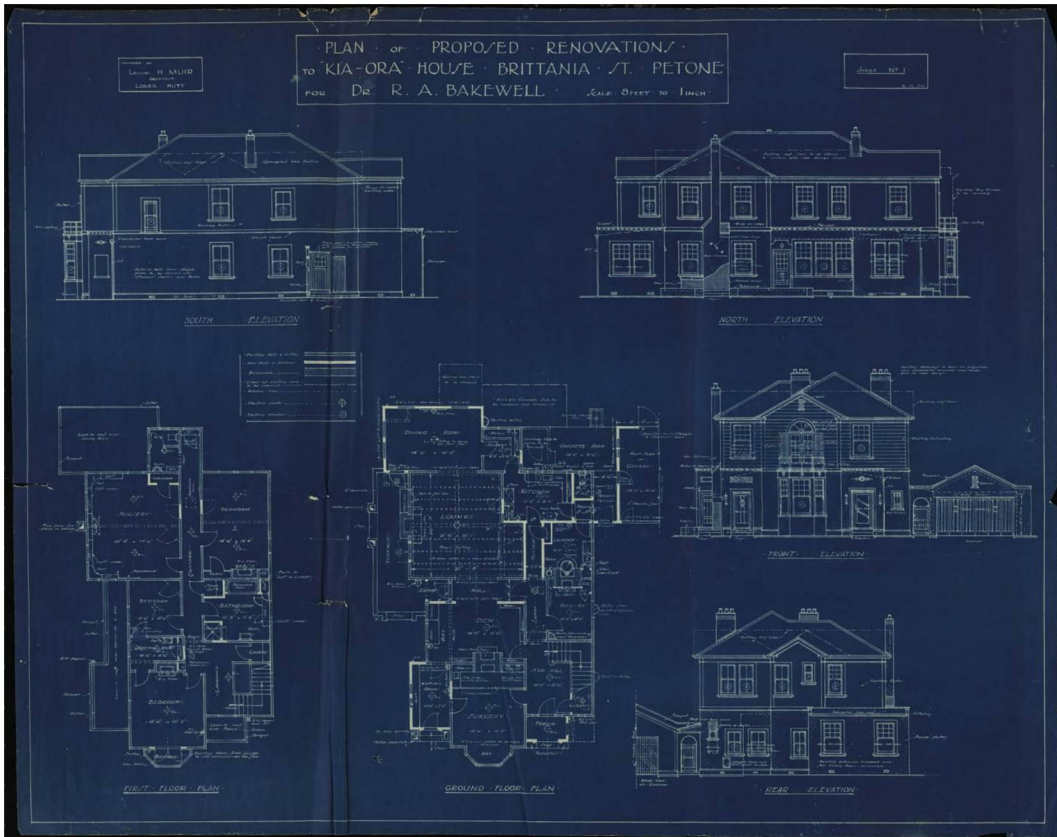
**Figure 2: Plans of addition (1937)**

6 Britannia Street was built in 1895 and altered in 1937. The building is 2 storey light timber framed construction. Ground level timber framed additions to the building were added in 1937 (Figure 2).
