Executive summary

We have now completed an Initial Seismic Assessment (ISA) of Moera Library at Randwick Crescent, Moera using the Initial Evaluation Procedure (IEP). The assessment was carried out after completing a site visit and an inspection of the building consent documentation.

Initial Evaluation Procedure (IEP) Assessment - Completed for Hutt City Council

Street Number & Name:	175 Randwick Road, Moera	Job No.:	5137964
AKA:		By:	RC
Name of building:	Moera Library	Date:	12/07/2018
City:	Moera	Revision No.:	0

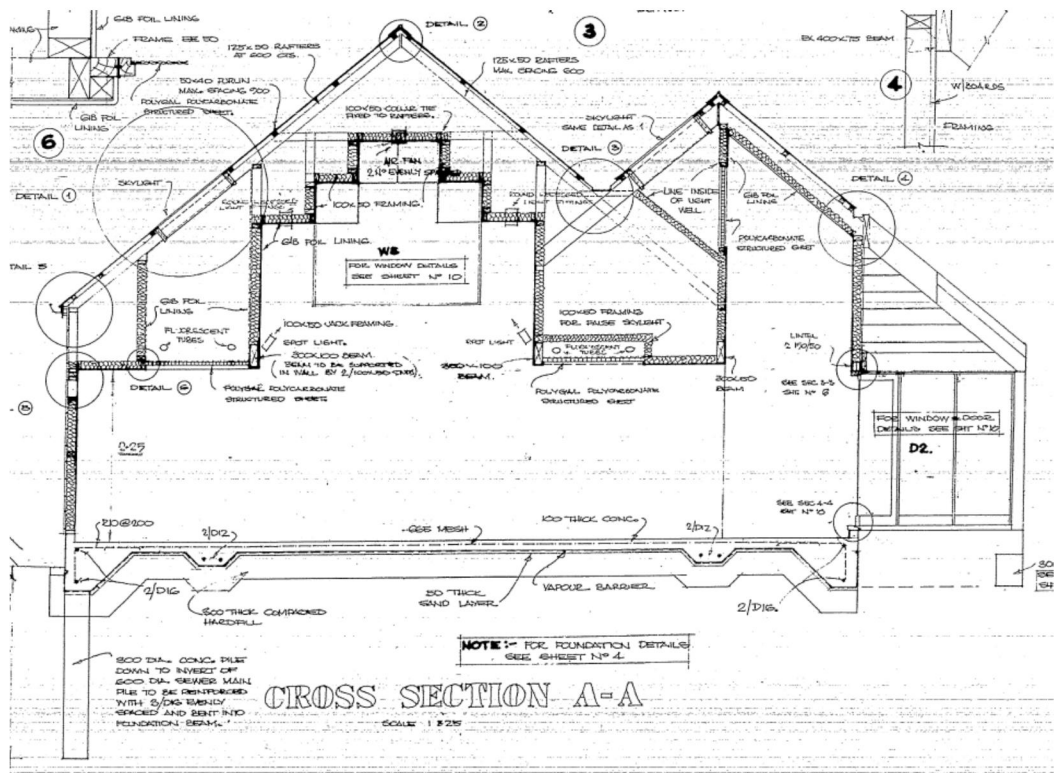
Figure 2 Cross section of the building

The building is of timber-framed construction. The bracing in both the transverse and longitudinal directions are provided by a combination of diagonal steel straps and plasterboard wall panels. There are extreme high-level windows and skylights at the top of the walls. There are glazing panels at the roof level supported by timber framing in front of reception area. The external wall cladding is weatherboard. The roof is of light-weight timber-framed construction with diagonal steel strap bracing. Refer to cross section of the building in Figure 2, the building foundation is comprised of a slab on grade, and concrete piles to the east edge of the building.
