9735

**Initial Seismic Assessment Report
Huia Pool Buildings - Huia Street, Lower Hutt**

**Initial Seismic Assessment
Appendix 1 – Technical Summary
Appendix 2 – IEPs [Initial Evaluation Procedures]
Huia Pool
6 Huia Street**

Initial Evaluation Procedure (IEP) Assessment - Completed for Hutt City Council

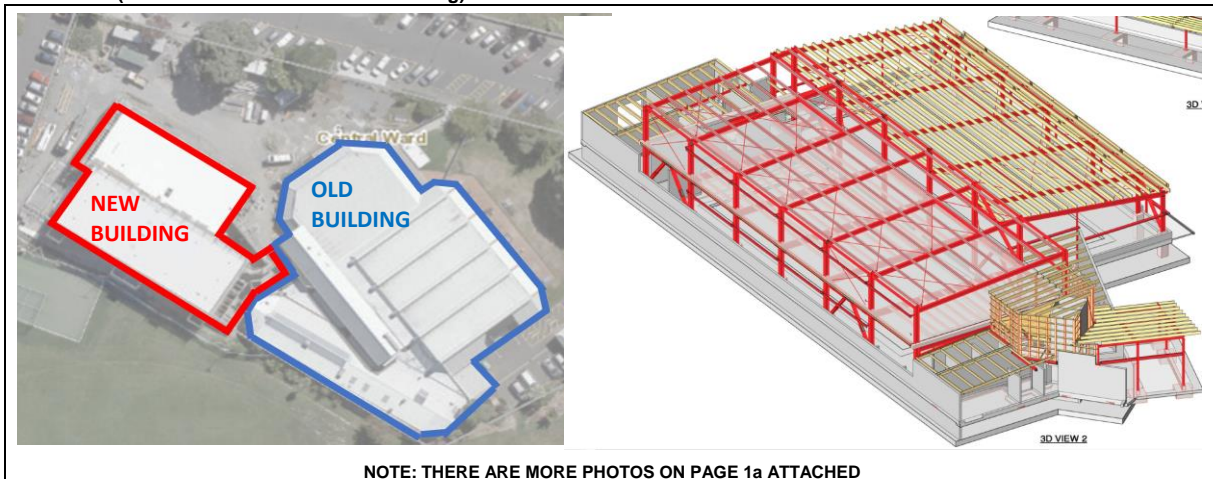
1.1 Photos (attach sufficient to describe building)

Downstairs offices, staff room and changing facilities at the east end. Downstairs are two swimming pools; and a plant room at the west end. Access to the upstairs is via stairs and lift at the east end, and stairs at the west end. Upstairs there are offices and toilet facilities at the east end. Upstairs is a weights gym; and a plant room at the west end. Roof bracing is tension only cross braced frames. Upstairs floor is rib and infill with 90mm topping concrete. Stairs appear to be pre-cast reinforced concrete with a low friction bearing strip at the bottom and 100mm seating at the top. Reinforced concrete masonry walls around the ground floor offices, staff room, changing facilities at the east end. Reinforced concrete masonry walls around the plant room and storage room at the west end. Transverse direction is moment frames. Longitudinal direction upstairs is cross braced frames. These are a mix of tension only systems and tensions compression systems. Longitudinal direction downstairs is eccentrically braced frames. There are large lights and fully glazed wall over one of the swimming pools. A moment frame beam is welded into the centre of a cross braced frame. The foundations for steel posts are reinforced concrete plinths on a 500mm thick slab on a 2m deep subgrade.
