Petone Recreation Ground Grandstand

Detailed Seismic Assessment

For Hutt City Council

Volume 2: Appendices

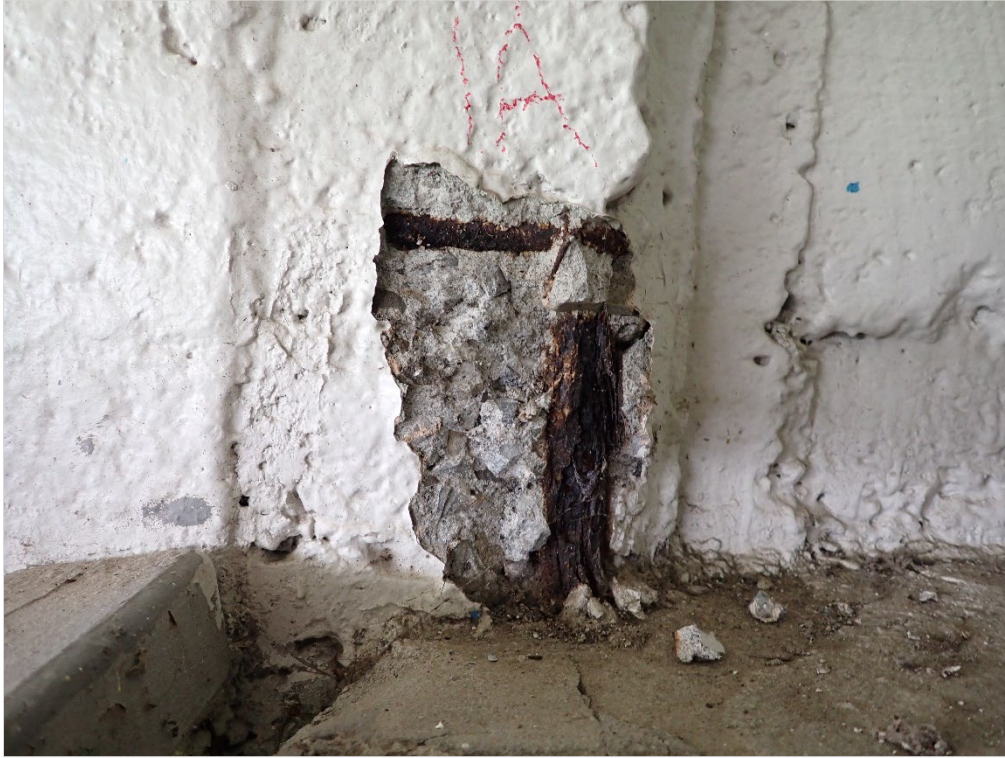
Figure 3: Location 1a - as-is

Figure 2, Figure 3 and Figure 4 display the condition of the structure at location 1a. Exposed and heavily corroded reinforcing was present. The expansion of the reinforcing bar inferred by corrosion put stress on the concrete, causing it to crack and eventually spall. Due to the progressed state of corrosion pitting and flaking on the bars has occurred.

The main bar appears to have an original bar diameter of 20mm. Due to corrosion the effective bar shape is not round anymore. Where measured, the narrowest portion of the cross section was 9mm. The cover is approximately 11mm.

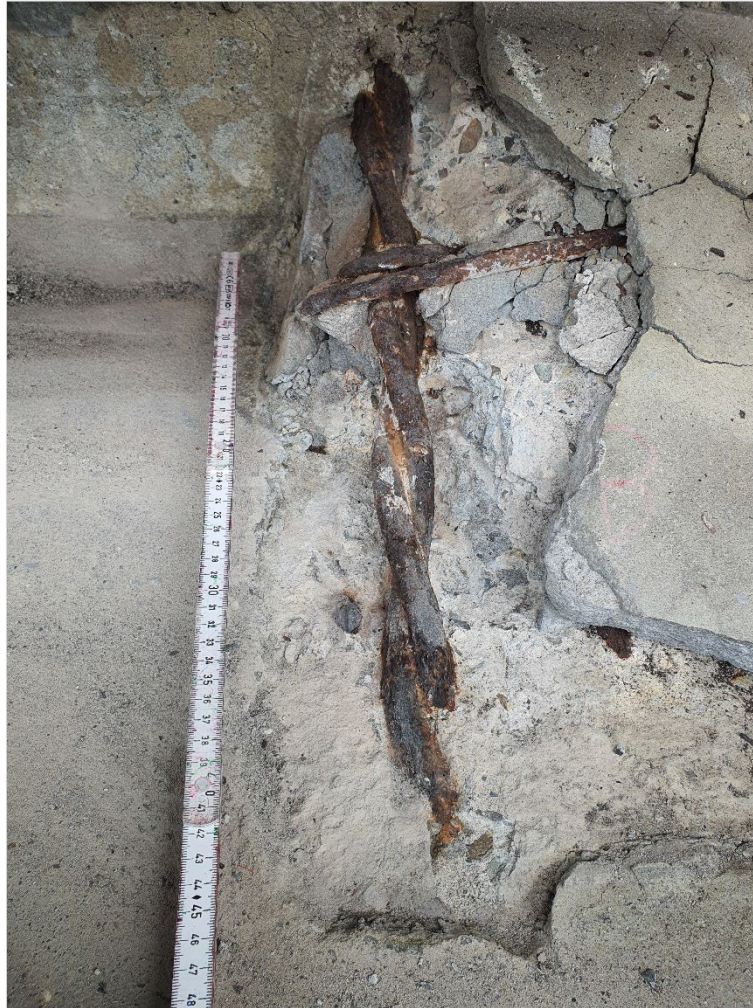
Figure 39: Location 3b - before breakout

Figure 39 displays the location before the concrete was removed around the bars.

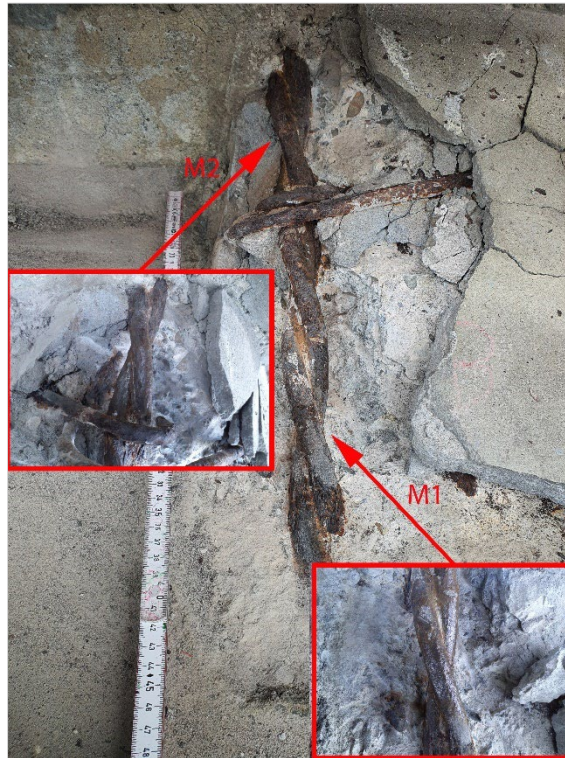
Figure 40: Location 3b - breakout locations

Figure 40 shows the locations where remaining cross sections were measured.

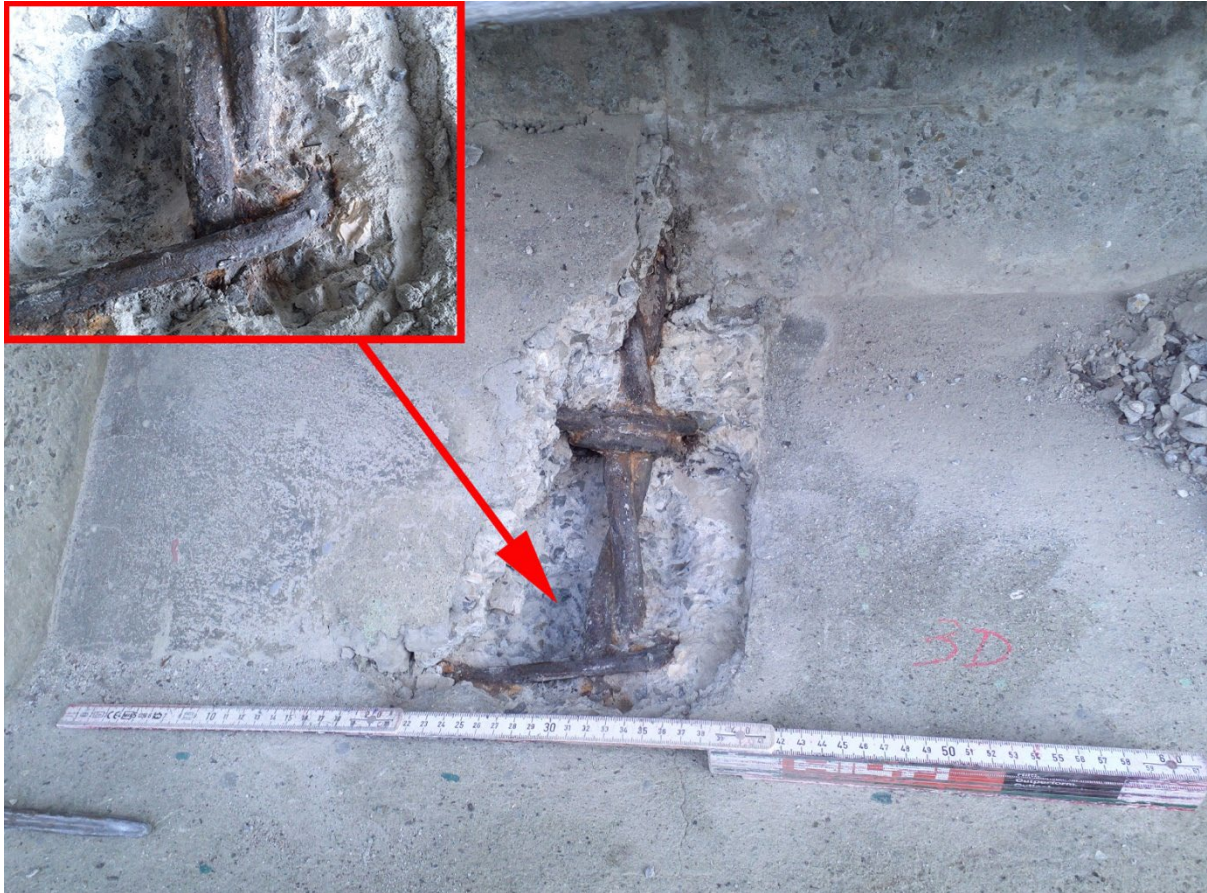
Figure 48 Location 3d - Breakout

The main bar, with a nominal bar diameter of 20mm, was measured to have a remaining cross section of 16.2mm.

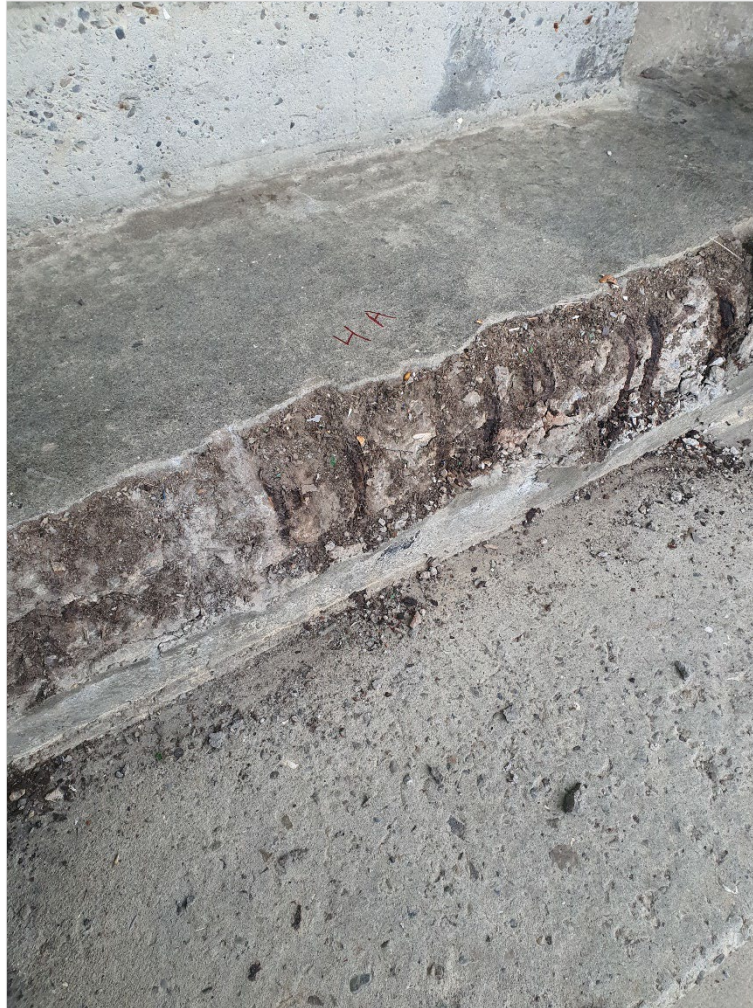
Figure 50: Location 4a - as is

Figure 50 shows the edge and vertical face on the beam after the newer material was removed. Very little impact was required for the material to break away.

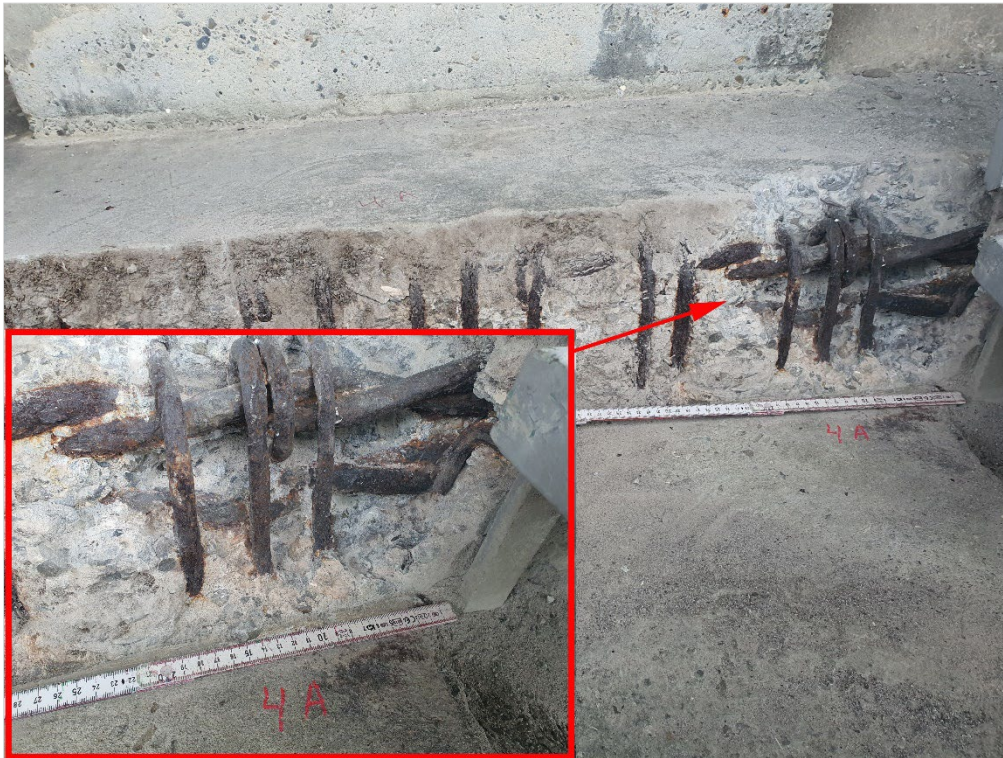
Figure 51: Location 4a – Breakout

One of the top main bars and one of the reinforcing layers below were measured. The nominal bar diameter is 20mm. Both bars had a reduced cross section of 15mm, respectively.

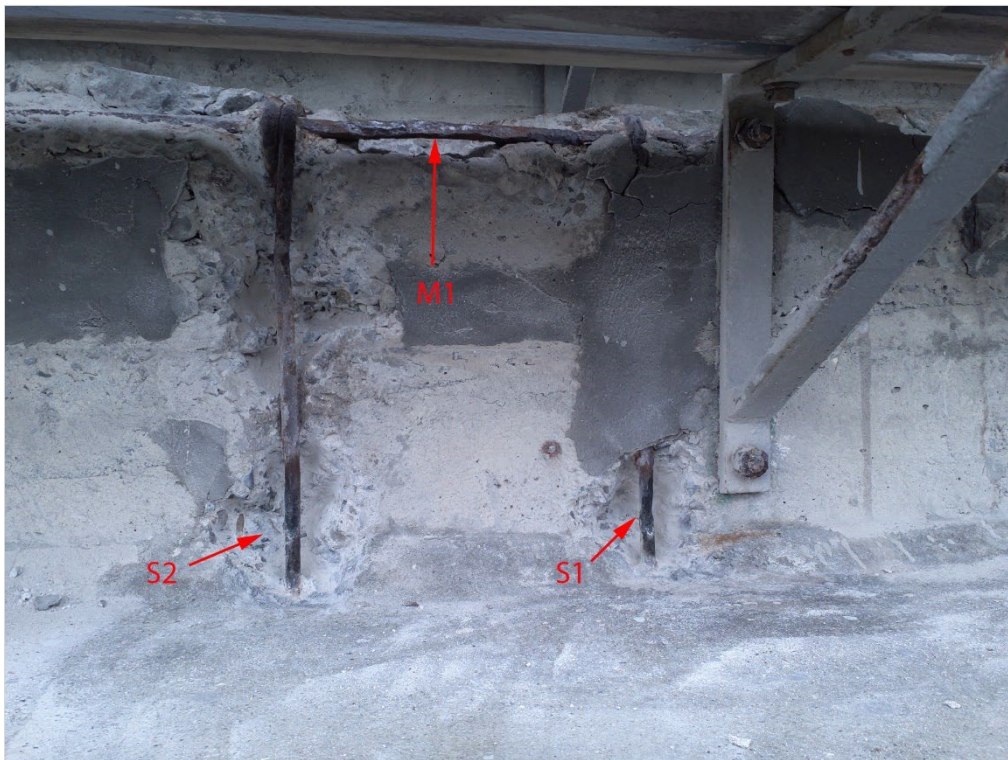
Figure 56: Location 4b.1 – Breakout

Figure 54, Figure 55, Figure 56, Figure 57, Figure 58, Figure 59, Figure 60 display the top corner and the vertical face of the beam at grid X. The location is 11.5m north of grid A. Bars can be seen exposed and heavily corroded, a portion of concrete was loose and able to be lifted off.

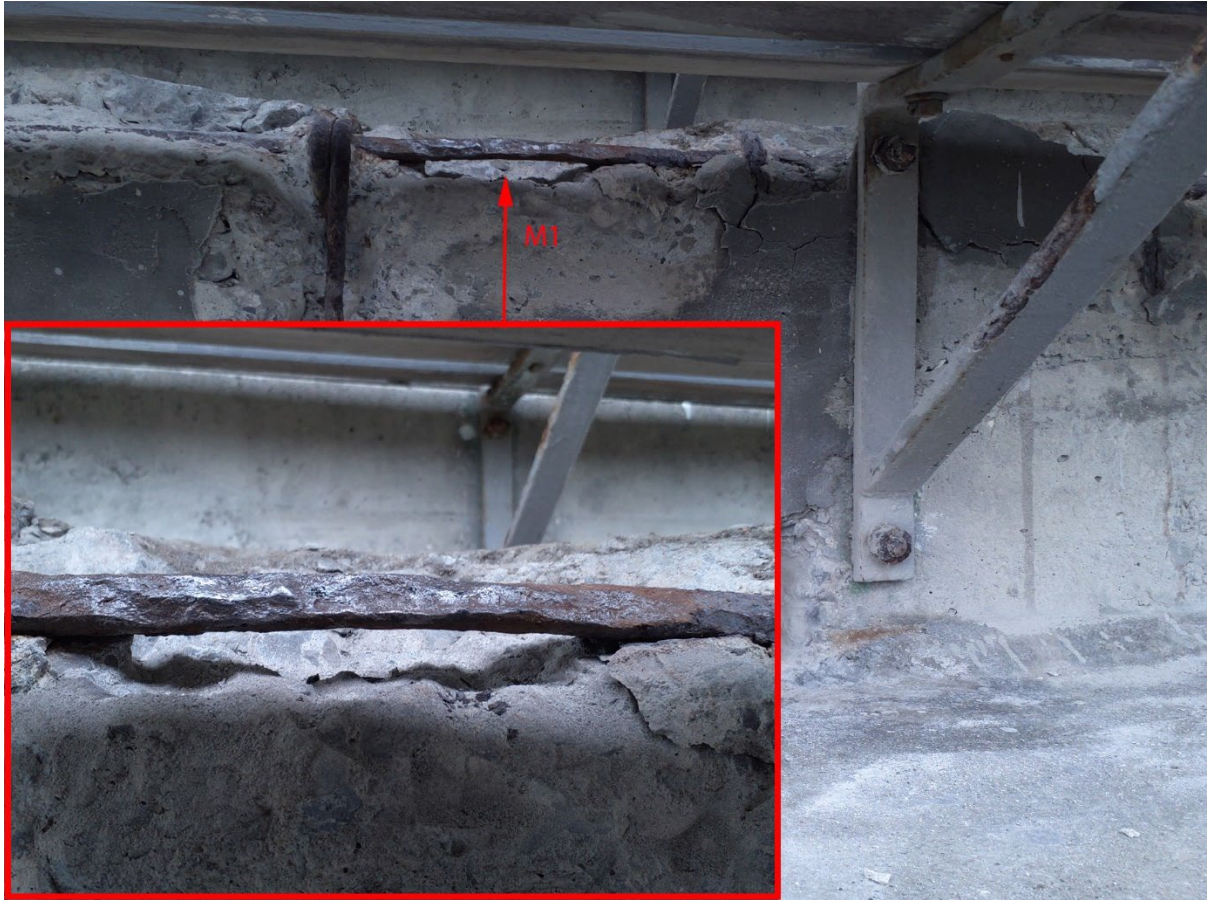
Figure 57: Location 4b.1 - main bar

The main bar's cross section has reduced to 9mm, from a nominal diameter of 20mm.

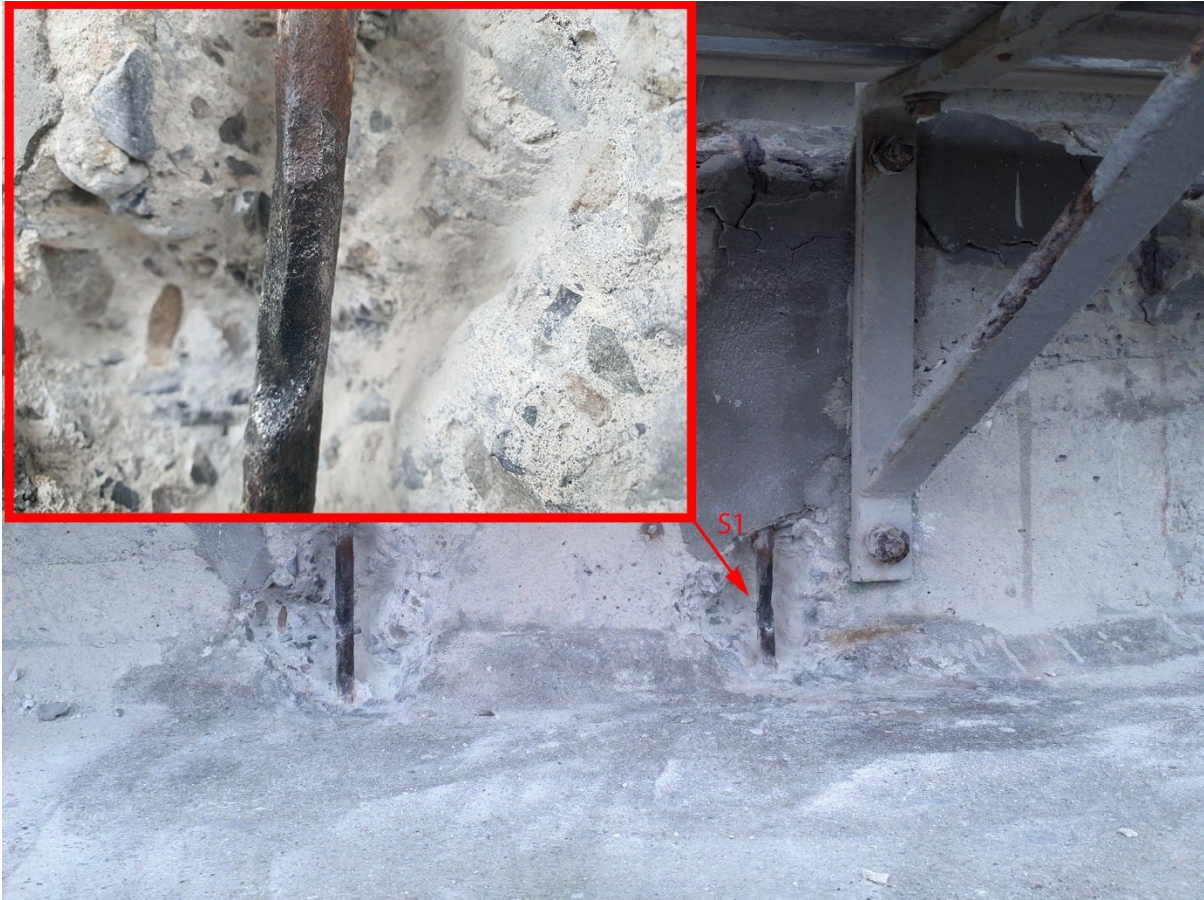
Figure 59: Location 4b.1 - stirrup S1

The diameter of the stirrup S1 was measured to have a cross section of 9.5mm. The nominal stirrup diameter is 12mm.

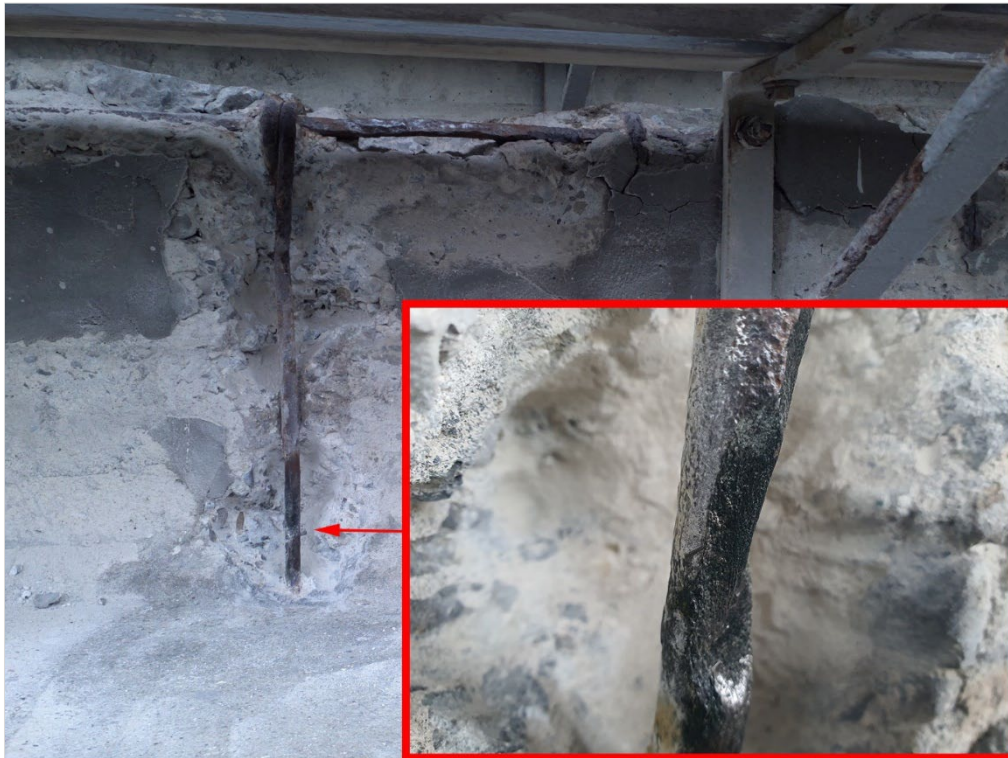
Figure 60: Location 4b.1 - stirrup S2

The diameter of the stirrup S2 was measured to have a cross section of 9mm. The nominal stirrup diameter is 12mm.

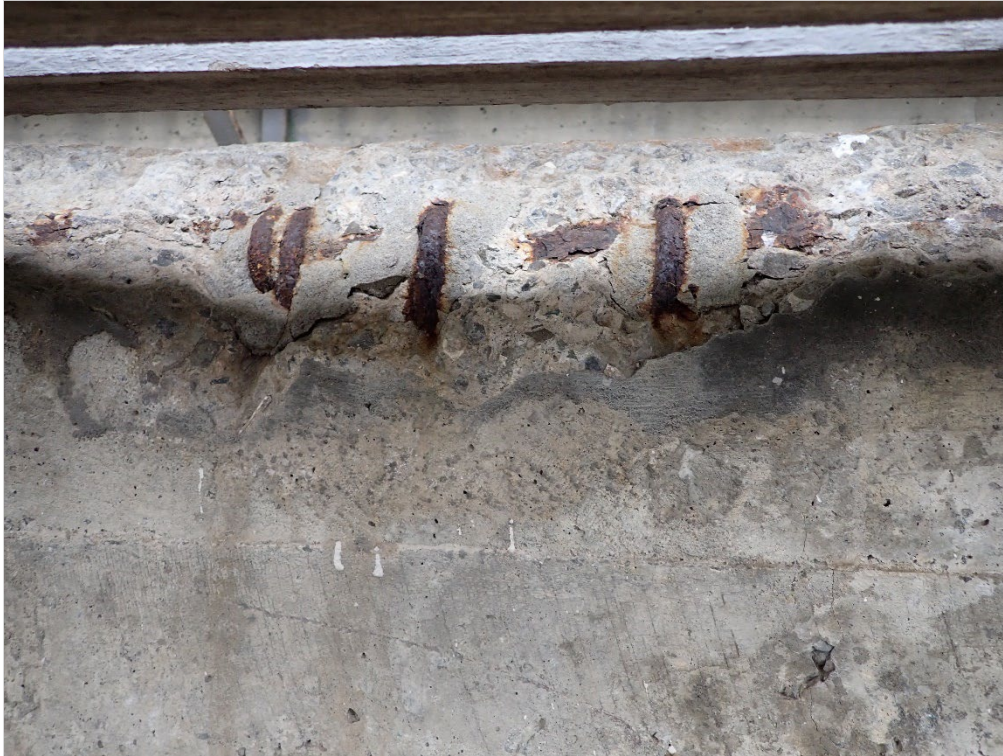
Figure 61: Location 4b.2 - as is

Figure 61, Figure 62, Figure 63, and Figure 64 display the vertical, east facing top corner of the beam at grid X. The location is 14.9m north of grid A. Material not resembling the original concrete is visible.

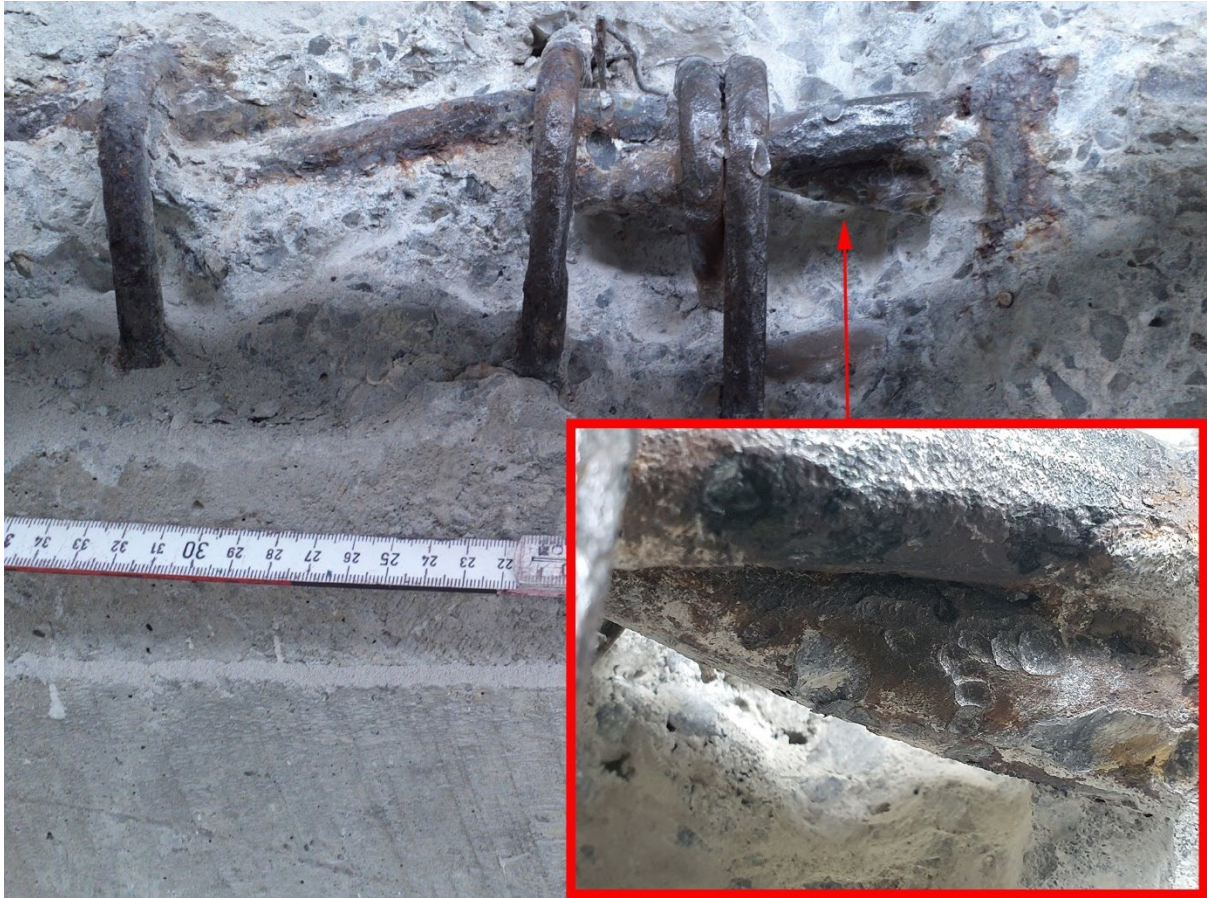
Figure 63: Location 4b.2 - main bar

One main bar, with a nominal diameter of 20mm, was measured to have a remaining cross section of 17.5mm.

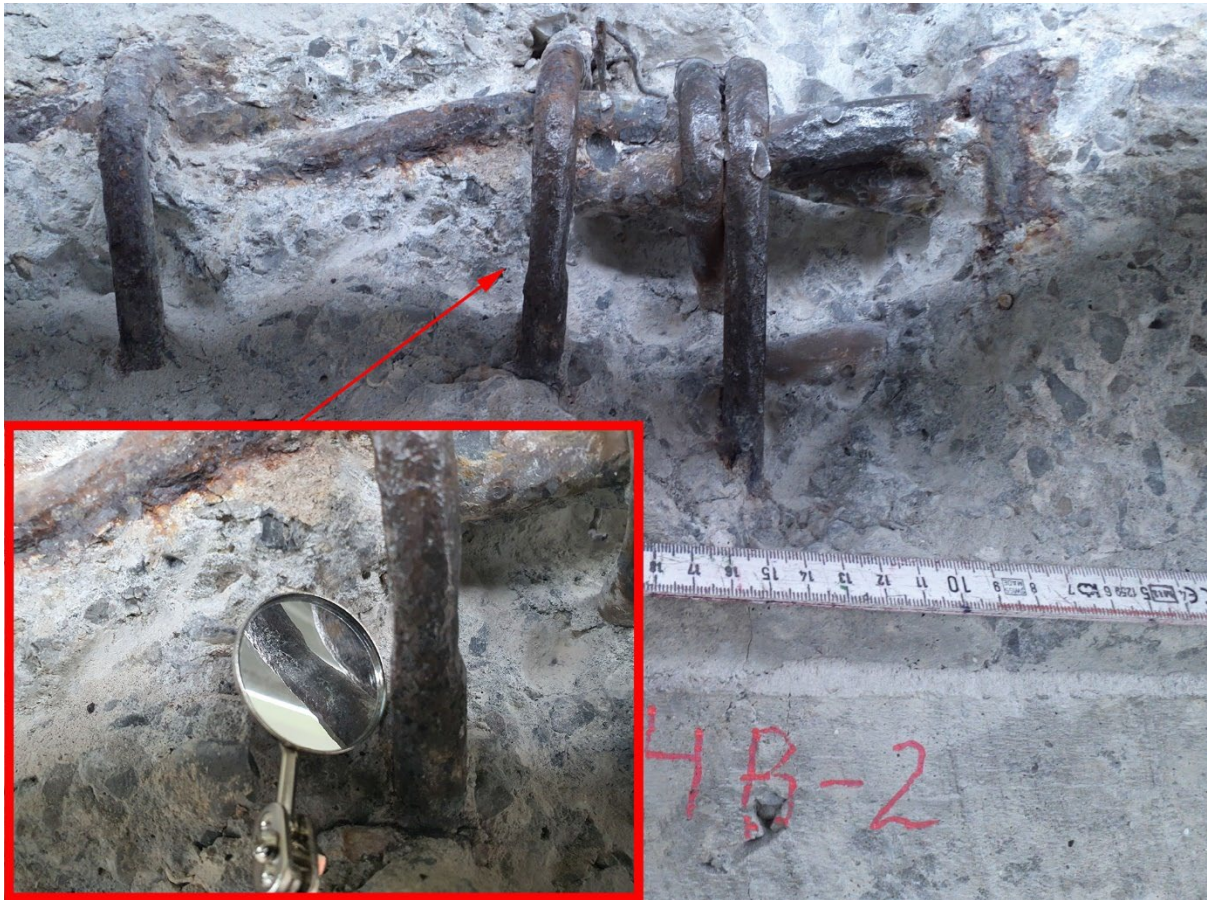
Figure 64: Location 4b.2 – Stirrup

The diameter of the stirrup was measured to have a remaining cross section of 10.5mm. The nominal stirrup diameter is 12mm.

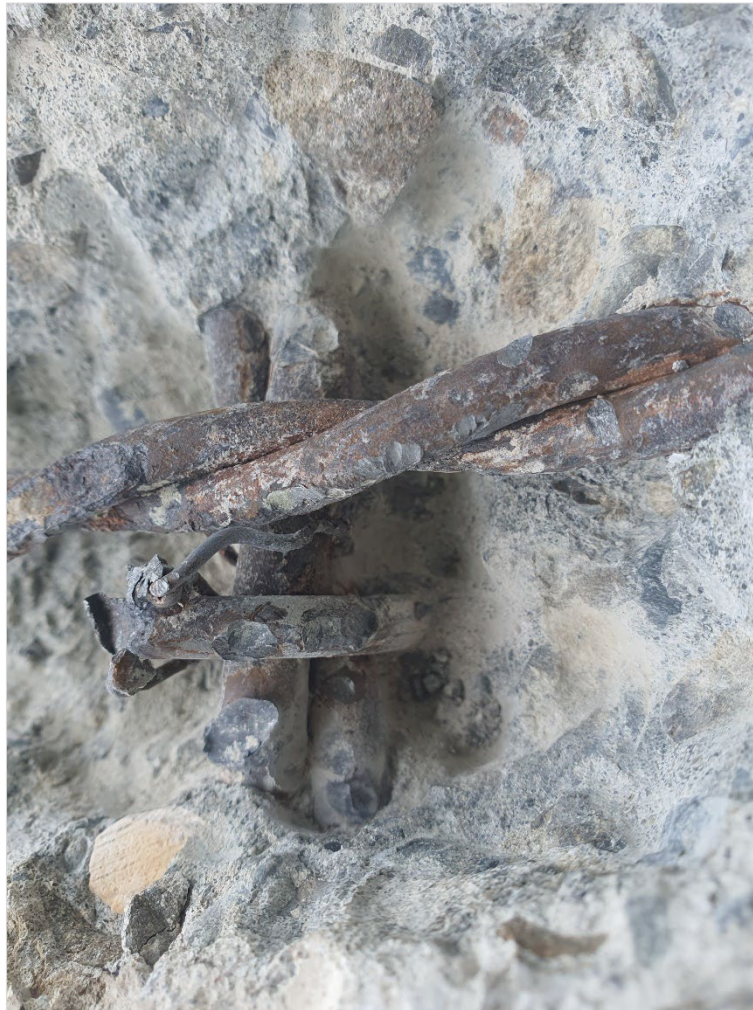
Figure 69: Location 5.1 – breakout

The second layer twisted bars (orientated in N-S direction) with a nominal diameter of 10mm show some corrosion, but no loss of cross section was noticeable.

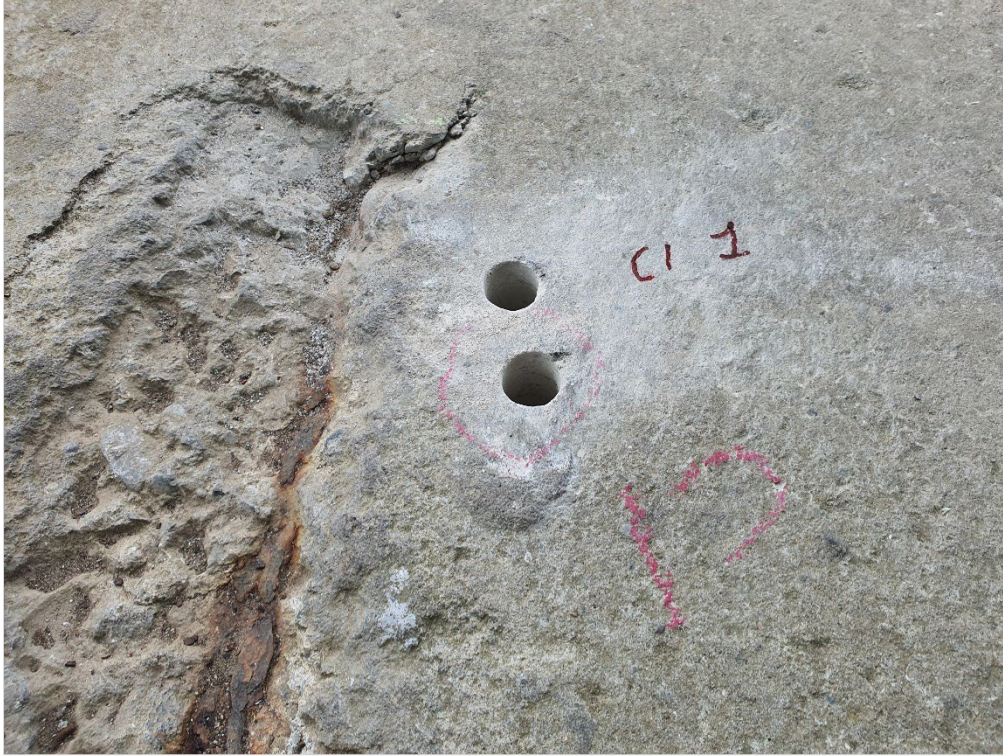
Figure 72: Chloride testing location Cl.1

Concrete samples Cl.1 were collected next at the location of Item 5.1. The location is on the slab near column 4 (grid D/X). Although the location is covered by the roof, it must be assumed that it is partially exposed to any weather systems approaching from the NE to SE.

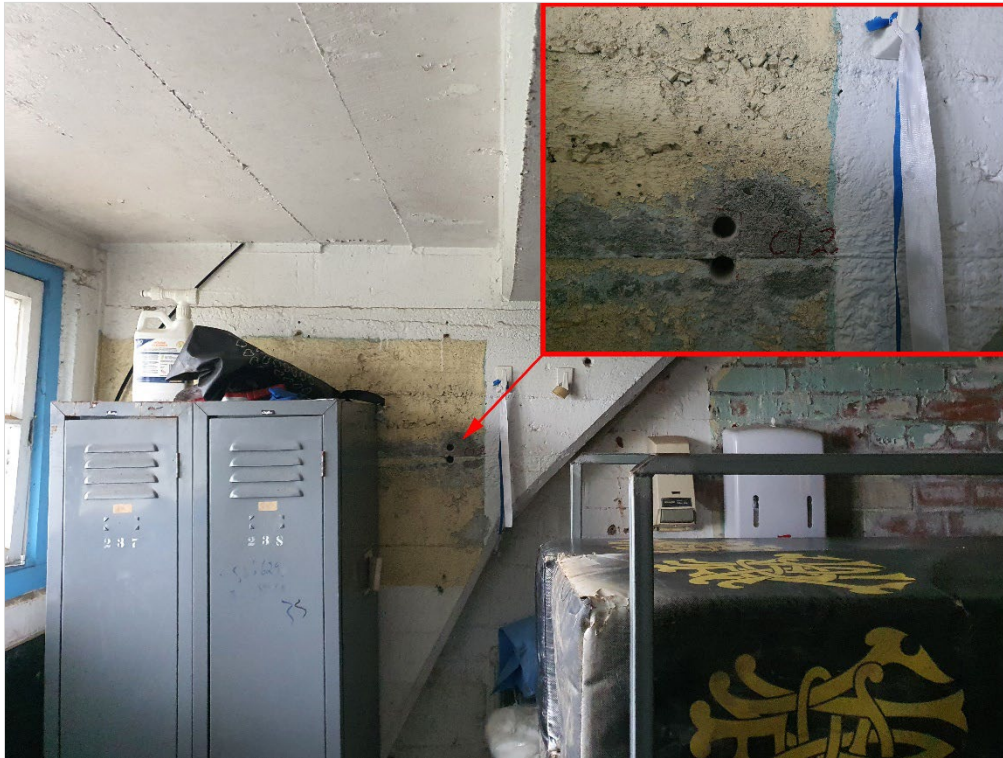
Figure 73: Chloride testing location CI.2

Concrete samples CI.2 were extracted on the northern face of column 1 (grid A/X). The wall is on the inside and has subsequently not been exposed to the weather and possible sea water.

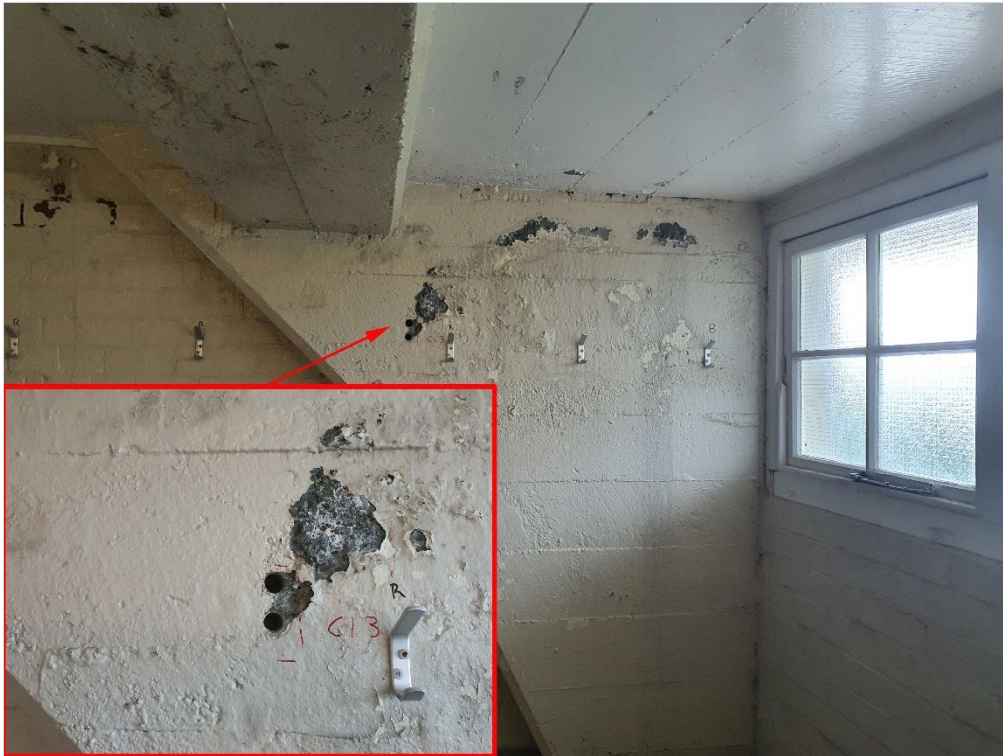
Figure 74: Chloride testing location CI.3

Concrete samples CI.3 were extracted on the southern face of column 6 (grid F/X). The wall is on the inside and has subsequently not been exposed to the weather. A large area (top portion of the column) is affected by efflorescence.

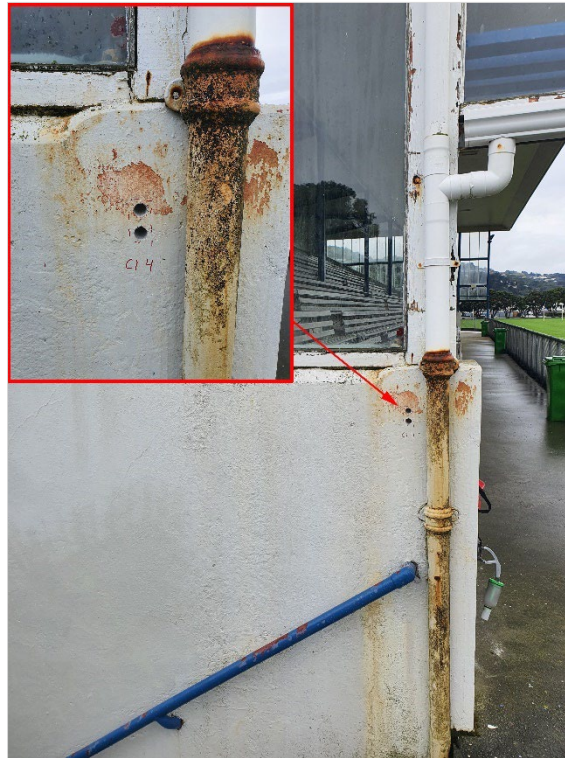
Figure 75: Chloride testing location Cl.4

Concrete samples Cl.4 were extracted on the southern face of column 1 (grid A/X). The surface is exposed to the elements, particularly any weather system approaching from the south. In addition, it is probable that the south facing walls are subjected to sea salts carried by strong southerly winds.

Comparing the samples (Cl.4 vs. Cl.5) taken on the outside of the walls on grid A and F, no significant difference is apparent. Subsequently it is very unlikely that sea salts are a contributing factor for the deterioration of the structure, although this is based on one sample only.

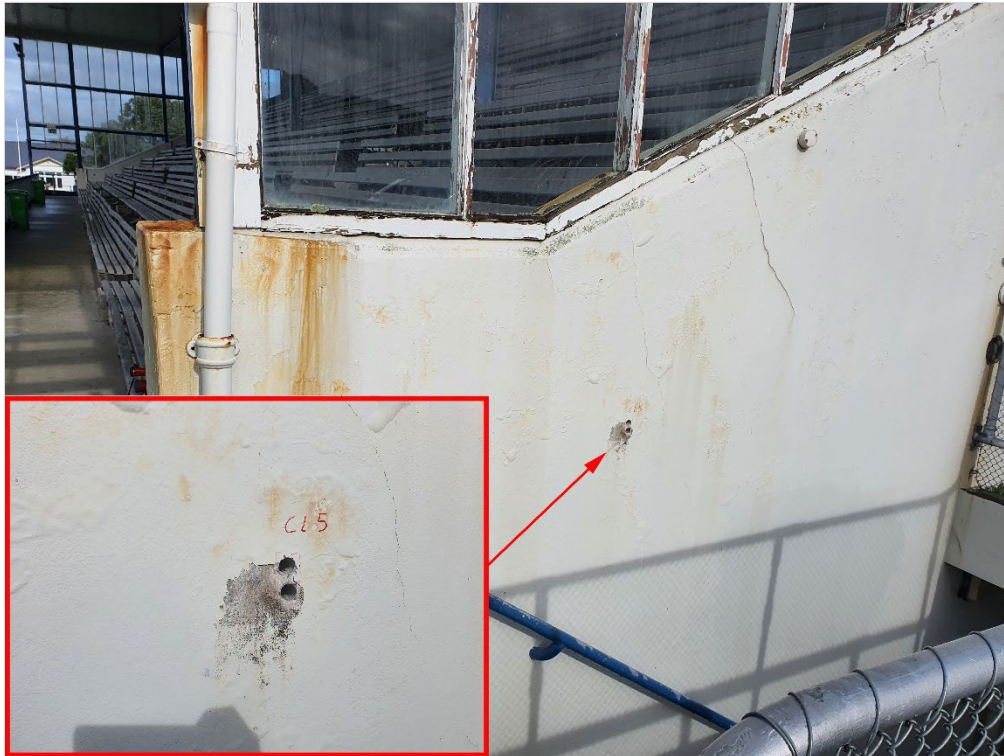
Figure 76: Chloride testing location CI.5

Concrete samples CI.5 were extracted on the northern face of the wall on grid F, between grids X and Y. The wall is exposed to the elements, predominantly to any weather system approaching from the south. Exposure to sea salts is not expected at this location.

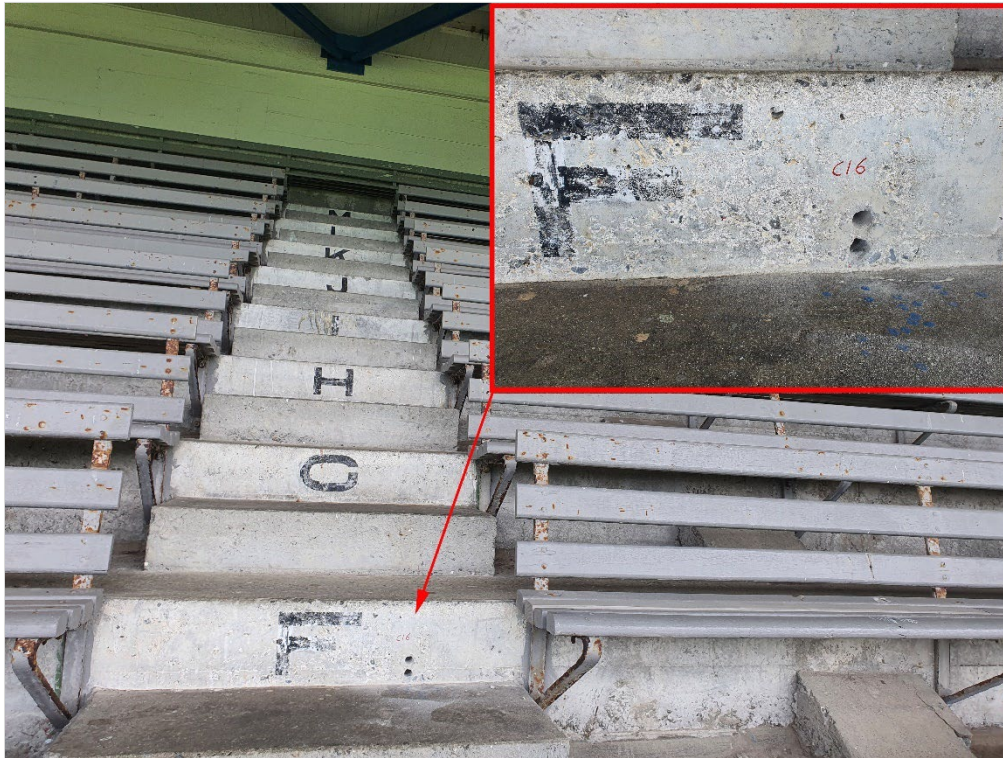
Figure 77: Chloride testing location Cl.6

Concrete samples Cl.6 were extracted on the middle flight of stairs, presumably on or near grid Y. The location is facing towards the east and is covered by the roof. Subsequently there is only minimal exposure to the elements.

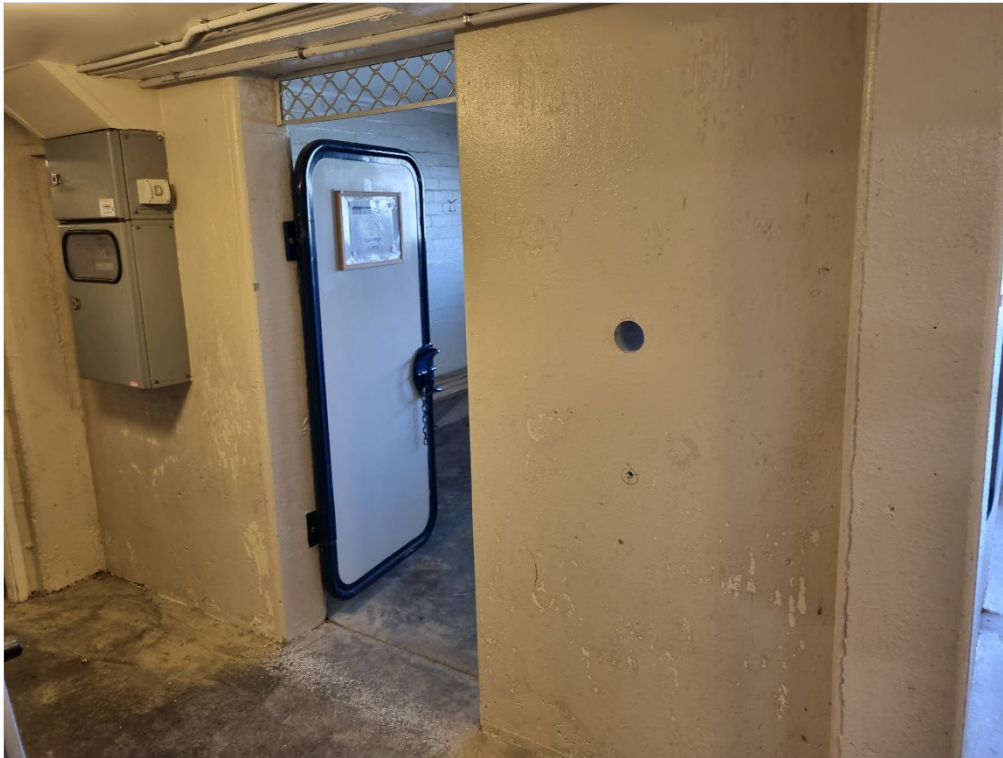
Figure 78: Core extraction location

Figure 78 displays the location where a core for compression testing was extracted. The core was taken south of column 10 on the wall on grid Y.

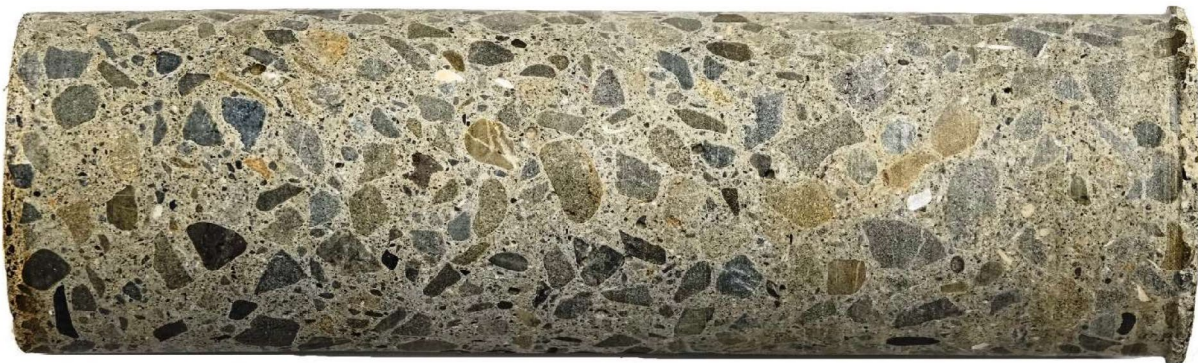
Figure 79: Extracted core

Compression testing confirmed a compressive strength for the core of 35 MPa.

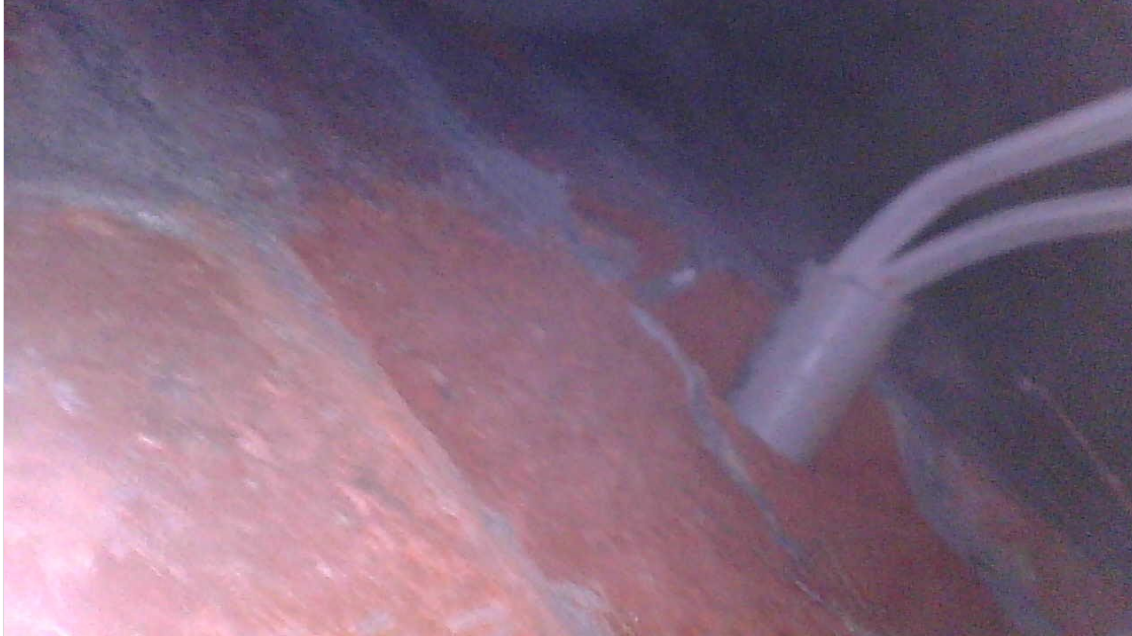
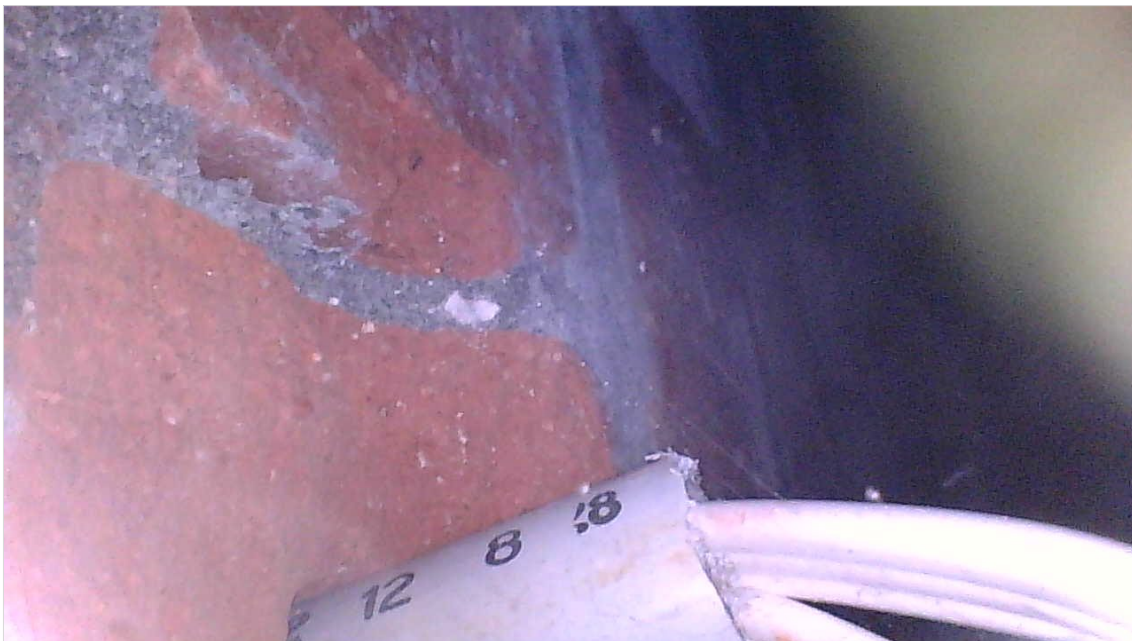
Figure 81: Wall between column 2&8

The location is approximately 1680mm East from column 8.

The wall on grid B consists of bricks.

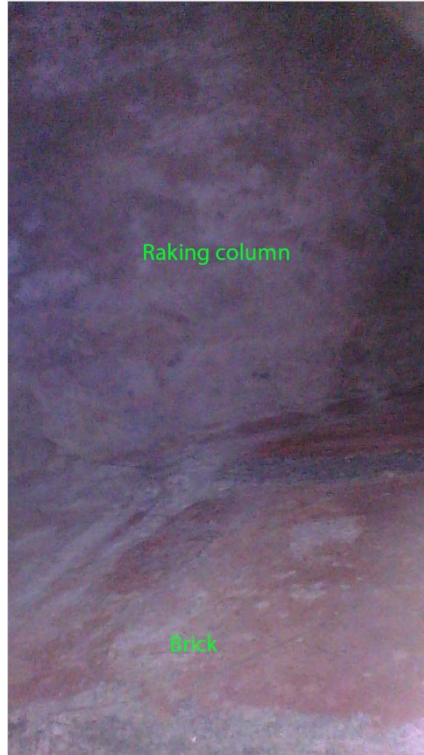
Figure 83: Wall between column 4&10

The wall on grid D consists of bricks.

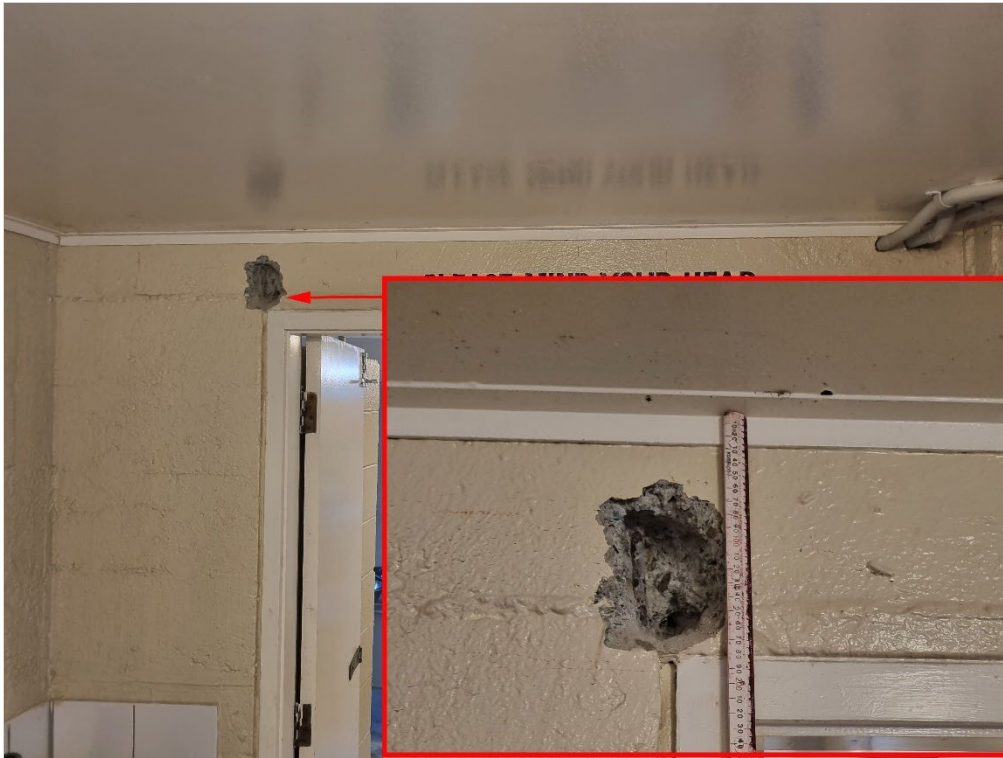
Figure 84: Lintel – grid D

Figure 84 displays a breakout on the southern side of the lintel. One vertical bar was exposed. GPR scanning indicated the presence of one horizontal bar at greater depth. Considering the signal characteristic, it can be concluded that the horizontal bar has the same or similar bar diameter as the vertical bar. The vertical bar was measured to be 9.8mm, refer to Figure 85.
