# INDEPENDENT STRUCTURAL INVESTIGATIONS REPORT

INVESTIGATIVE REPORT

| JOB NAME | Petone Grandstand |

| Corrosion survey on the Grandstand Petone. |

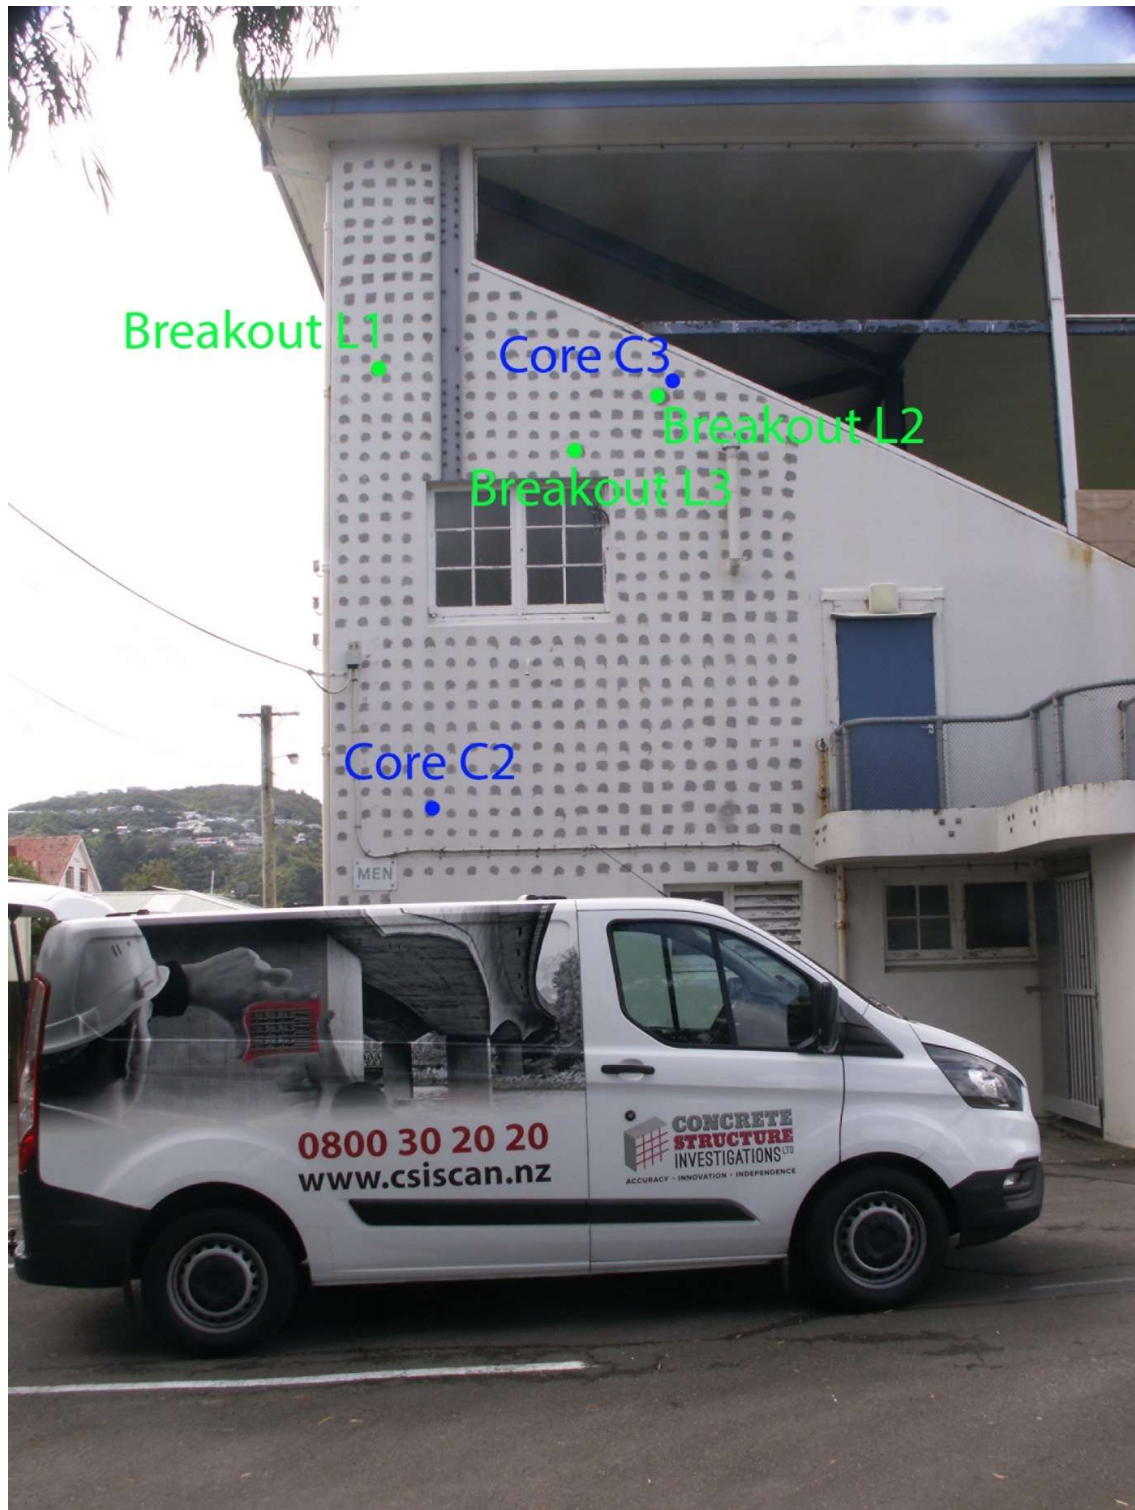
Figure 4: South Wall - Core and Breakout Locations

| Comment: | <p>South Wall</p> <p>Half-Cell Potential:</p> <ul style="list-style-type: none"><li>• Blue shaded areas have a 50% probability of active corrosion</li></ul> <p>Cover Map:</p> <ul style="list-style-type: none"><li>• The reinforcing cover is <math>\geq 30\text{mm}</math></li><li>• Most red data points are isolated detections, and likely relate to tie wires<ul style="list-style-type: none"><li>○ Ties with insufficient cover can initiate corrosion</li><li>○ The corrosion from ties migrates deeper into the structure till it reaches the reinforcing, causing the bars to corrode</li></ul></li></ul> | | |

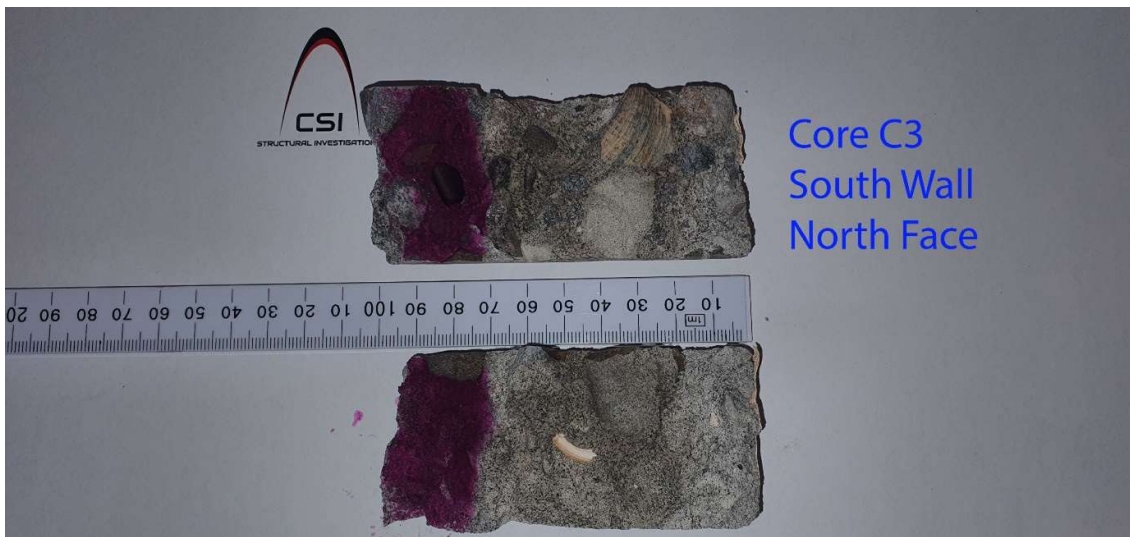
Figure 6: South Wall / North Face - Carbonation Testing

| Comment: | <p>South Wall</p> <p>Carbonation:</p> <ul style="list-style-type: none"> <li>• South Face: <ul style="list-style-type: none"> <li>◦ Core C2: No carbonation is induced</li> </ul> </li> <li>• North Face: <ul style="list-style-type: none"> <li>◦ Carbonation is apparent up to a depth of around 70mm</li> <li>◦ The concrete does not provide any passive protection against corrosion</li> </ul> </li> </ul> <p>Additional findings;</p> <ul style="list-style-type: none"> <li>• Shells are embedded in the concrete. It is possible that sand was sourced from estuaries containing potentially salts.</li> </ul> | | |

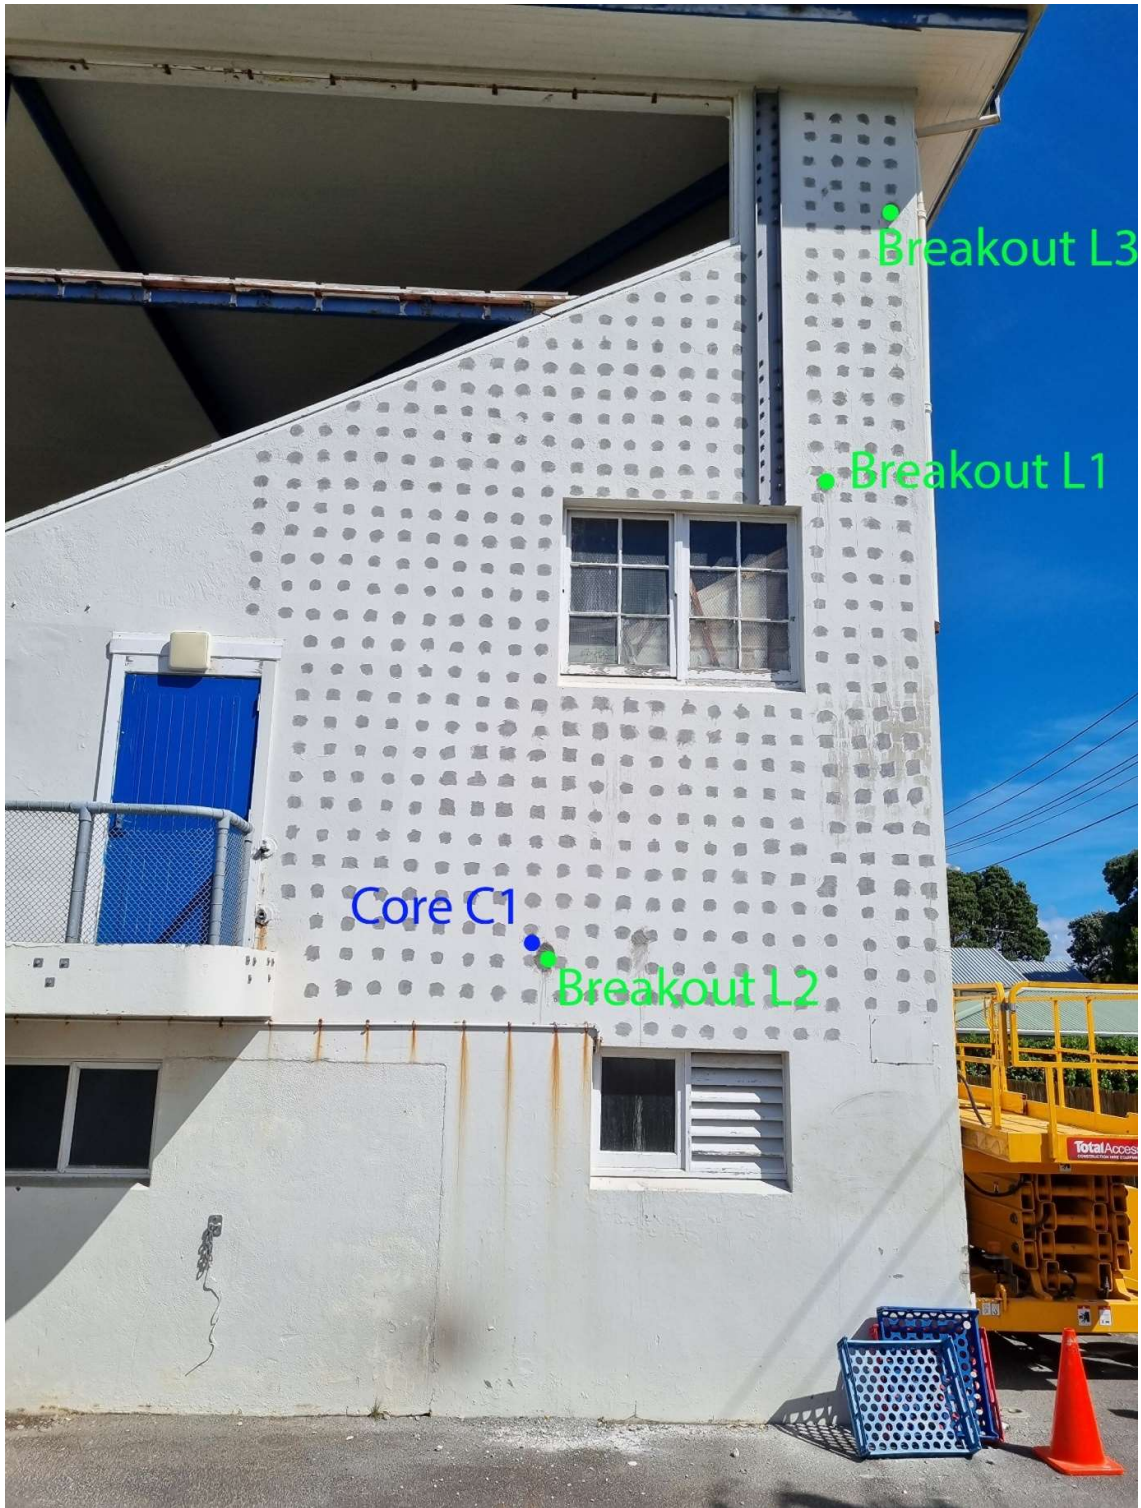
Figure 12: North Wall - Core and Breakout Locations

| Comment: | <p>North Wall</p> <p>Half-Cell Potential:</p> <ul style="list-style-type: none"><li>• Blue shaded areas have a 50% probability of active corrosion</li></ul> <p>Cover Map:</p> <ul style="list-style-type: none"><li>• The reinforcing cover is <math>\geq 30\text{mm}</math></li><li>• One area in the lower portion of the wall has cover values <math>&lt; 30\text{mm}</math></li><li>• Cover values <math>&lt; 30\text{mm}</math> (red) are observable for column reinforcing</li><li>• Single red data points likely relate to ties wires<ul style="list-style-type: none"><li>○ Ties with insufficient cover can initiate corrosion</li><li>○ The corrosion from ties migrates deeper into the structure till it reaches the reinforcing, causing the bars to corrode</li></ul></li></ul> | | |

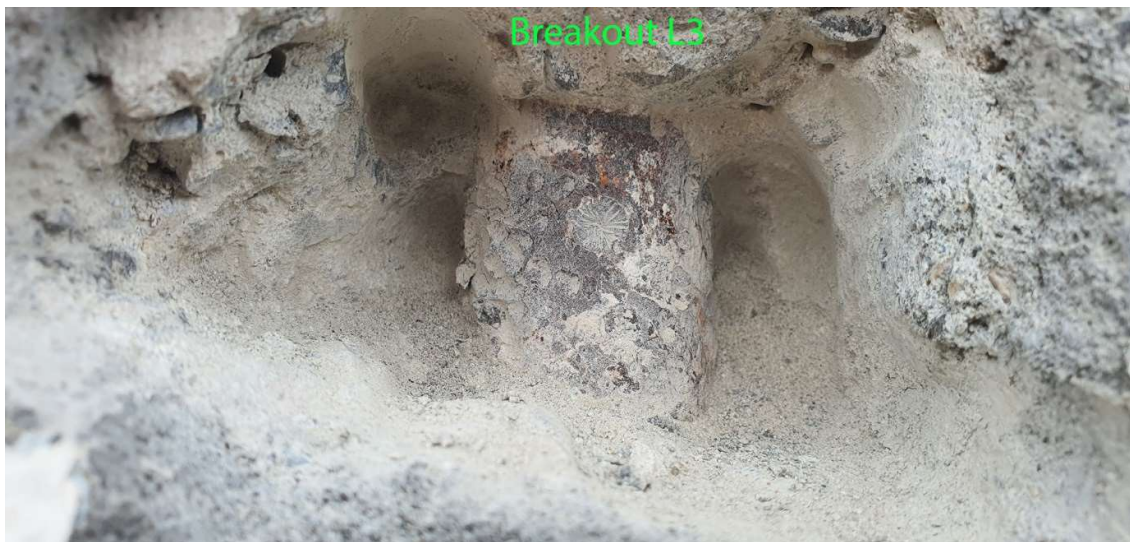
*Figure 15: North Wall - Breakout L3*

| Comment: | <p>North Wall</p> <p>Breakout L1</p> <ul style="list-style-type: none"><li>The unpolished bar was measured to have a diameter of just below 10mm, the increased diameter is due to the volume expansion iron-oxide.</li></ul> <p>Breakout L2</p> <ul style="list-style-type: none"><li>Half-Cell testing indicates a 50% probability for active corrosion occurring</li><li>Some pitting is visible on the polished bars</li><li>The unpolished bars were measured to have a diameter of 10mm, the increased diameter is due to the volume expansion iron-oxide.</li></ul> <p>Breakout L3 – Column</p> <ul style="list-style-type: none"><li>The main bar seems to have only a thin layer of corrosion</li><li>The diameter was measured to be 30mm (nominal diameter is 32mm)</li></ul> | | |

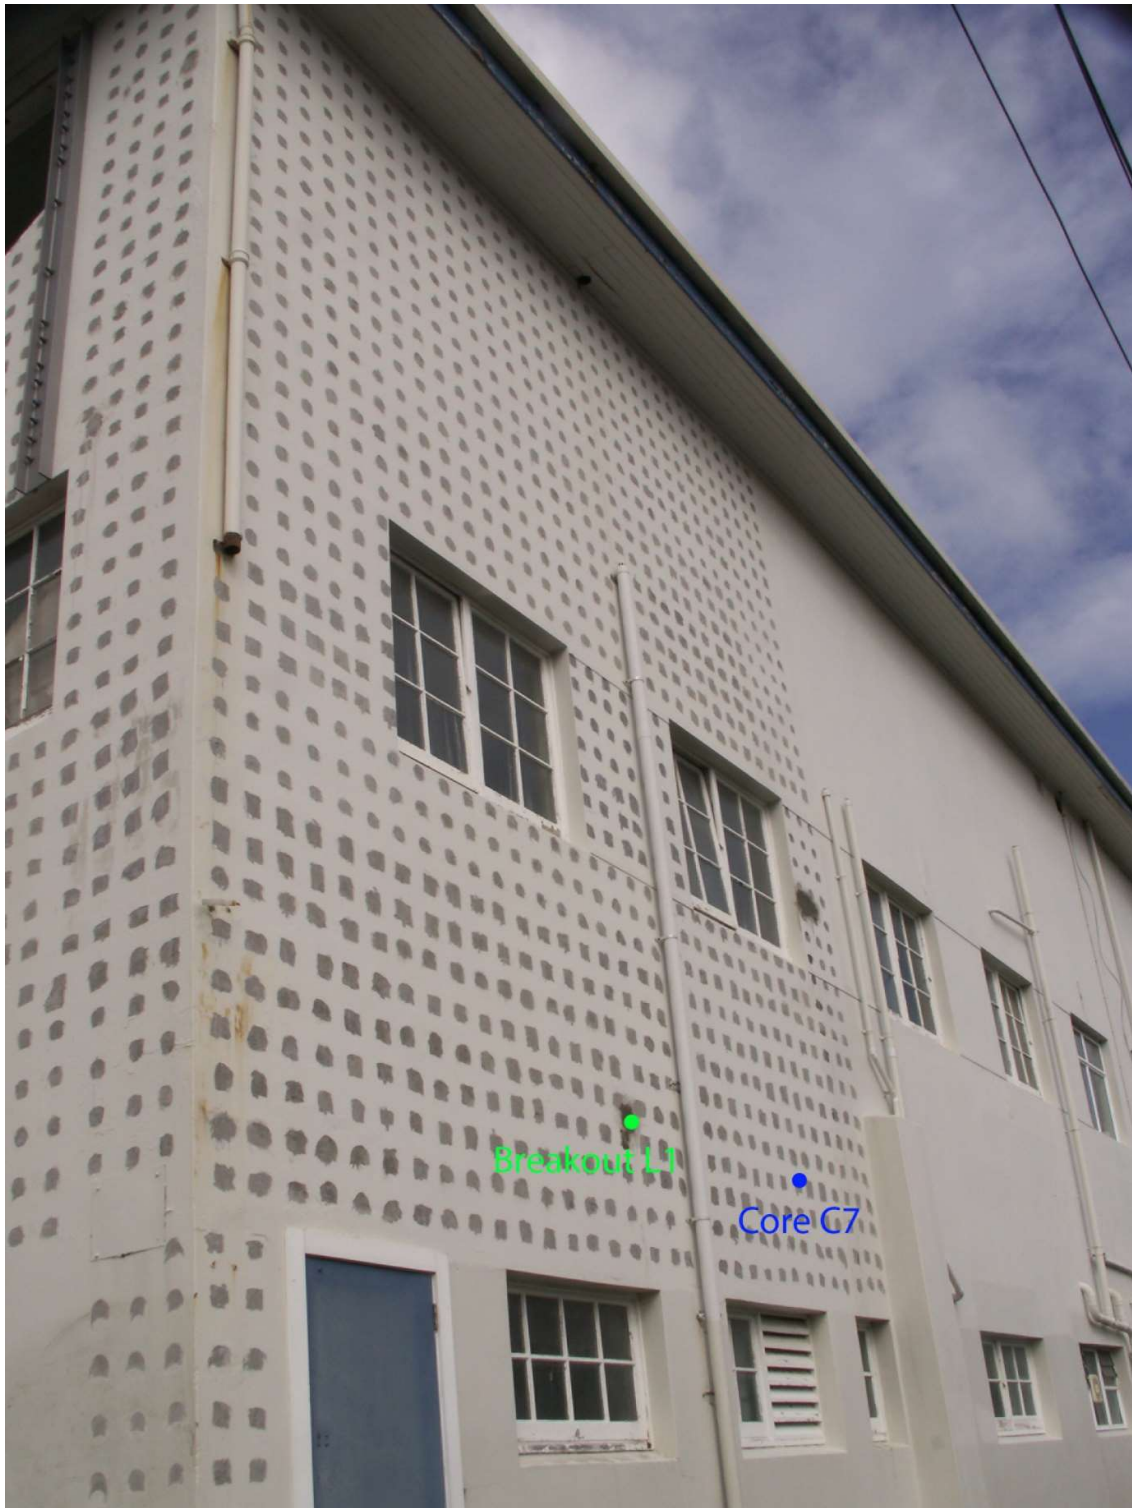
*Figure 17: West Wall Grid E-F - Breakout Location*

| Comment: | <p>West Wall<br/>Grid E-F</p> <p>Half-Cell Potential:</p> <ul style="list-style-type: none"> <li>Blue shaded areas have a 50% probability of active corrosion</li> </ul> <p>Cover Map:</p> <ul style="list-style-type: none"> <li>Large areas have reinforcing with covers &lt; 30mm (red) <ul style="list-style-type: none"> <li>Some low cover reinforcing is within areas where Half-Cell testing has a 50% probability of active corrosion</li> </ul> </li> </ul> | | |

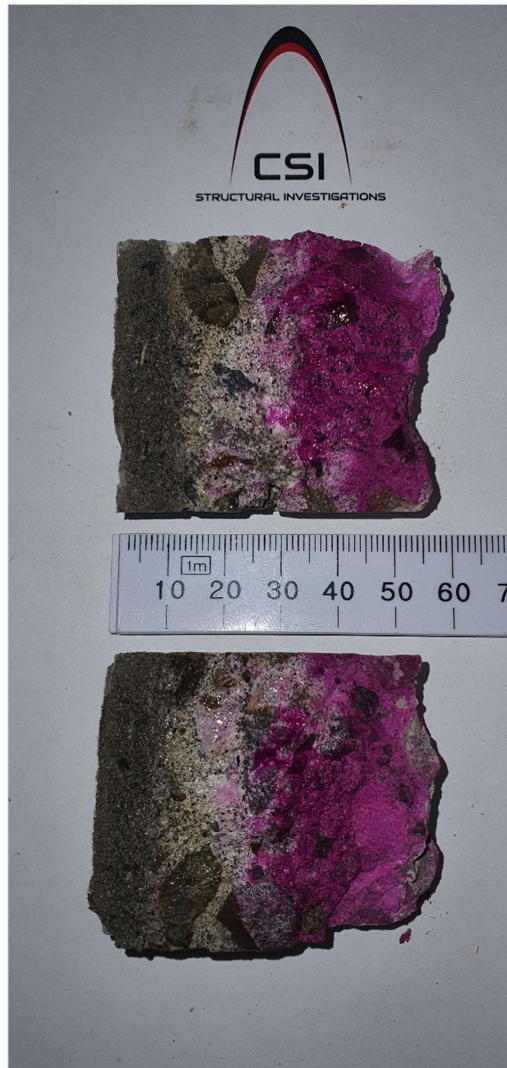
Figure 18: West Wall Grid E-F - Carbonation Testing

| Comment: | <p>West Wall<br/>Grid E-F</p> <p>Carbonation:</p> <ul style="list-style-type: none"> <li>West Face: <ul style="list-style-type: none"> <li>Carbonation is apparent to a depth of 20-30mm</li> </ul> </li> </ul> <p>Additional findings:</p> <ul style="list-style-type: none"> <li>The added, remedial material is thinner than at other locations <ul style="list-style-type: none"> <li>Approx. thickness is 10mm</li> </ul> </li> </ul> | | |

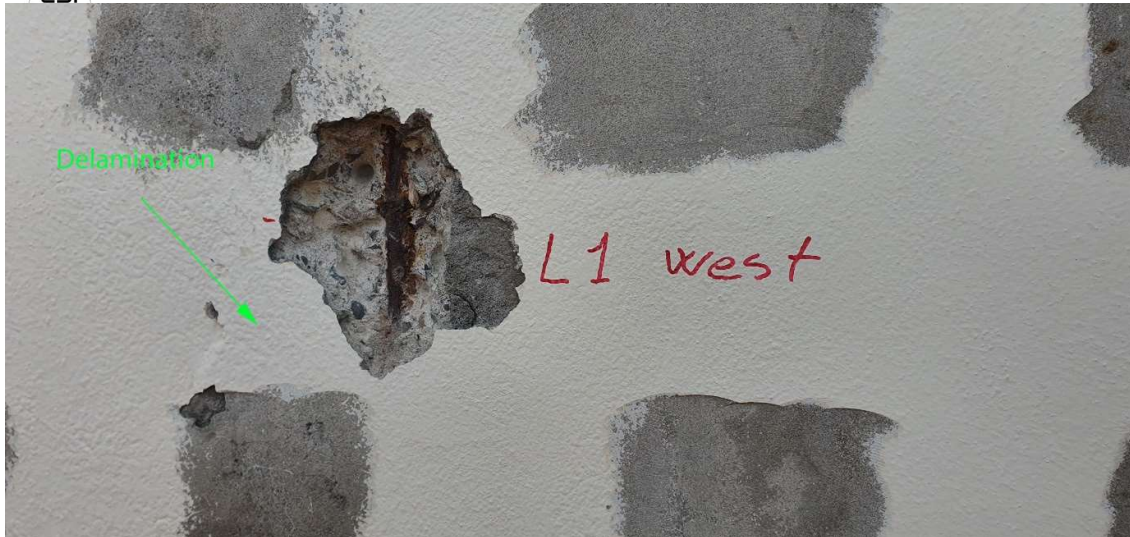
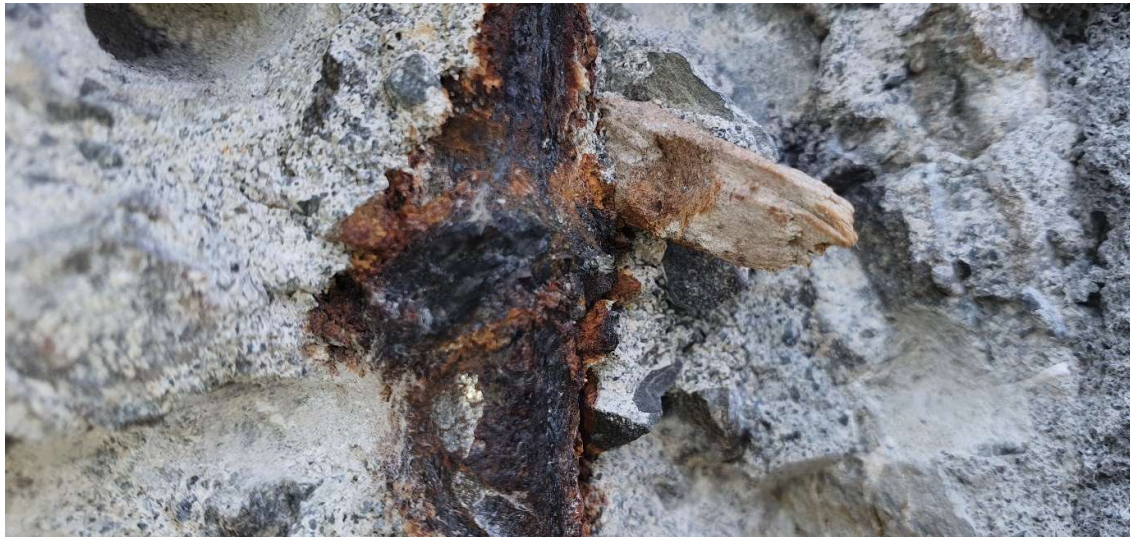
Figure 19: West Wall – Grid E-F - Breakout L1

| Comment: | <p>West Wall<br/>Grid E-F</p> <p>Breakout L1</p> <ul style="list-style-type: none"> <li>The area was delaminated and some of the spalled material was removed</li> <li>Half-Cell testing indicates a 50% probability for active corrosion occurring</li> <li>The bar is severely corroded</li> <li>A piece of timber is embedded in the concrete and in contact with the bar <ul style="list-style-type: none"> <li>Timber has a high absorption rate and may have contributed to draw and deliver moisture to the bar, which would have led to corrosion.</li> </ul> </li> <li>It must be assumed that the bar is in a similar condition as the exposed bar at the breakout L3 on the West Wall – Grid B-C</li> </ul> | | |

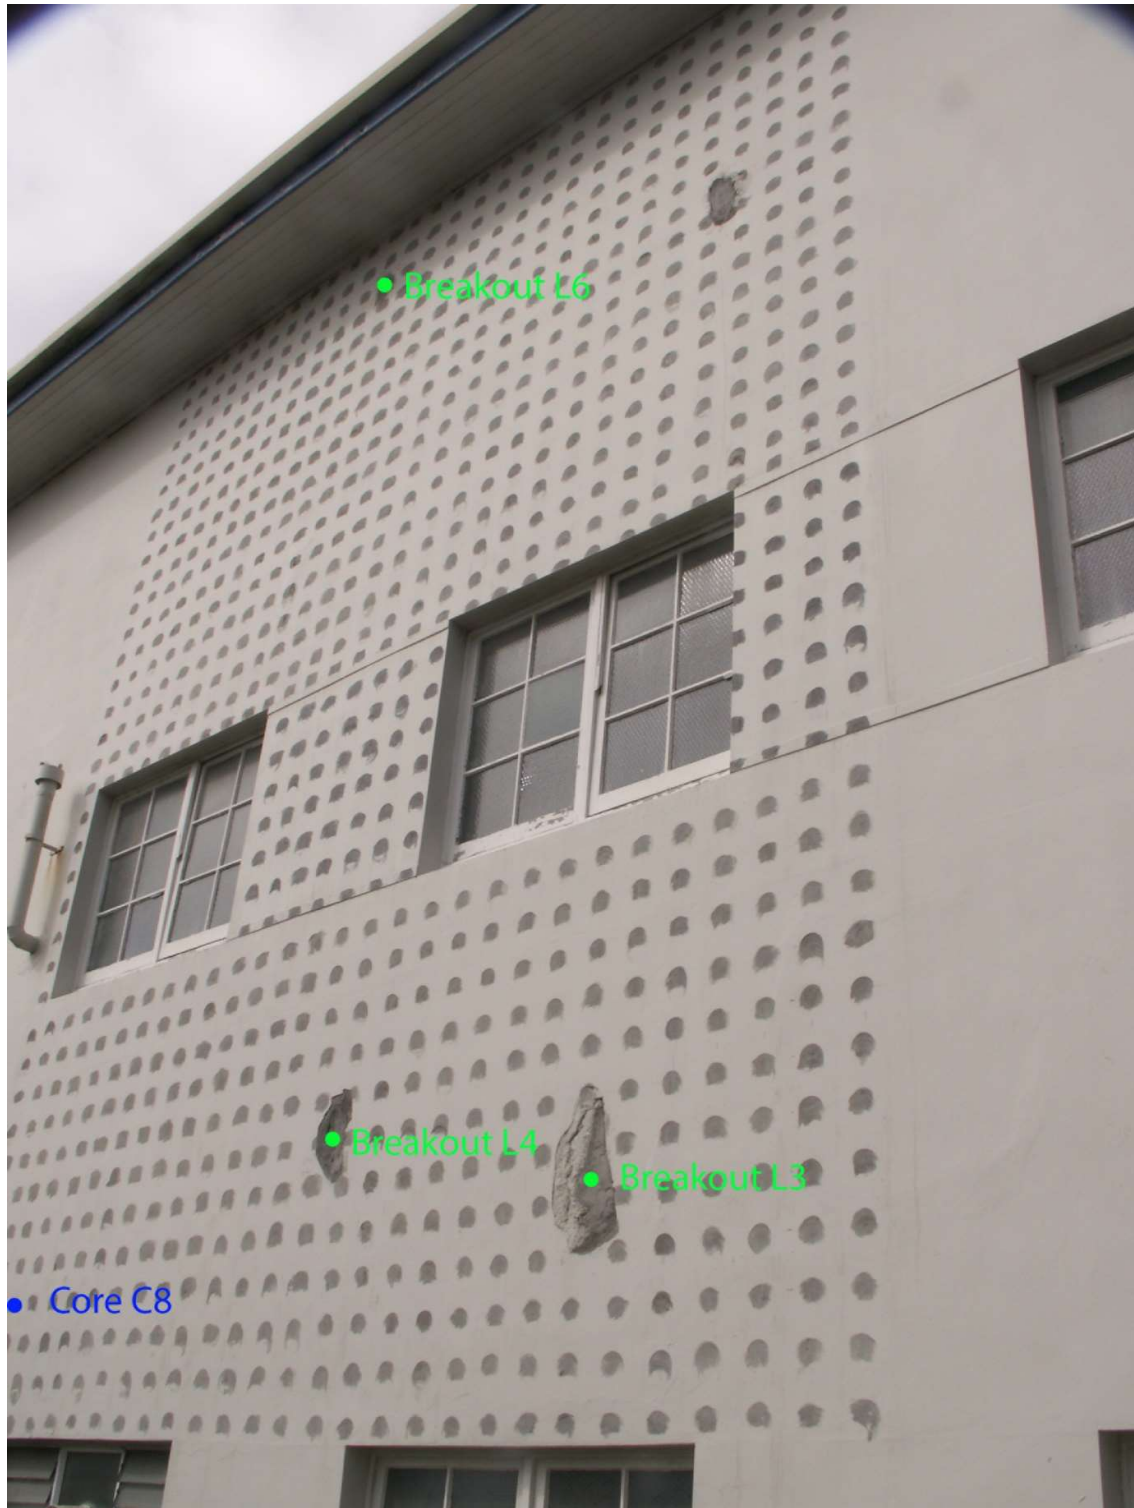
Figure 21: West Wall Grid B-C – Core and Breakout Locations

| Comment: | <p>West Wall<br/>Grid B-C</p> <p>Half-Cell Potential:</p> <ul style="list-style-type: none"><li>• Blue shaded areas have a 50% probability of active corrosion</li></ul> <p>Cover Map:</p> <ul style="list-style-type: none"><li>• Large areas have reinforcing with covers &lt; 30mm (red)<ul style="list-style-type: none"><li>○ Some low cover reinforcing is within areas where Half-Cell testing has a 50% probability of active corrosion</li></ul></li></ul> | | |

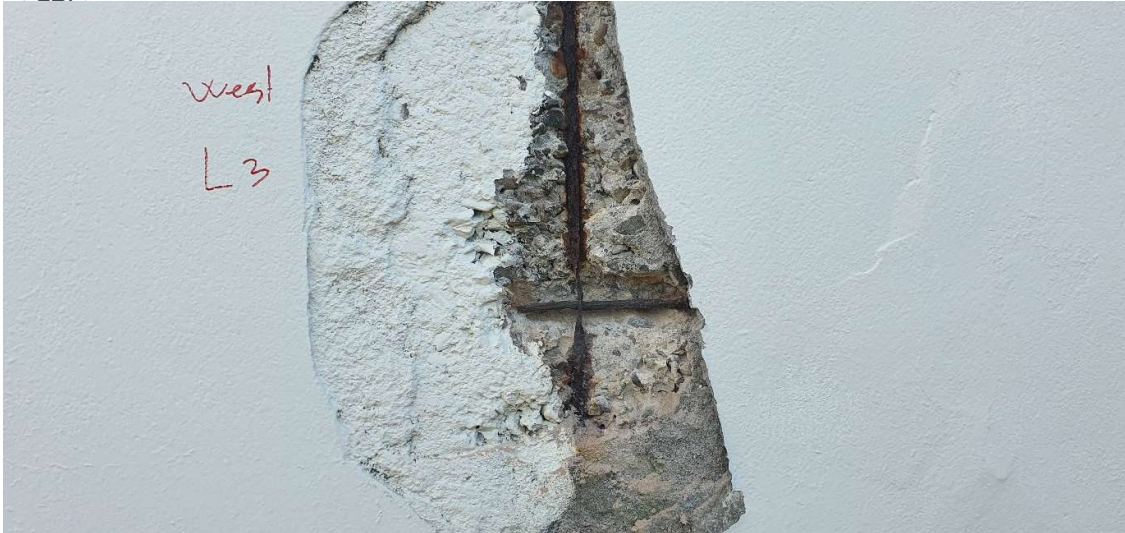
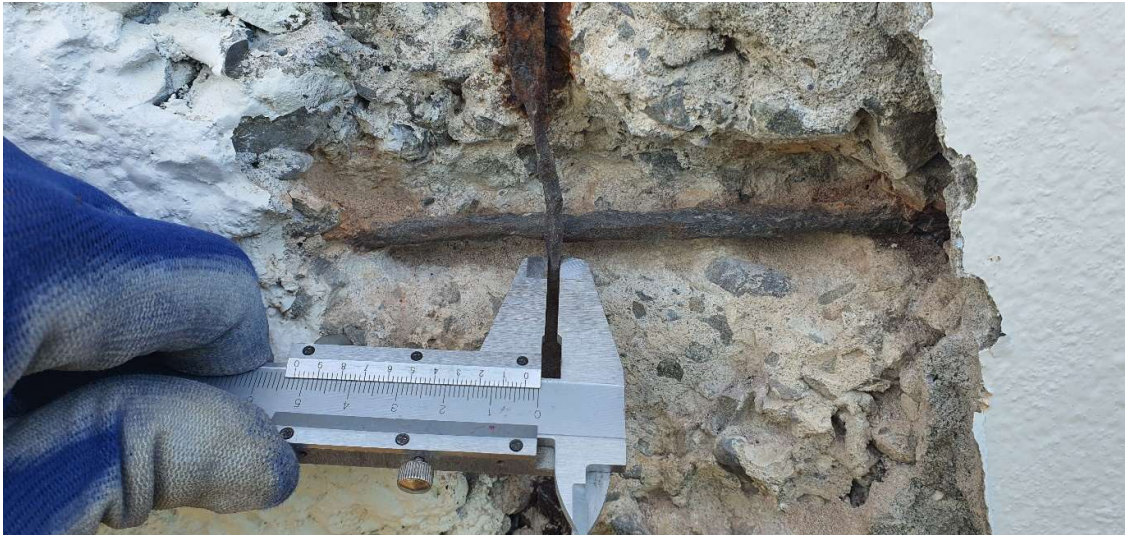
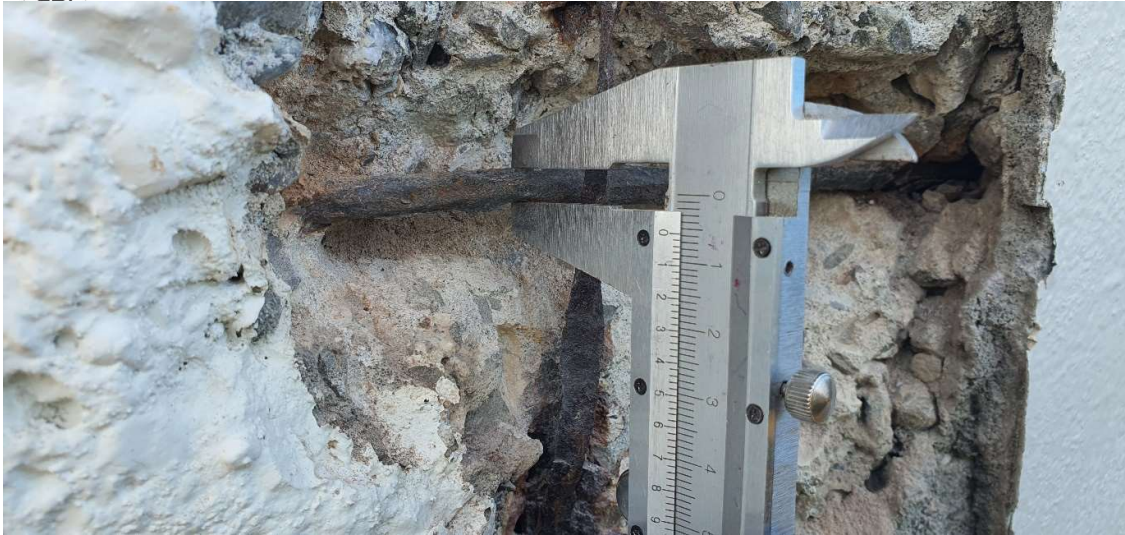
*Figure 24: West Wall - Grid B-C - Breakout L3*

| Comment: | <p>West Wall<br/>Grid B-C</p> <p>Breakout L3</p> <ul style="list-style-type: none"> <li>• The location had a spalled area, observed by CSI already two years ago</li> <li>• The reinforcing was exposed to the atmosphere and is severely corroded</li> <li>• The vertical bar has a remaining diameter of 3mm</li> <li>• The horizontal bar has a remaining diameter of 6mm</li> <li>• The concrete is porous, nested aggregates were found</li> </ul> | | |

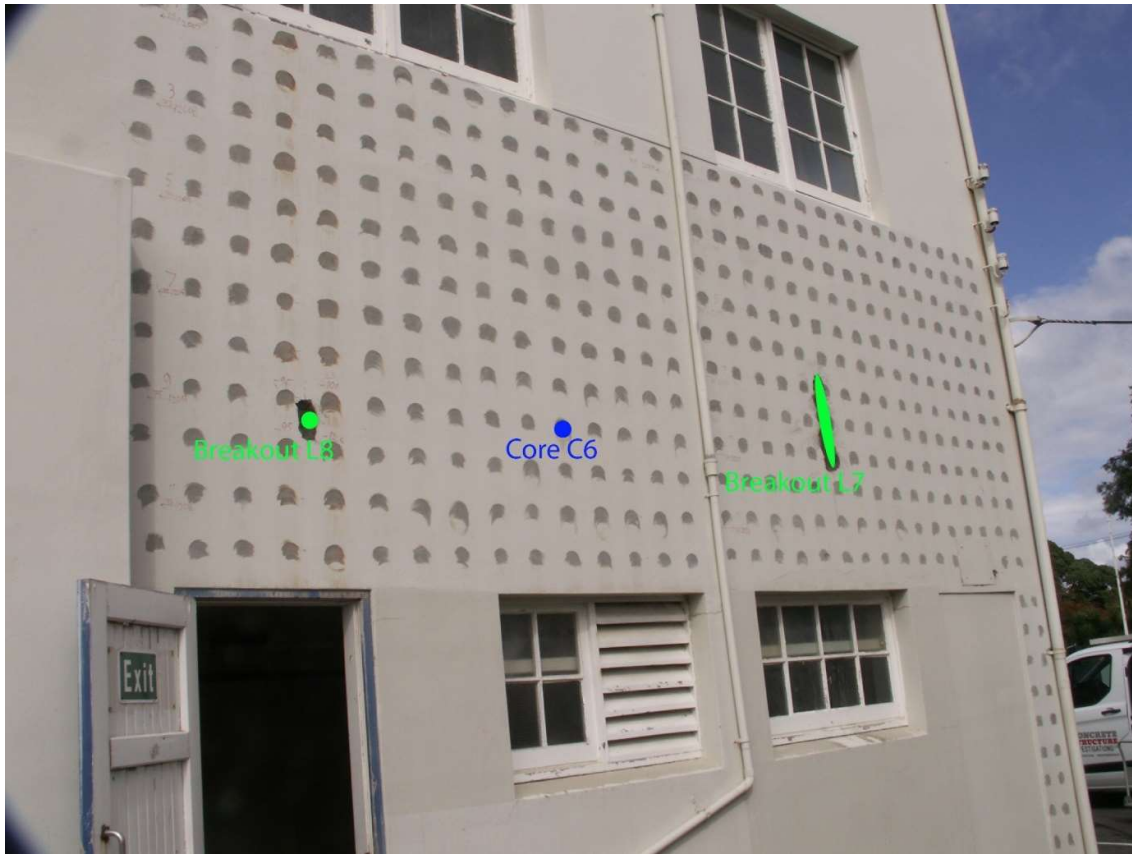
*Figure 31: West Wall Grid A-B - Core and Breakout Locations*

| Comment: | <p>West Wall<br/>Grid A-B</p> <p>Half-Cell Potential:</p> <ul style="list-style-type: none"><li>Blue shaded areas have a 50% probability of active corrosion</li></ul> <p>Cover Map:</p> <ul style="list-style-type: none"><li>Some reinforcing with cover values &lt; 30mm (red) is apparent</li><li>Isolated detections likely relate to ties wires<ul style="list-style-type: none"><li>Ties with insufficient cover can initiate corrosion</li><li>The corrosion from ties migrates deeper into the structure until it reaches the reinforcing, causing the bars to corrode</li></ul></li></ul> | | |

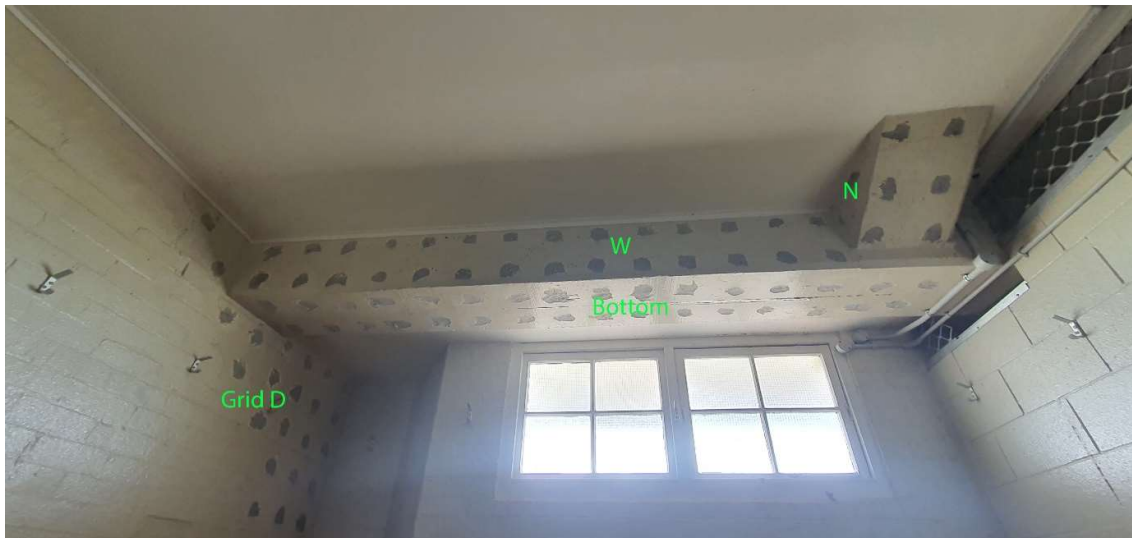
Figure 67: Beam Grid X/D-C

| Comment: | <p>Beam - Inside<br/>Grid X/C-E</p> <p>No maps are displayed for the locations.<br/>Data indicate a 90% probability that no active corrosion is occurring.<br/>The reinforcing of the raking beam shown in photo Figure 67 is heavily corroded from the top (stands). Corrosion has not progressed further down.</p> | | |
