**DETAILED SEISMIC ASSESSMENT FOR  
38 NORMANDALE ROAD, MINOH  
HOUSE, LOWER HUTT.**

DSA REPORT

91 WESTERN HUTT ROAD,  
NORMANDALE, LOWER HUTT 5010

P330

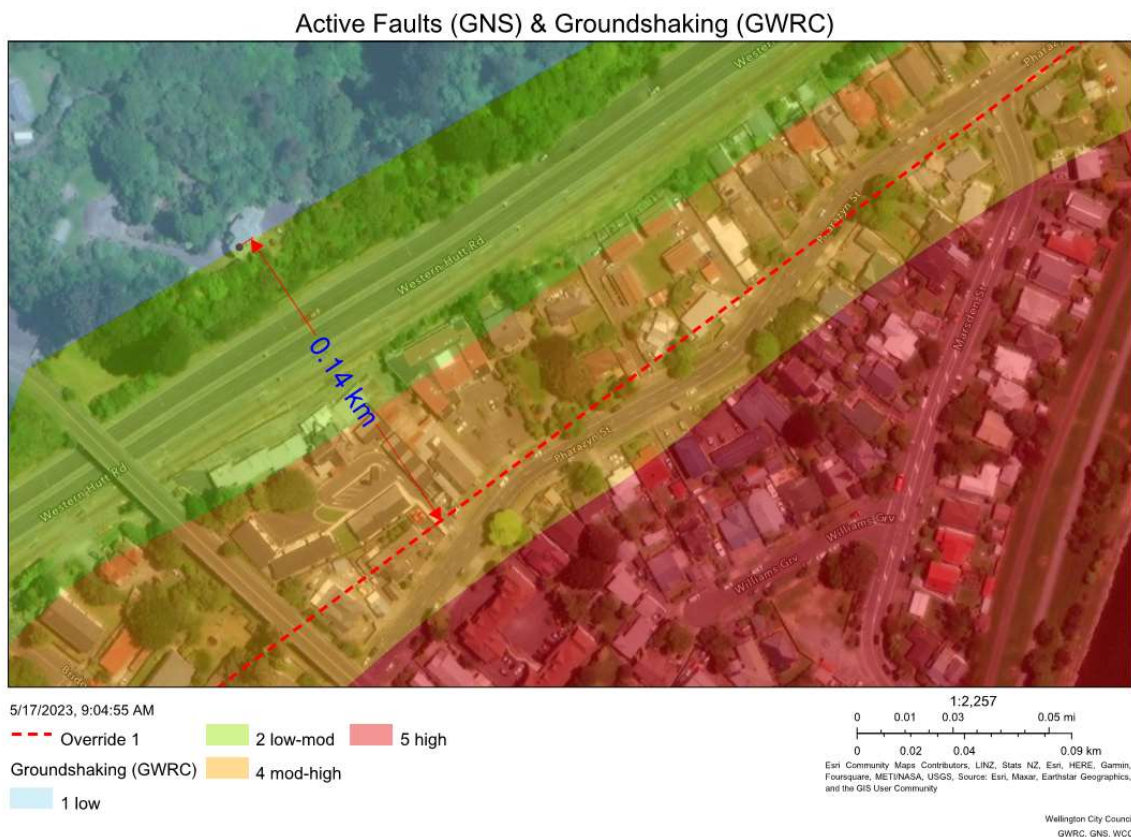
**Figure 4.** Location of the building and active fault (GWRC Webmap)

The building is roughly 200 m to the South-East of the Wellington Fault line trace. The estimated natural period of vibration of the building is less than 0.4 seconds and therefore is not sensitive to near-fault directivity effects as per provisions of the near-fault effects listed in AS/NZS 1170.5. Soil testing has not been completed as part of this DSA but reasonable data is available in technical literature, on NZGS database and our knowledge of working with buildings in the same area.

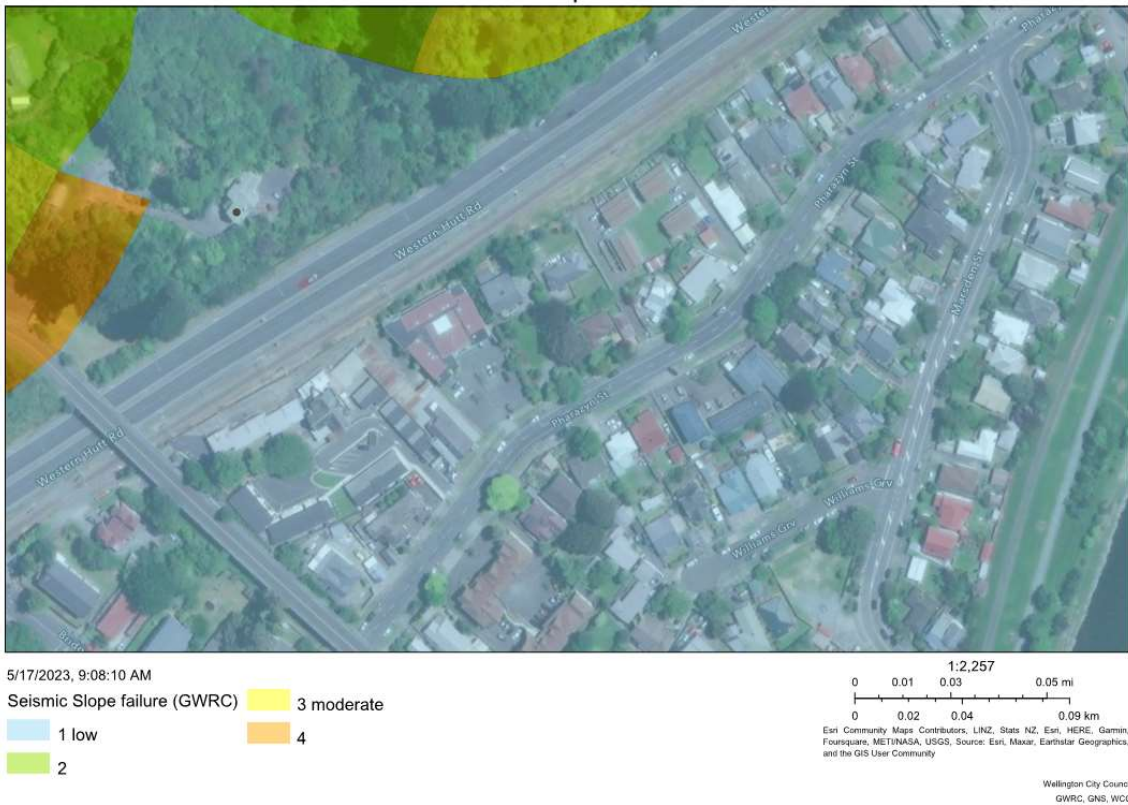
**Figure 5.** Location of the building and eismic slope failure (GWRC Webmap)

The underlying soil at the site is considered to be likely subsoil class B. Figure 5 shows a low risk for seismic slope failure at the location of the assessed building. Liquefaction analysis is outside the scope of this assessment. However, Figure 6 shows low liquefaction risk, and its likely impacts on the timber-framed structure supported by piles could be negligible to pose a life safety risk. Given the size and structural configuration of the building, the building’s seismic response is likely to be dominated by the superstructure.

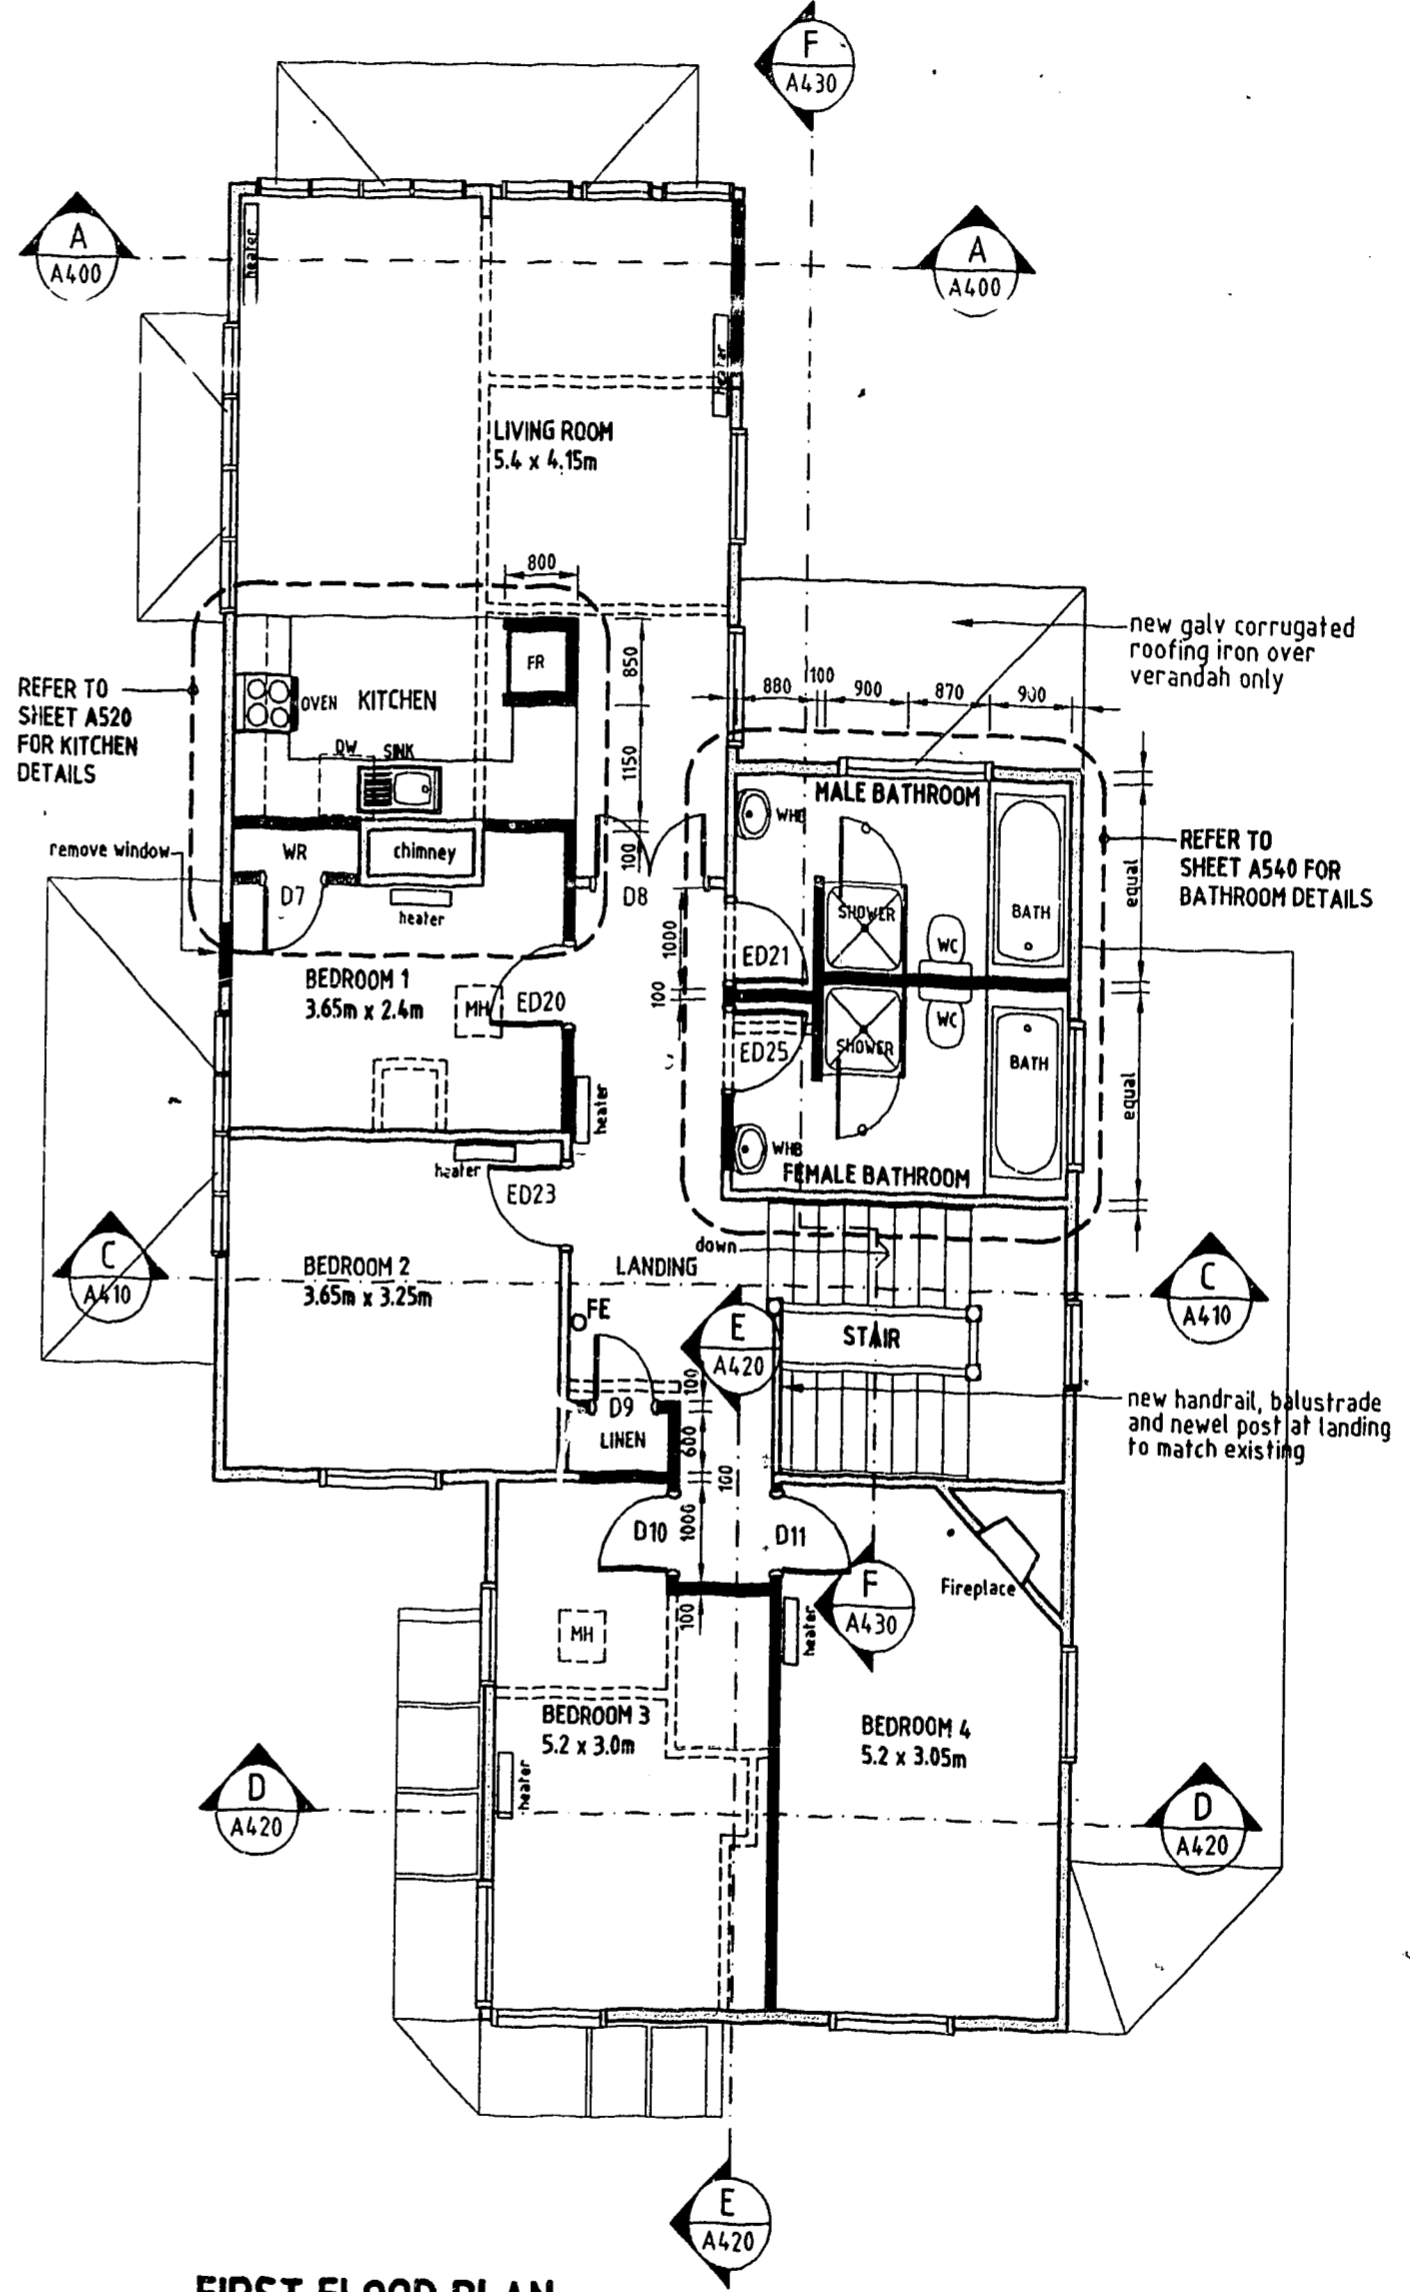
FIRST FLOOR PLAN AS PROPOSED

As can be seen on Figure 1, several walls have been removed (shown with dashed line in the figure) due to the 1998 upgrade. There is no evidence in the HCC archives showing adequate compensating actions carried out after the wall removal, which would negatively affect the lateral bracing capacity of the building specifically along the transverse direction. This weakness can be a significant issue in regions R1 and R2 as marked in Figure 1. The presence of two heavy/tall brick chimneys (Figure 2), making them earthquake-prone non-structural elements, in the building can pose a life safety risk and can decrease the building room score to values < 34% NBS (IL2) corresponding to seismic grade D (High Risk)
