Request for Information pursuant to the Local Government Official Information and Meetings Act 1987 (LGOIMA)

Could you please provide me with copies of reports you have on hand relating to the stability of the slope located above Eastern Hutt Road and below Holborn Drive (in particular relating to the area below the land at 58 and 60 Holborn Drive).

Claim for Natural Disaster (Landslip) Damage

60 Holborn Drive Slope Re-Assessment and Remedial Works

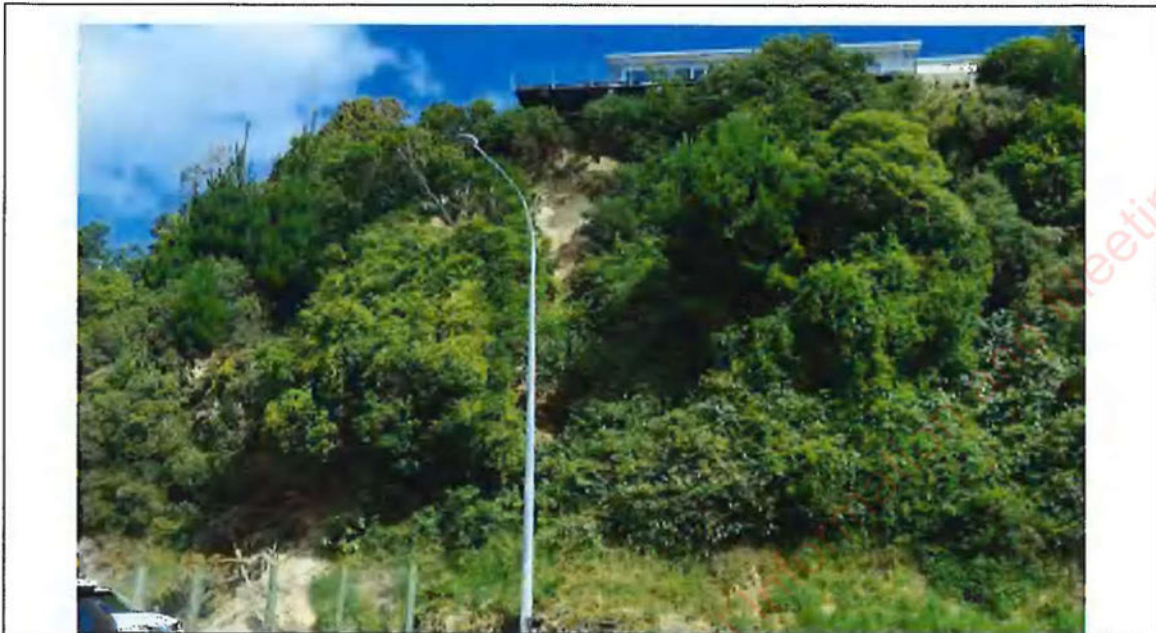
Photograph 1: Dwelling and landslip 1 from Eastern Hutt Road (Photo taken 10 January 2022).

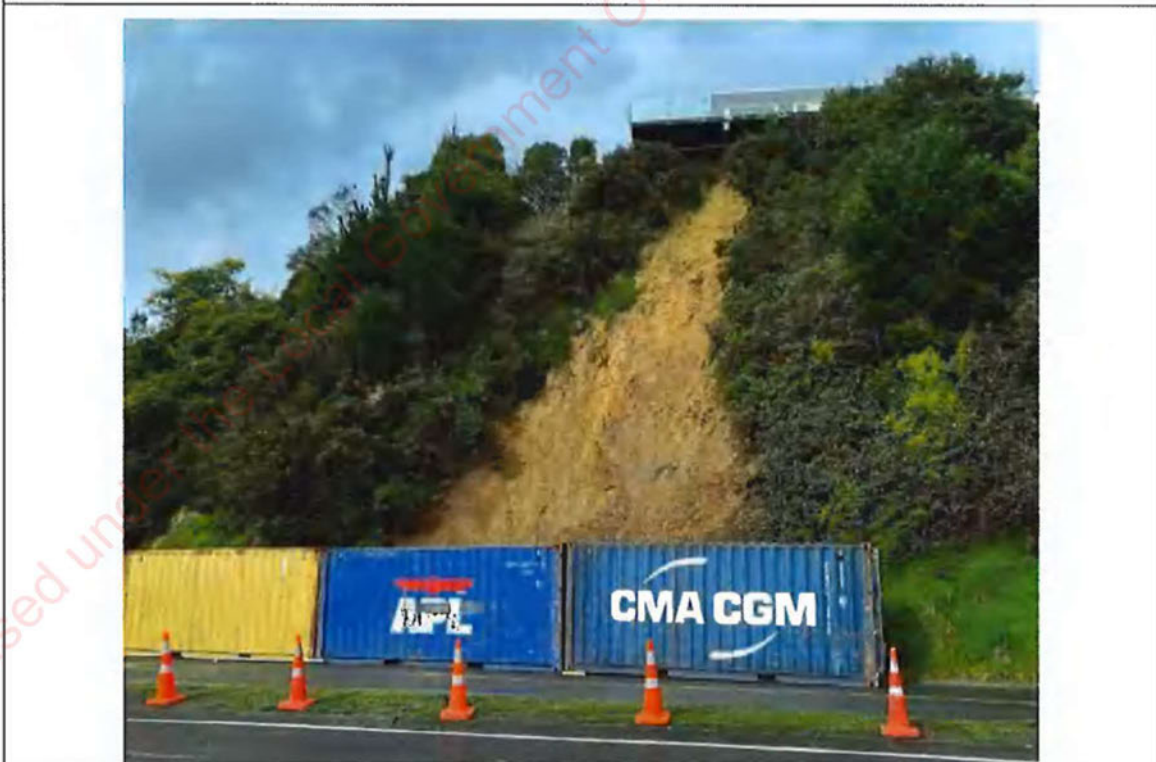
Photograph 2: Dwelling and landslip 1 from Eastern Hutt Road (Comparison photo taken 26 July 2022).

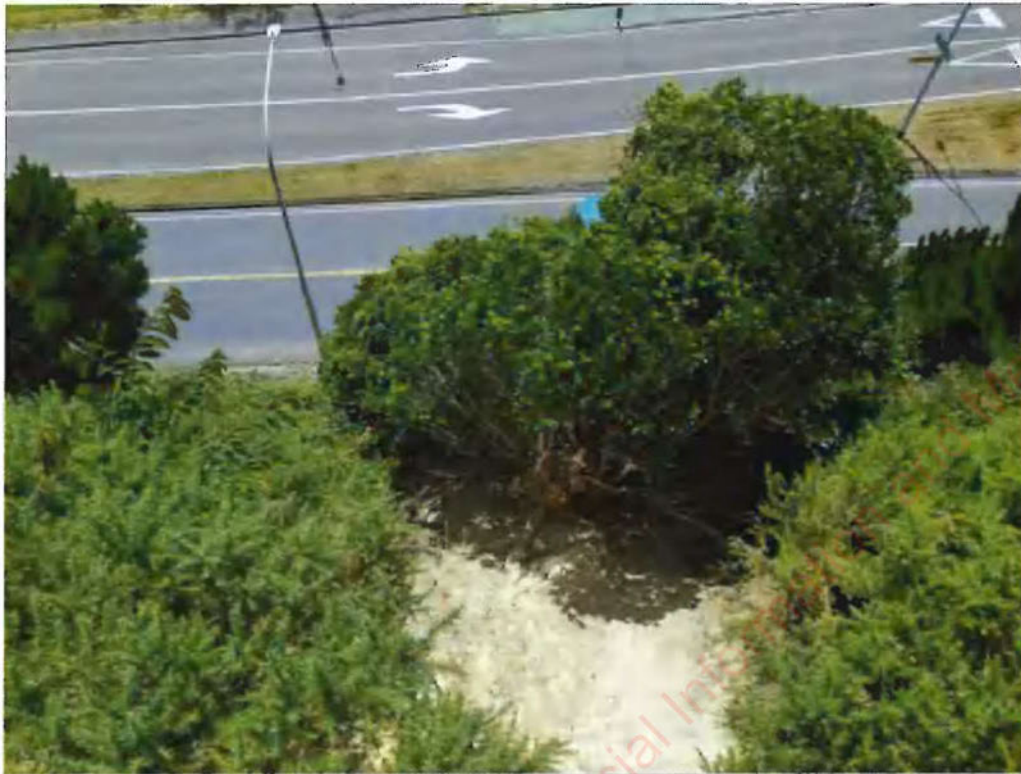
Photograph 3: View of landslip 1 from above – taken from deck (Photo taken 10 January 2022).

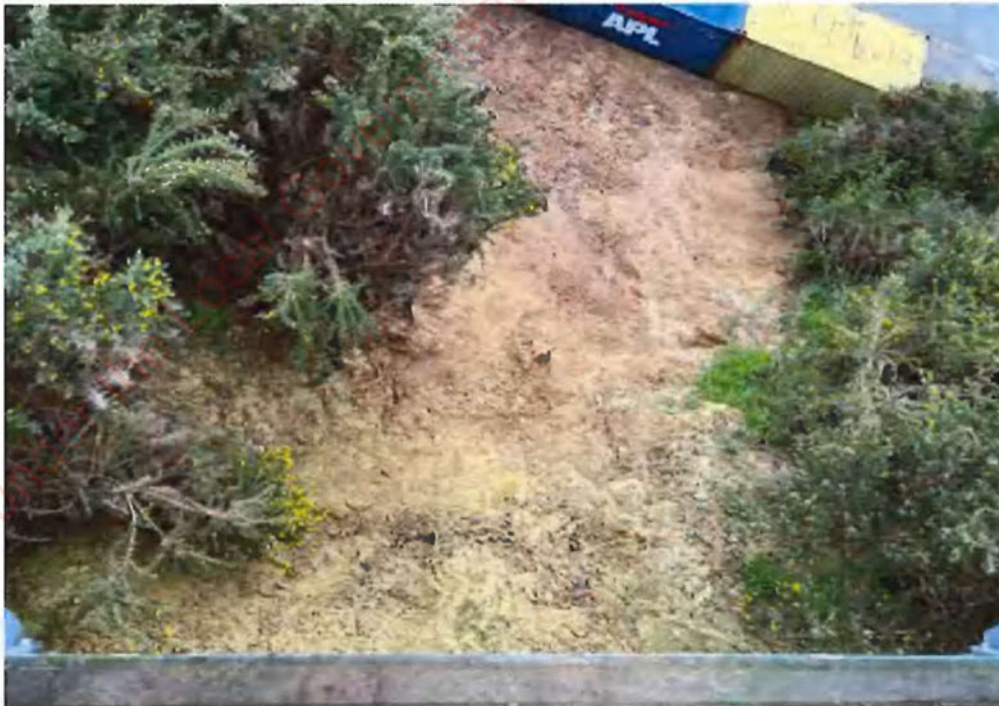
Photograph 4: View of landslip 1 from above – taken from deck (Comparison photo taken 26 July 2022).

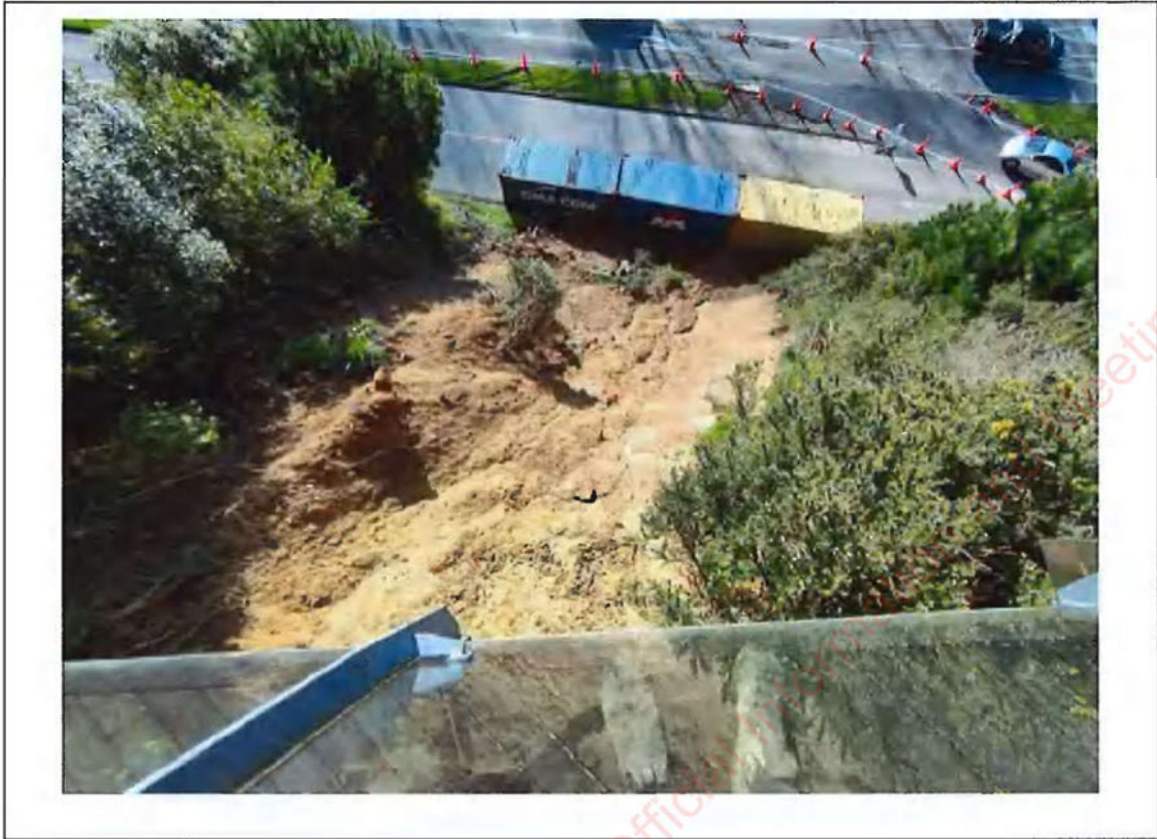
Photograph 5: View of landslip 1 from above – taken from deck (Comparison photo taken 23 August 2022).

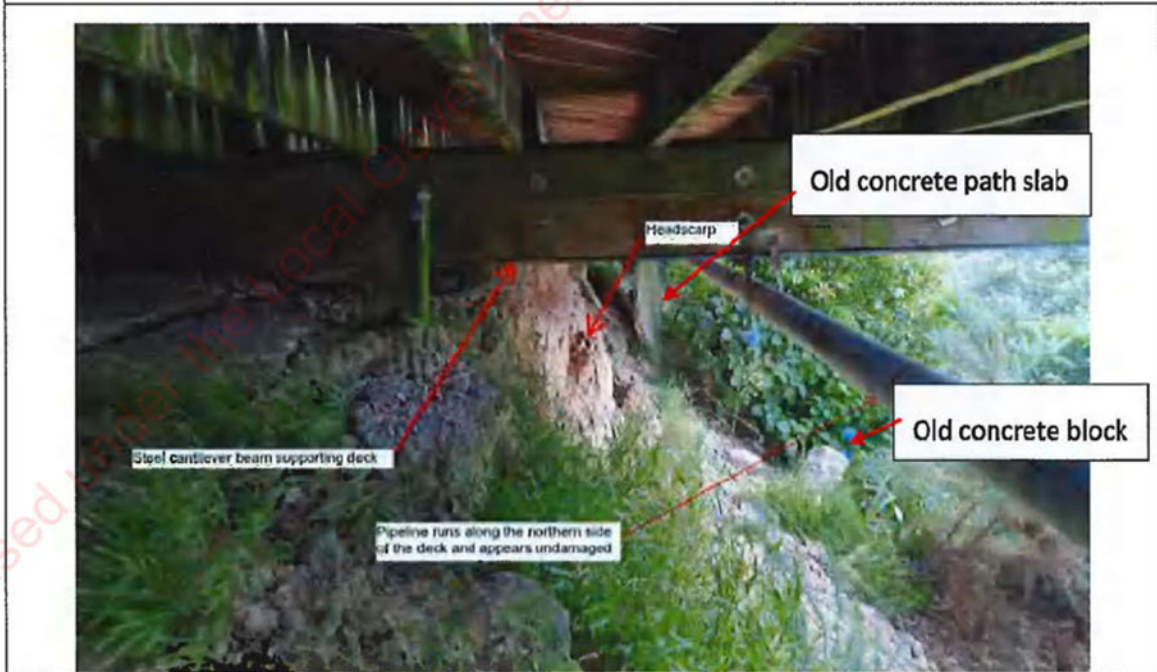
Photograph 6: View at top of landslip 1 from below deck (looking from east to west) (Photo taken 10 January 2022).

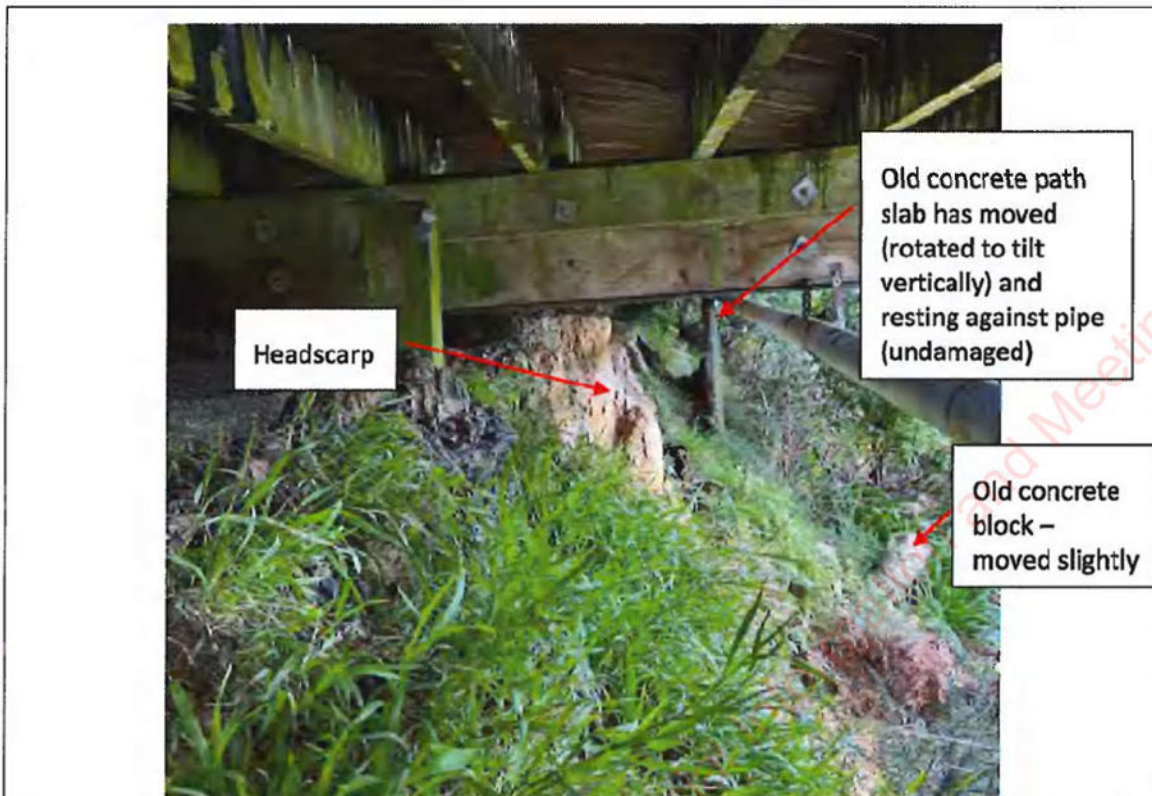
Photograph 7: View at top of landslide 1 from below deck (looking from east to west) (Comparison photo taken 26 July 2022).

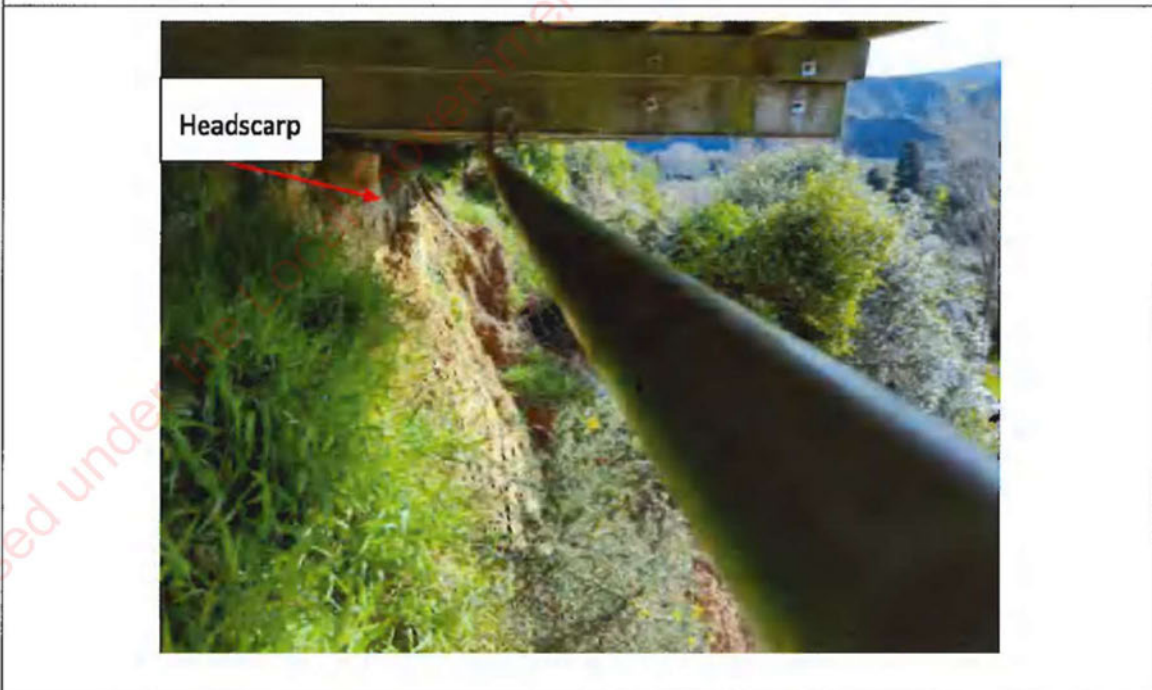
Photograph 8: View at top of landslide 1 from below deck (looking from east to west) (Comparison photo taken 23 August 2022).

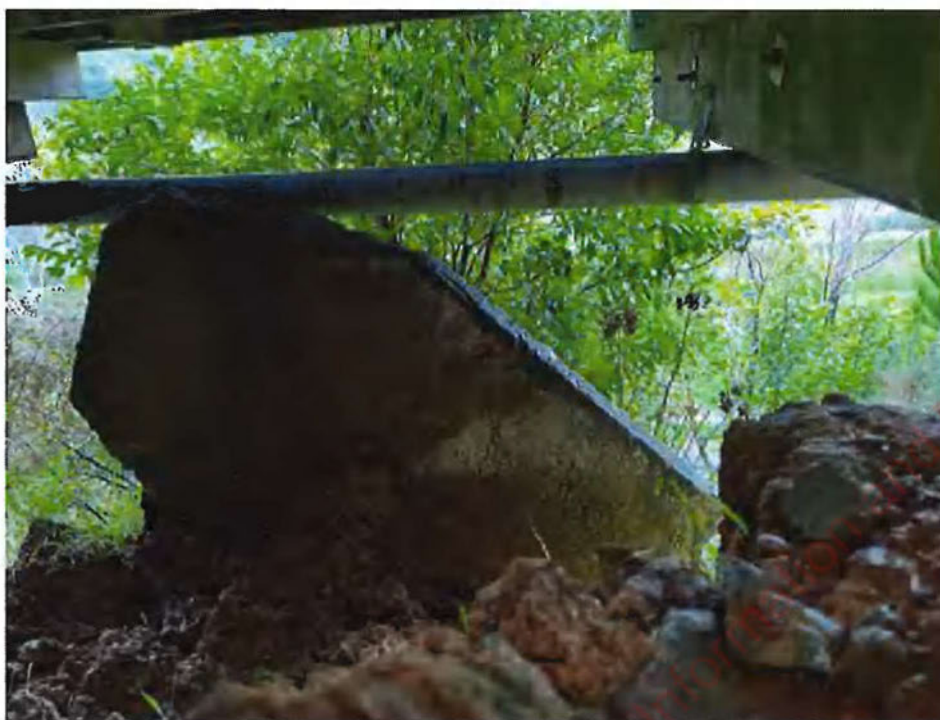
Photograph 9: View under deck (looking north) of landslip 1 (Photo taken 26 July 2022). Old concrete path slab has moved (rotated and tilted vertically) and resting against pipe (undamaged).

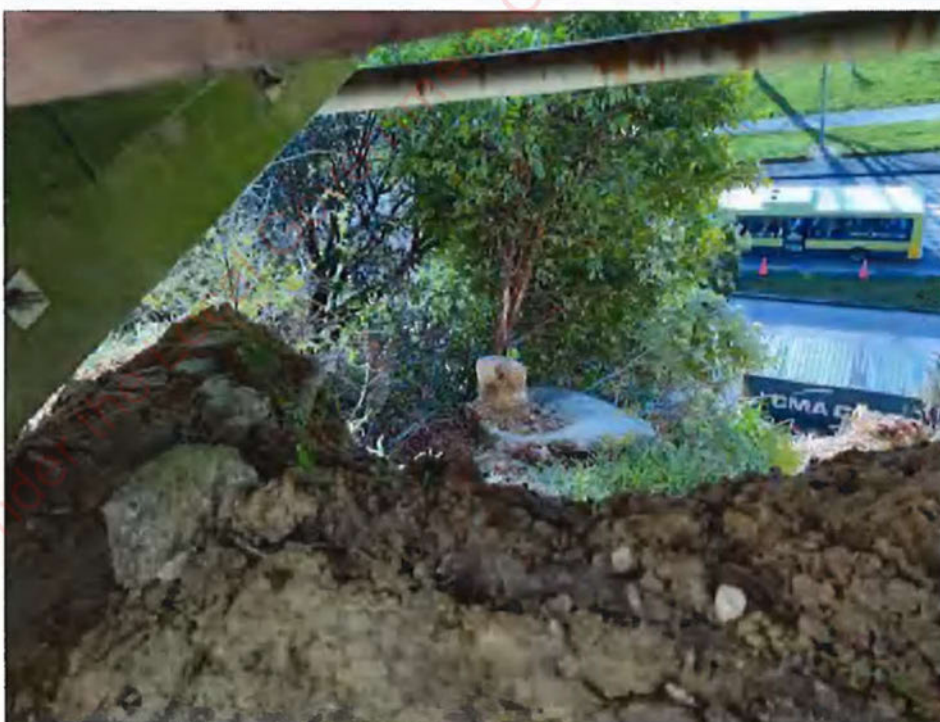
Photograph 10: View under deck (looking north) of landslip 1 (Photo taken 23 August 2022). Old concrete path slab has moved downslope as a result of further land movement.

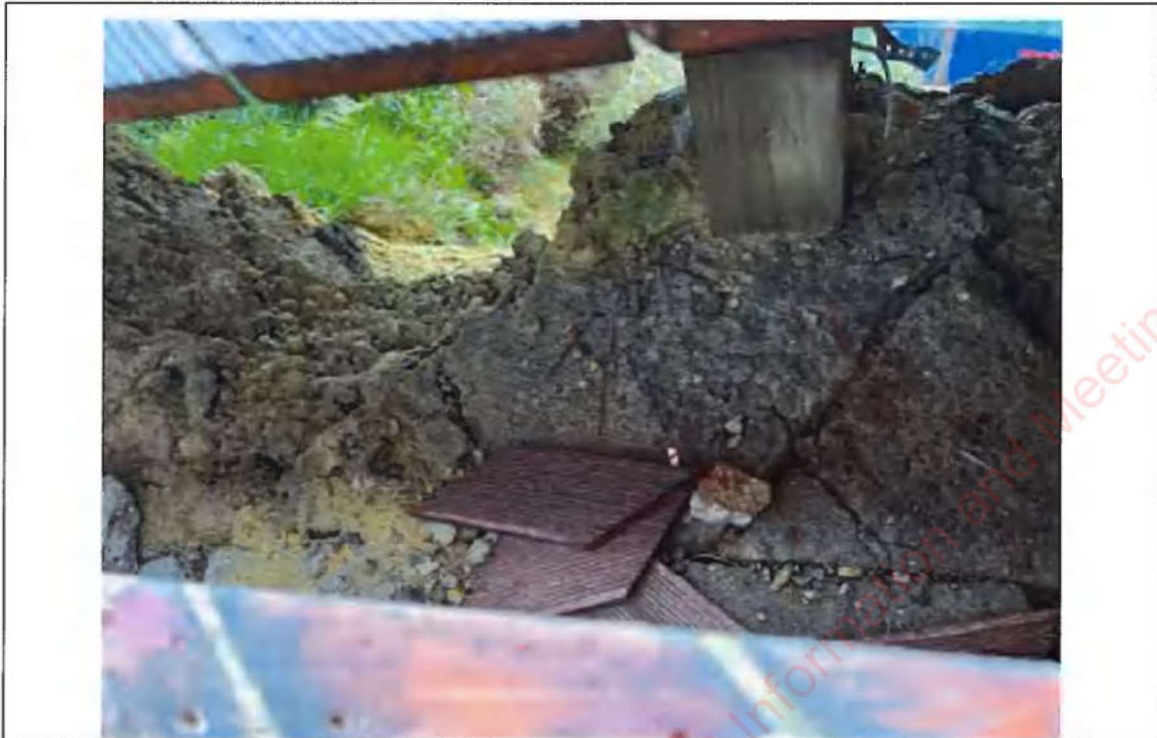
Photograph 11: View under undamaged deck (looking north) down the landslip 1 (Photo taken 26 July 2022). Note old timber pile is not attached to the deck (undamaged).

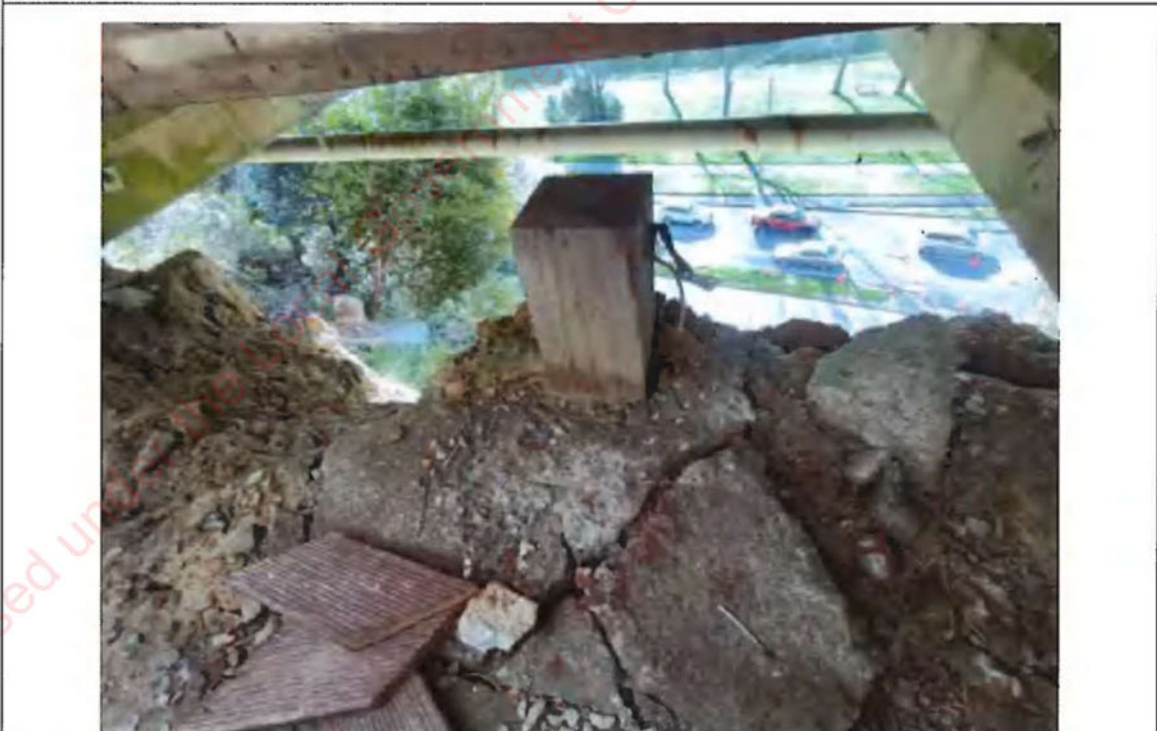
Photograph 12: View under deck (looking north) down the landslip 1 (Photo taken 23 August 2022). Note timber pile is not attached (assumed to be old deck pile).

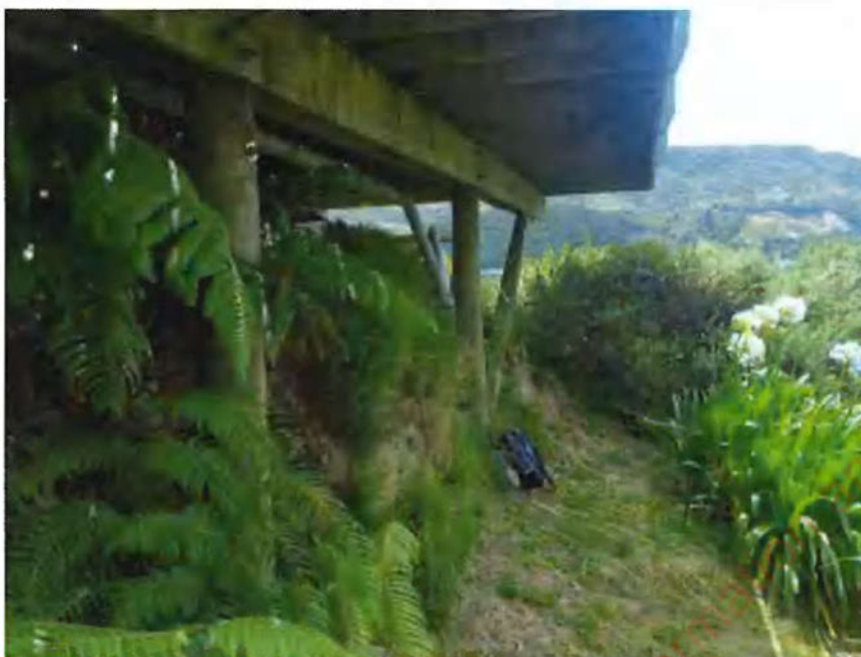
Photograph 13: Access to landslip 1. View from below eastern side of deck looking north-west (Photo taken 10 January 2022). This section of deck is supported by timber poles and timber beam.

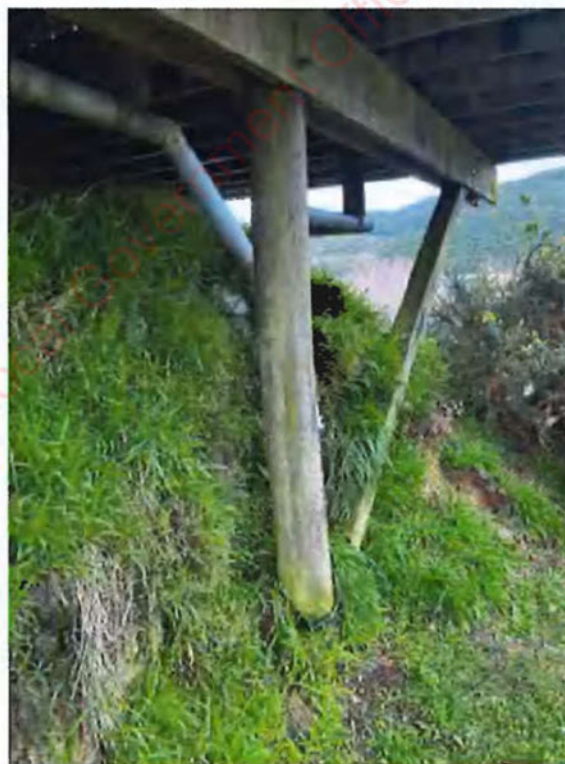
Photograph 14: Access to landslip 1. View from below eastern side of deck looking north-west (Comparison photo taken 26 July 2022). This section of deck is supported by timber poles and timber beam (undamaged).

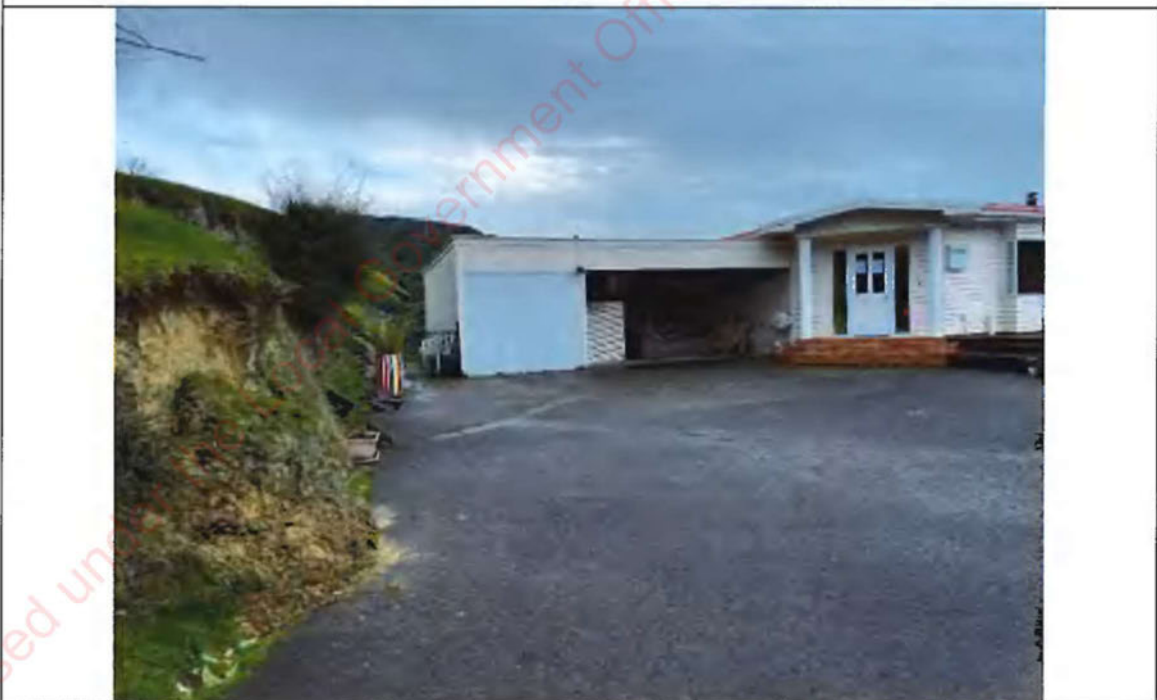
Photograph 20: Landslip 2 taken looking north with dwelling in background. (Photo taken 26 July 2022).

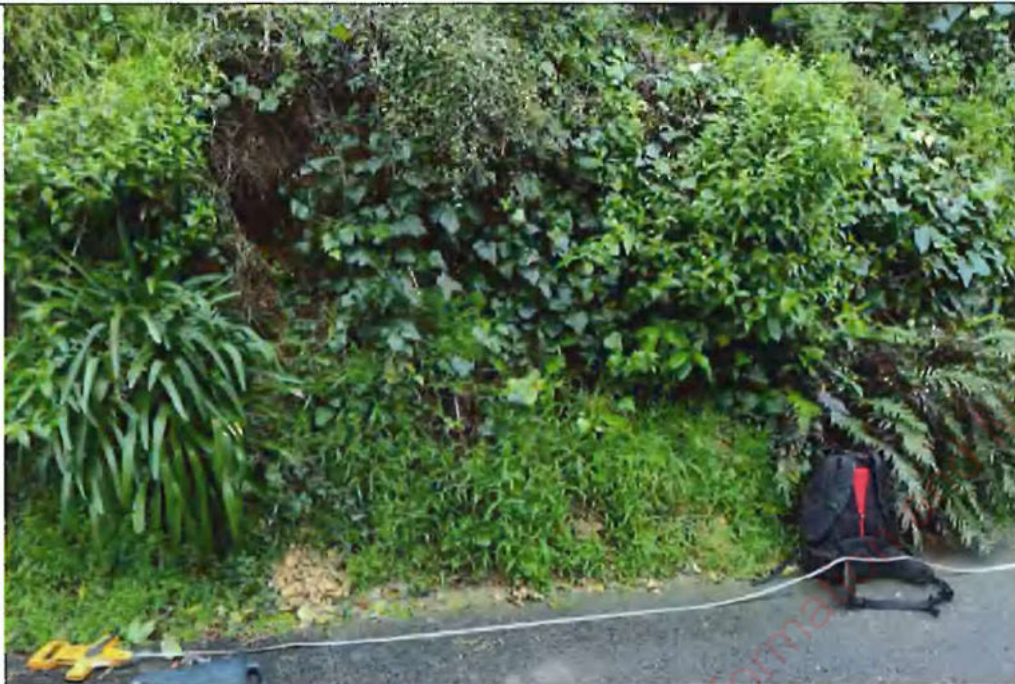
Photograph 21: Landslip 3 on the accessway with minor debris inundation onto accessway within 60 m dwelling. View looking north-west. (Photo taken 26 July 2022).

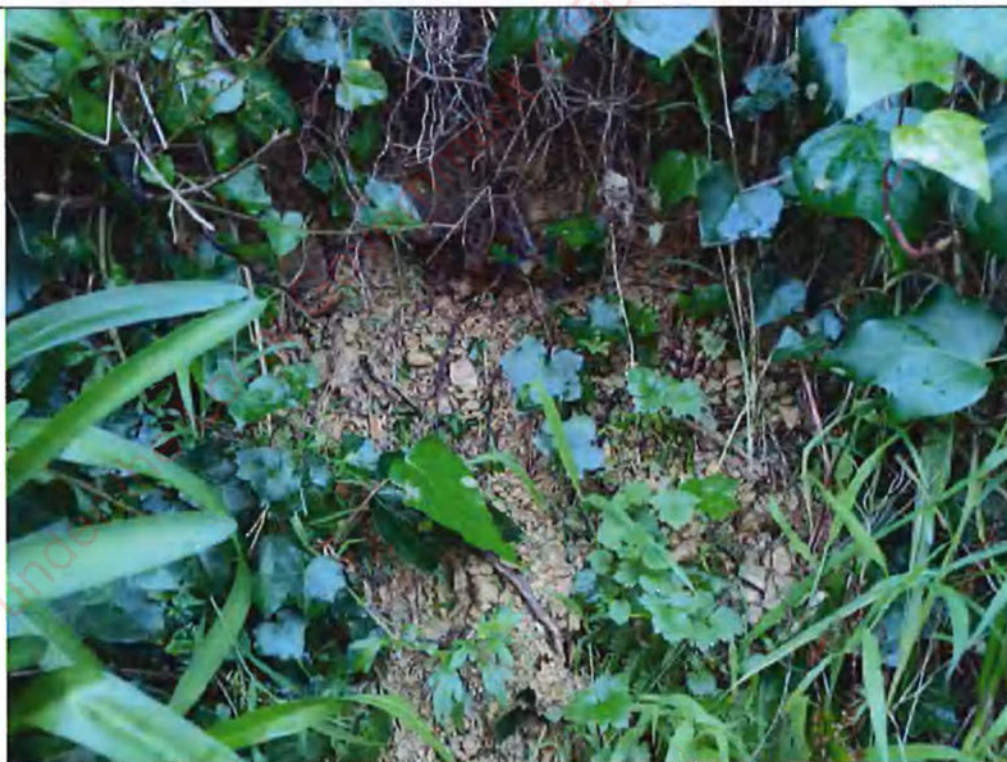
Photograph 22: Landslip 3 close up showing landslide headscarp. (Photo taken 26 July 2022).

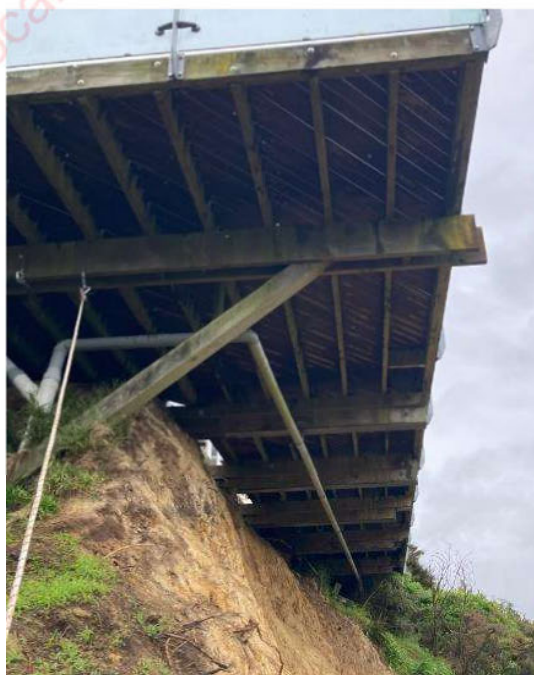
Figure 3 View of cantilevered deck and proximity of existing instability

As a minimum, the partial or complete removal of the cantilevered deck is anticipated to be required to facilitate the installation of retaining structures (e.g. anchored shotcrete wall). Further discussion about the constructability of retaining structures is provided in section 5.2.2. If the deck is removed the slope should be monitored and protected against erosion as the top 4-5 m typically comprises of completely weathered greywacke (soil).

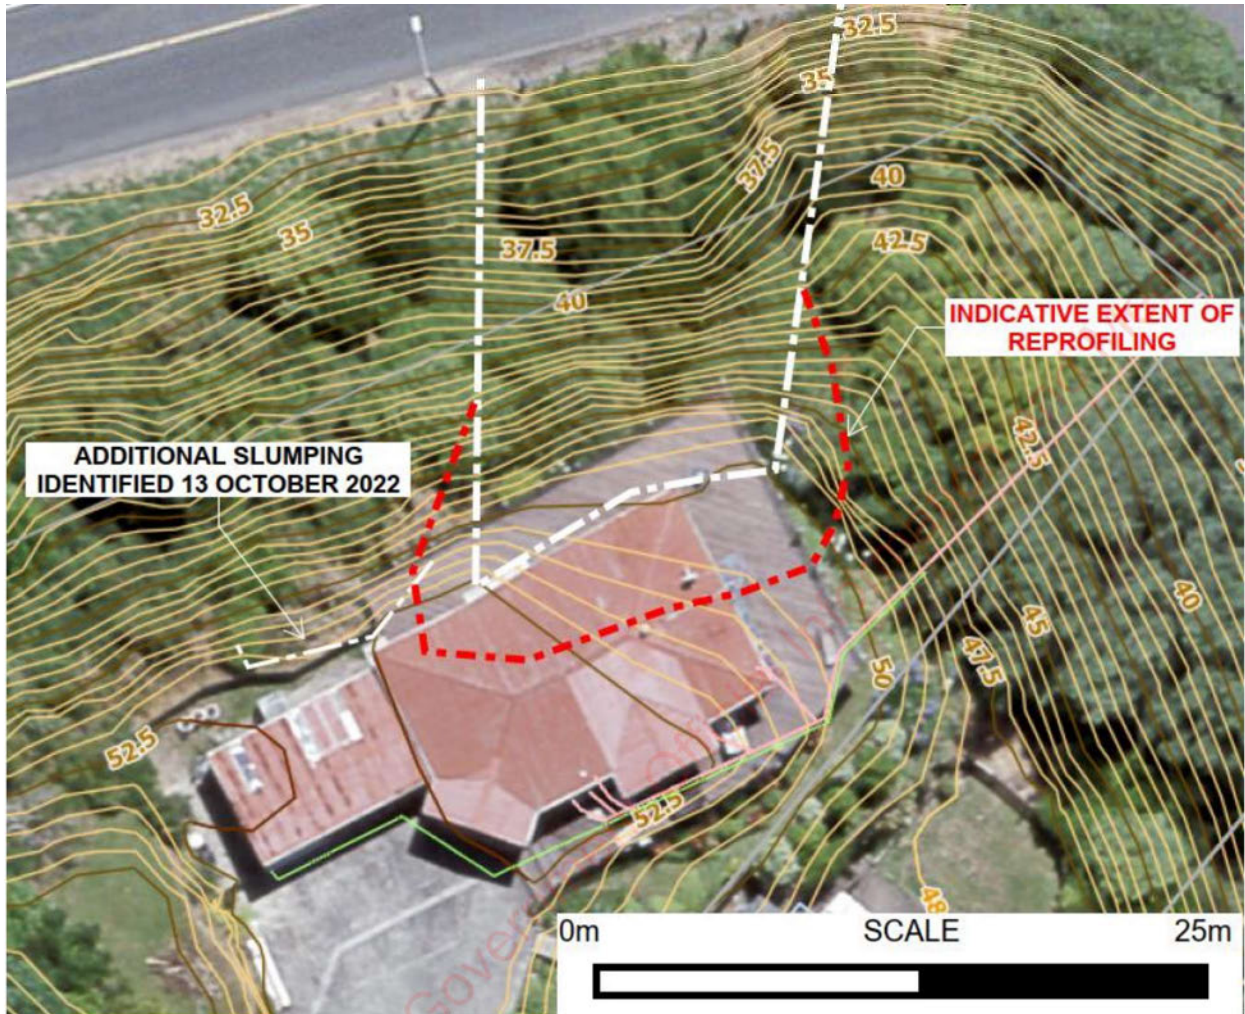
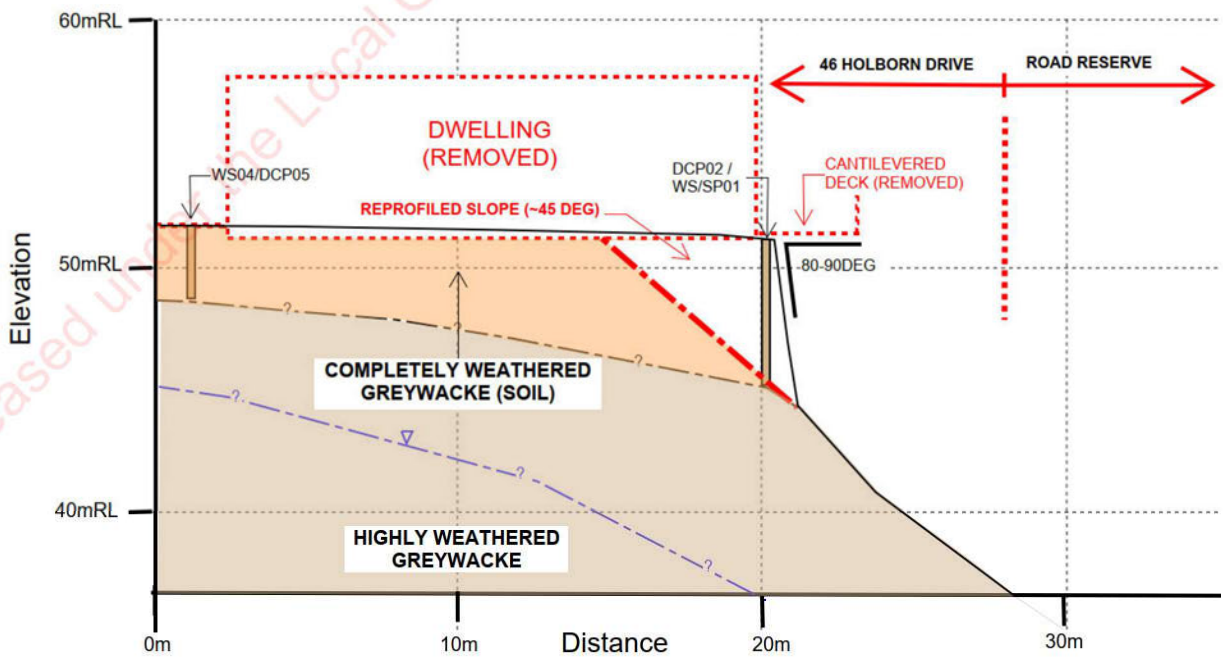
Figure 5 Indicative impact of re-profiling on private property and potential building platform.

Reprofiling the slope to reduce the risk to road users would result in the reduction of usable land. Substantial retaining structures may be required to construct a suitable building platform if another dwelling was to be constructed. An indicative cross section is provided in Figure 5 indicating the potential impact on private property.

The angle which the soil could be laid back should be confirmed using slope stability analysis. If rock was encountered during the excavation process, then the impact may be lessened as a steeper slope angle may be adopted.

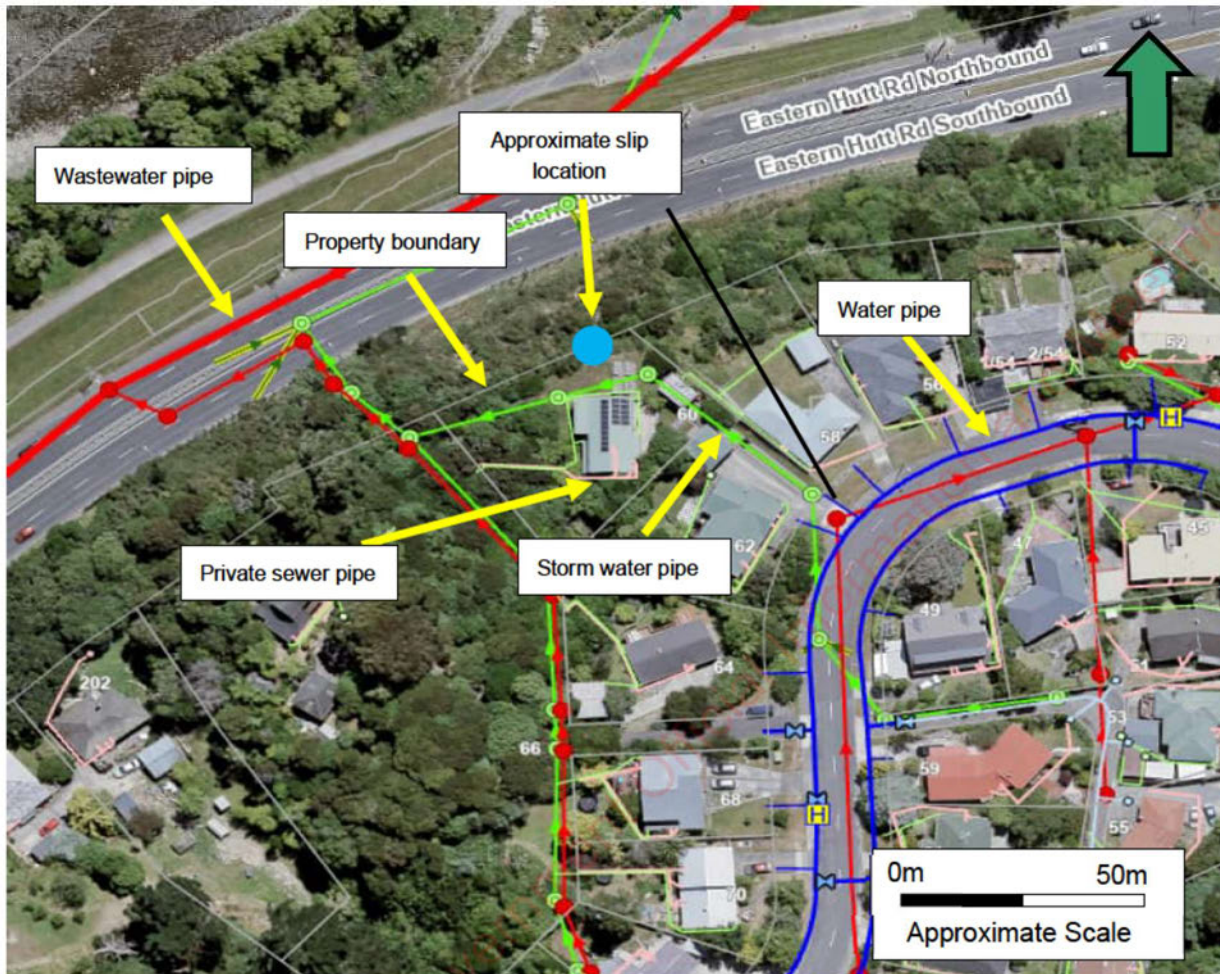
Figure 2 Site location plan (source: HCC Webmaps & NZGD)

- Slip occurred in the evening of 21 July 2022.
- Slipped debris on the Eastern Hutt Road was cleared around 2:30am (22 July 2022).
- Between 2:30am to 11am more debris accumulated at the toe of slope, and some spread over the southbound lane.
- Debris appears to be soil with medium-sized rock fragments (Appendix A).
- The upper 3-4m of the slope is nearly vertical (80-90 degrees) and with pronounced tension cracks on the ground above (Appendix A).
- Tension cracks are visible on the surface above, the cracks are about 5m away from the building footprint.
- There is an area of ground subsidence noted and below this are overhanging trees that can potentially come down any time (Appendix A)
- Underground stormwater pipe runs below the property going towards the southwest towards dense vegetation as shown in the site location plan above (Figure 2).

- HCC webmaps indicate the slip to be located within private property and some within public land as shown in Figure 2.
- The total width of the affected area is approximately 33.2m along Eastern Hutt Road.
- Major rock outcrop is visible at about 16m above the road as shown in the marked-up photo (Appendix A)
- The surrounding slopes are well vegetated and comprise of small to medium-sized shrubs, trees, and grass.

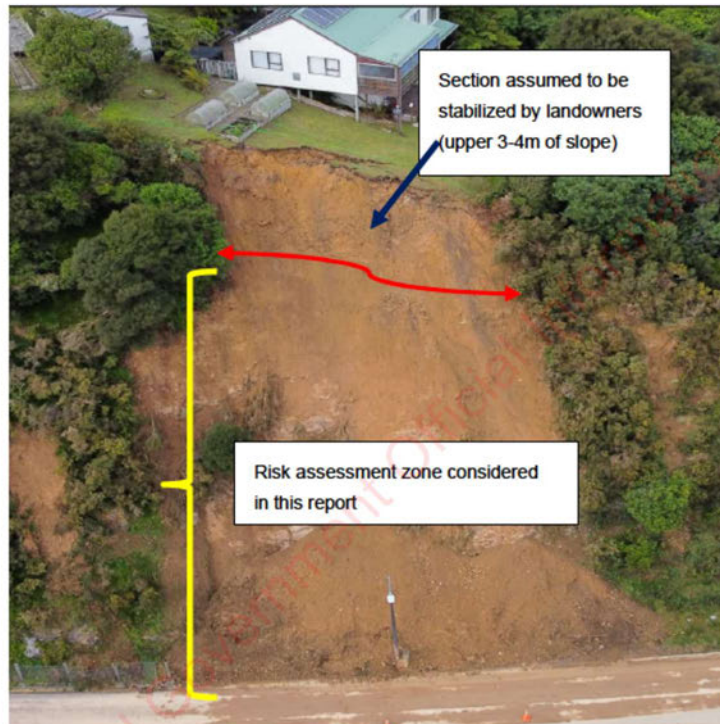
Figure 3 Risk assessment zone (AECOM)

A risk assessment for the site is provided in Appendix C and utilises the HCC standard template. The risk posed due to localised failure in the mid-section of the slope (assuming that the top 3-4m of the slope has been stabilised already by the landowners – refer to Figure 3) is considered to be **very high**. The consequences associated with the instability of the middle section of the slope are identified to be major due to the proximity of the Eastern Hutt Road to the slope. Falling debris will cause temporary closure of the southbound lanes or block one lane causing major delays. Due to the presence of containers at the toe of the slope the impact on HCC assets following further dropout is expected to be minimised (i.e. minor). However, it is acknowledged that the containers have reduced Eastern Hutt Road to one lane (southbound traffic) and are considered a temporary solution.

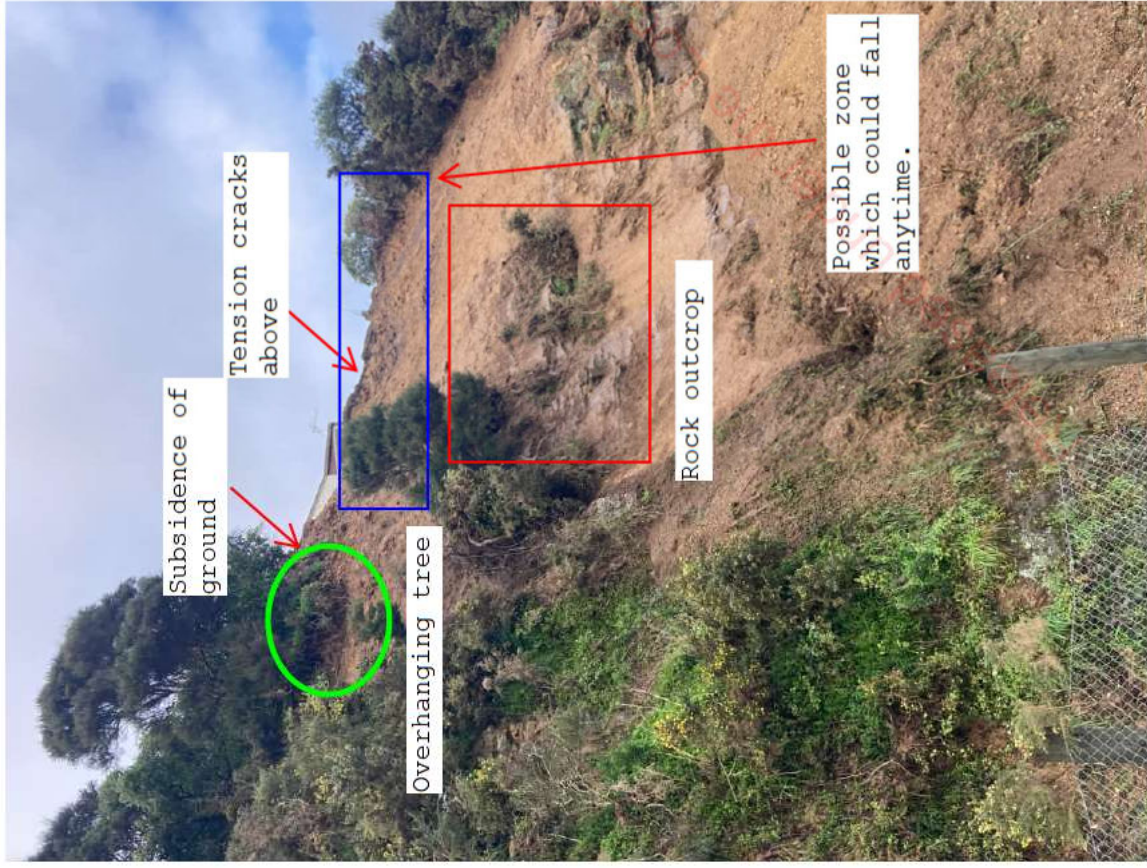
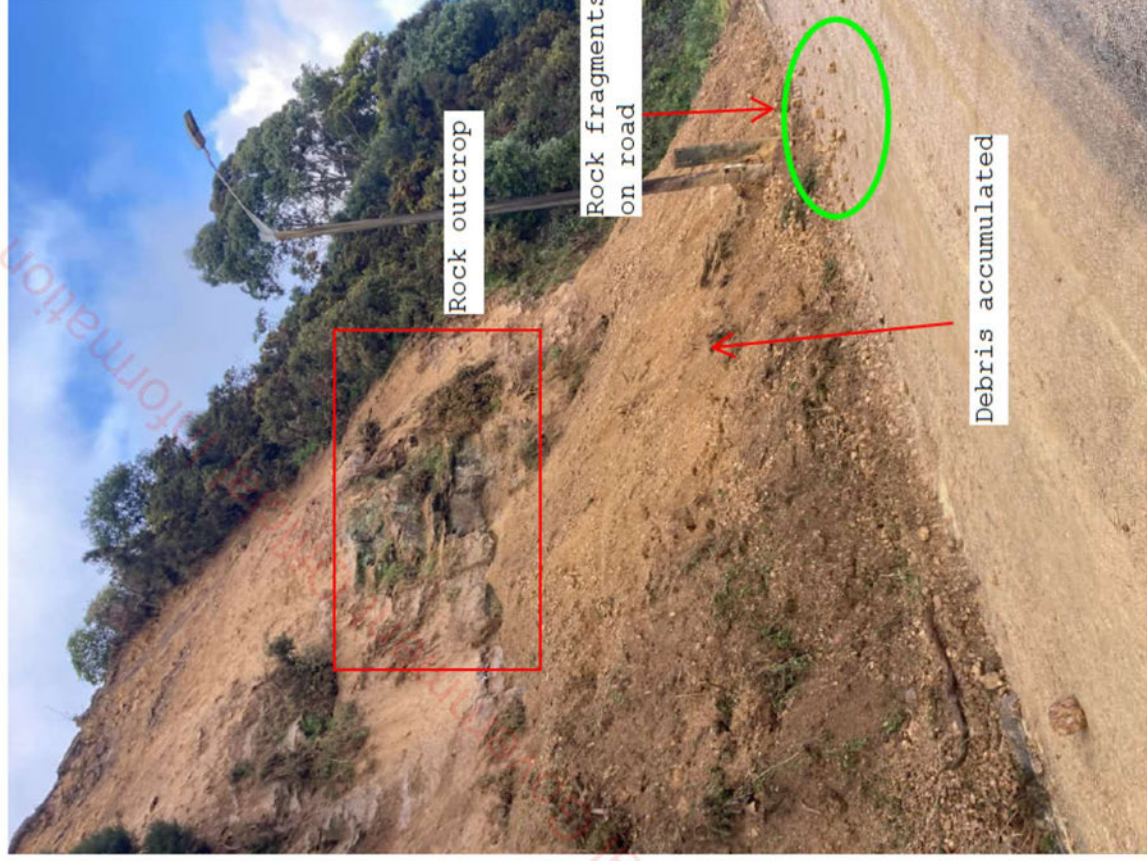
1. Slip occurred in the evening of 21 July 2022.
2. Debris fell on the Eastern Hutt road which was cleared around 2:30am (22 July 2022).
3. Between 2:30am to 11am more slip debris has accumulated at the toe and some spread over the SB lane.
4. Debris appears to be soil with some medium-sized rock fragments.
5. Major rock outcrop is noted about 16m from the road.

6. The upper 3-4m of the slope is nearly vertical and with pronounced tension cracks on the ground above the slope.
7. Tension cracks are visible on the surface as indicated in the left photo, the cracks are about 5m away from the building footprint.
8. There is an area of ground subsidence noted (refer to left photo) and below this are overhanging trees which can potentially come down anytime.

12. A high risk of further failure is likely.
13. An underground storm water pipe runs below the property and goes southwest toward the dense vegetation

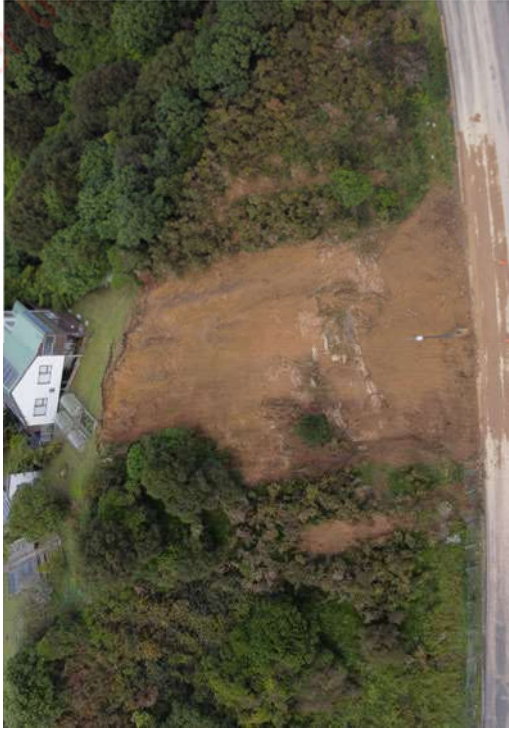
Figure 5 Aerial view of the slip

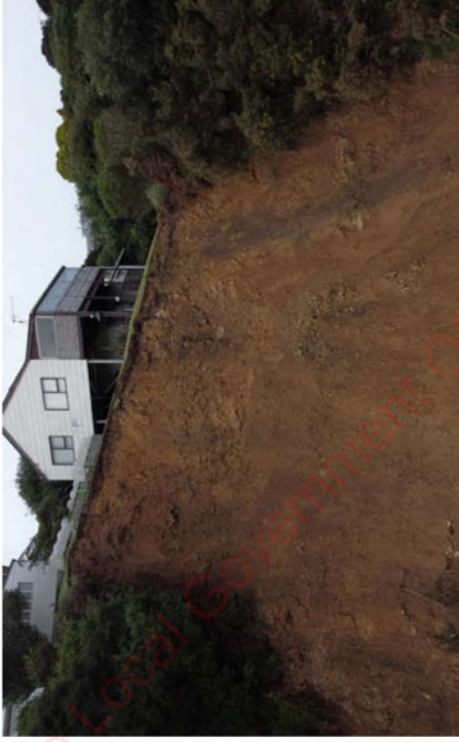
Figure 6 Upper 3-4m of the slope

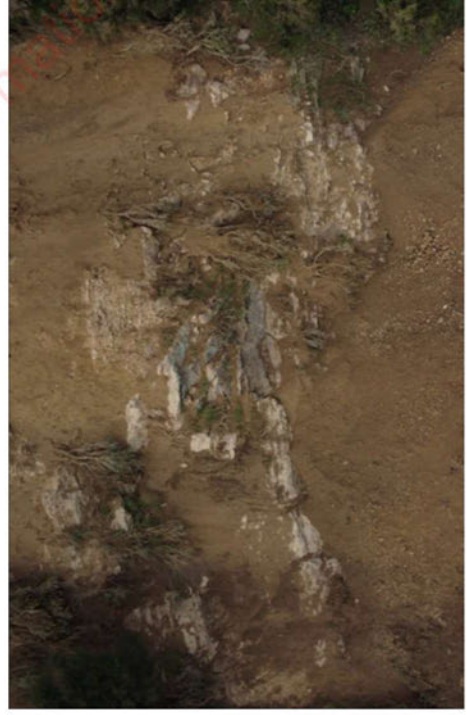
Figure 9 Rock outcrop in the middle section

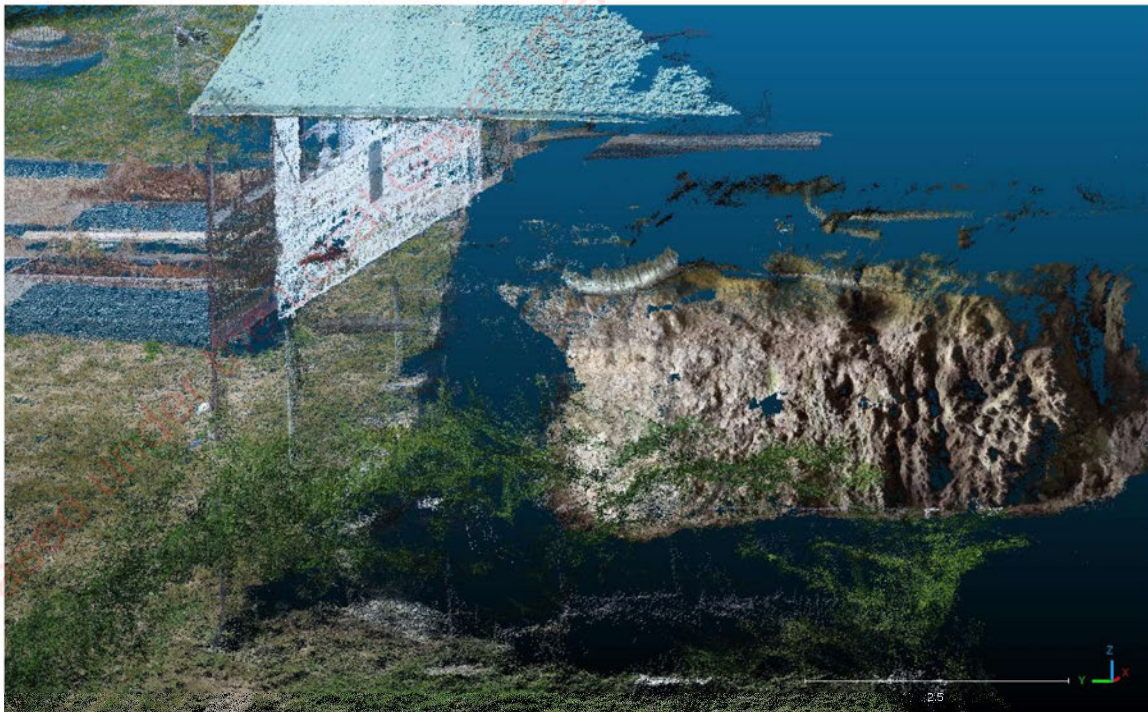
Figure 3 Point cloud - excavation for house foundations

On February 17, 2023, IRBA staff used an iPhone 13 Pro Max to capture a detailed point cloud of the unsupported excavated slope behind the lower level of the house. The data were processed using the Scaniverse⁴ application. These data were integrated into the CloudCompare model, as shown on Figure 3.

The house foundations at 60 Holborn Drive are timber poles and timber piles 175mm and 150mm diameter. The main part of the house is located on a bench cut into the slope, hence the rock exposure

shown in Figure 3. About midway along the length of the bench, there is a contact with overlying colluvium that dips to the south. The north half of the house is located on greywacke, and the southern half on colluvium.
