Request for Information pursuant to the Local Government Official Information and Meetings Act 1987 (LGOIMA)

Could you please provide me with copies of reports you have on hand relating to the stability of the slope located above Eastern Hutt Road and below Holborn Drive (in particular relating to the area below the land at 58 and 60 Holborn Drive).

Claim for Natural Disaster (Landslip) Damage

60 Holborn Drive Slope Re-Assessment and Remedial Works

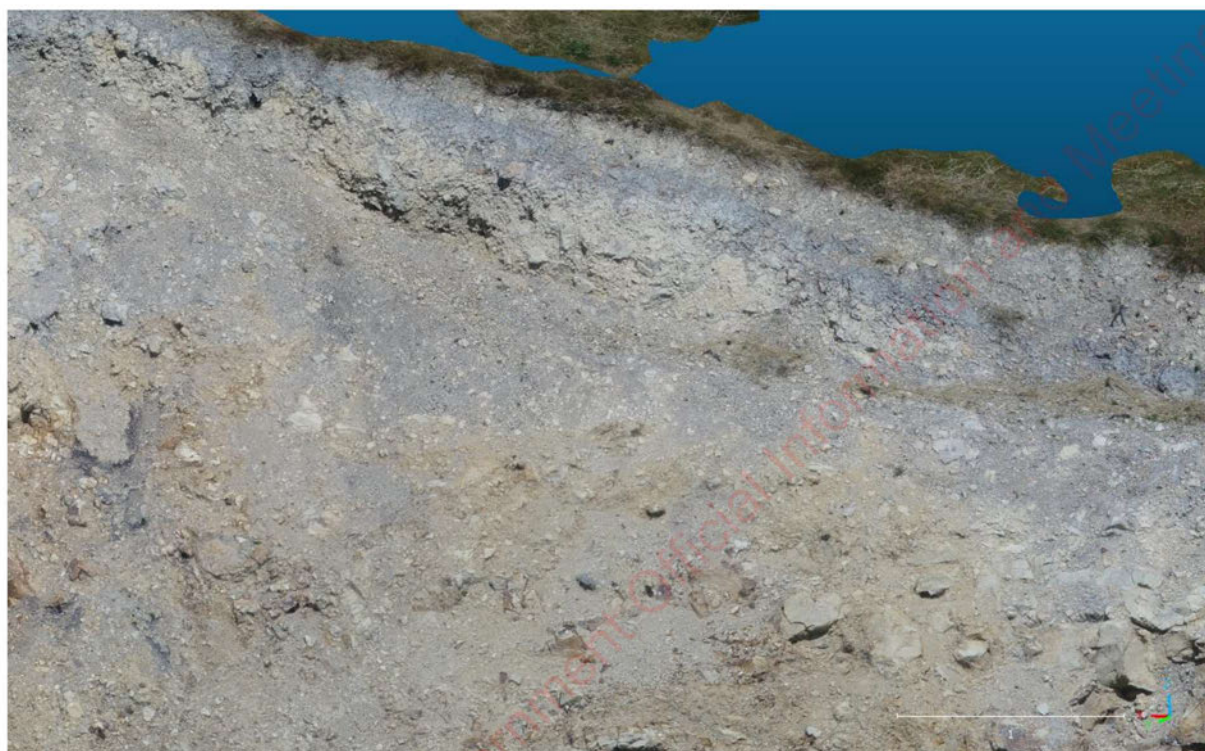
From inspection of the point cloud using our January 25 data, we can see a layer (c. 1m thick) of colluvial material at the top of the slope (Figure 4). Note the scale bar at the bottom right corner of the figure. There is also a thin veneer of fill above the colluvium probably resulting from earthworks, including stormwater drain construction, placed at the time of preparation for land subdivision.

Figure 4 Colluvium exposed at top of slope

Figure 4 also shows *in situ* greywacke exposed in the lower right corner of the point cloud image. This provides evidence that *in situ* rock is present at a much higher level than had been assumed by both Tonkin and Taylor Ltd, and AECOM New Zealand Limited. However, they would not have had the benefit of observing the slope following scaling and clean up by Hutt City Council contractors.

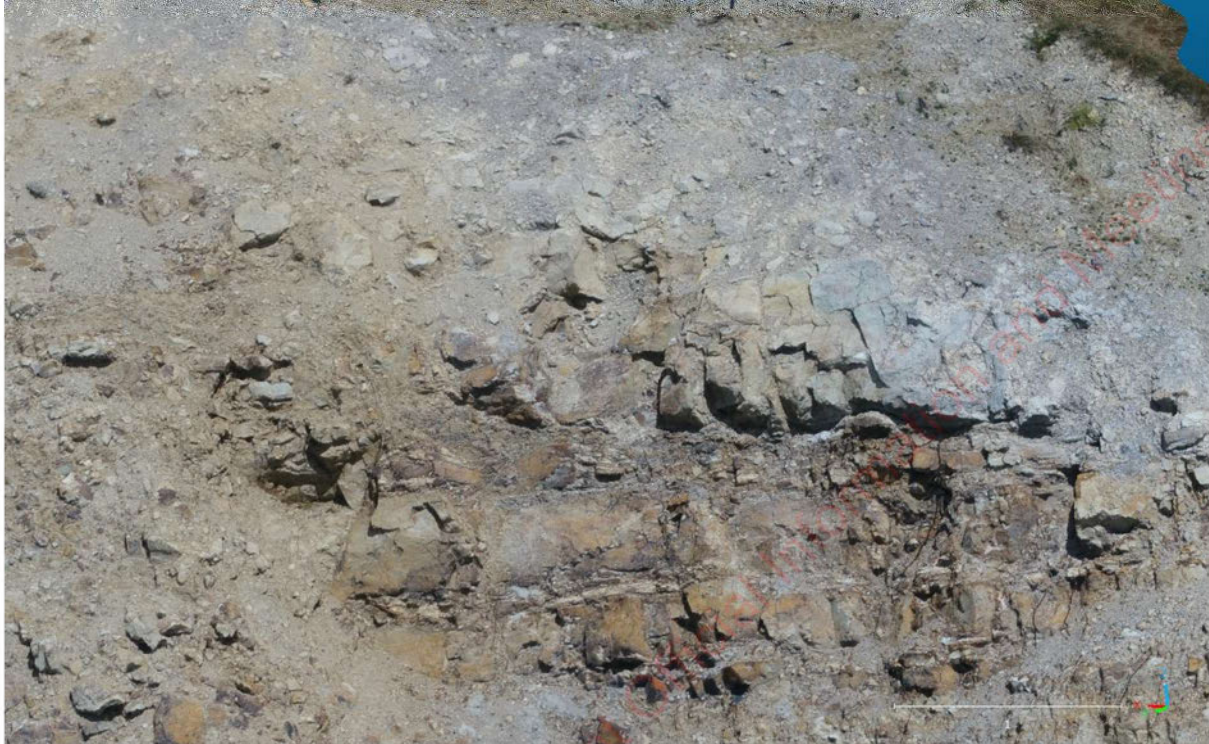
A view of the rock exposed a little further down the slope (Figure 5) shows the structure of the exposed greywacke. This image overlaps with the bottom right area of Figure 1. We can see what appears to be bedding trending across the slope, and steeply dipping fractures (joints) that strike nearly normal to the slope. The rock mass can be described as blocky, with blocks formed by the intersection of joints and bedding.

The attitude of joints in the greywacke exposed below the house was measured using a clinometer. The major joint set is near parallel to the excavated slope, and has a mean resultant plane orientation of about 71° dip and 266° dip direction. This is consistent with the joint orientations shown in the point cloud of the landslide scarp (Figure 5).

Figure 5 Rock exposed in slope, below and adjacent to view in Figure 4

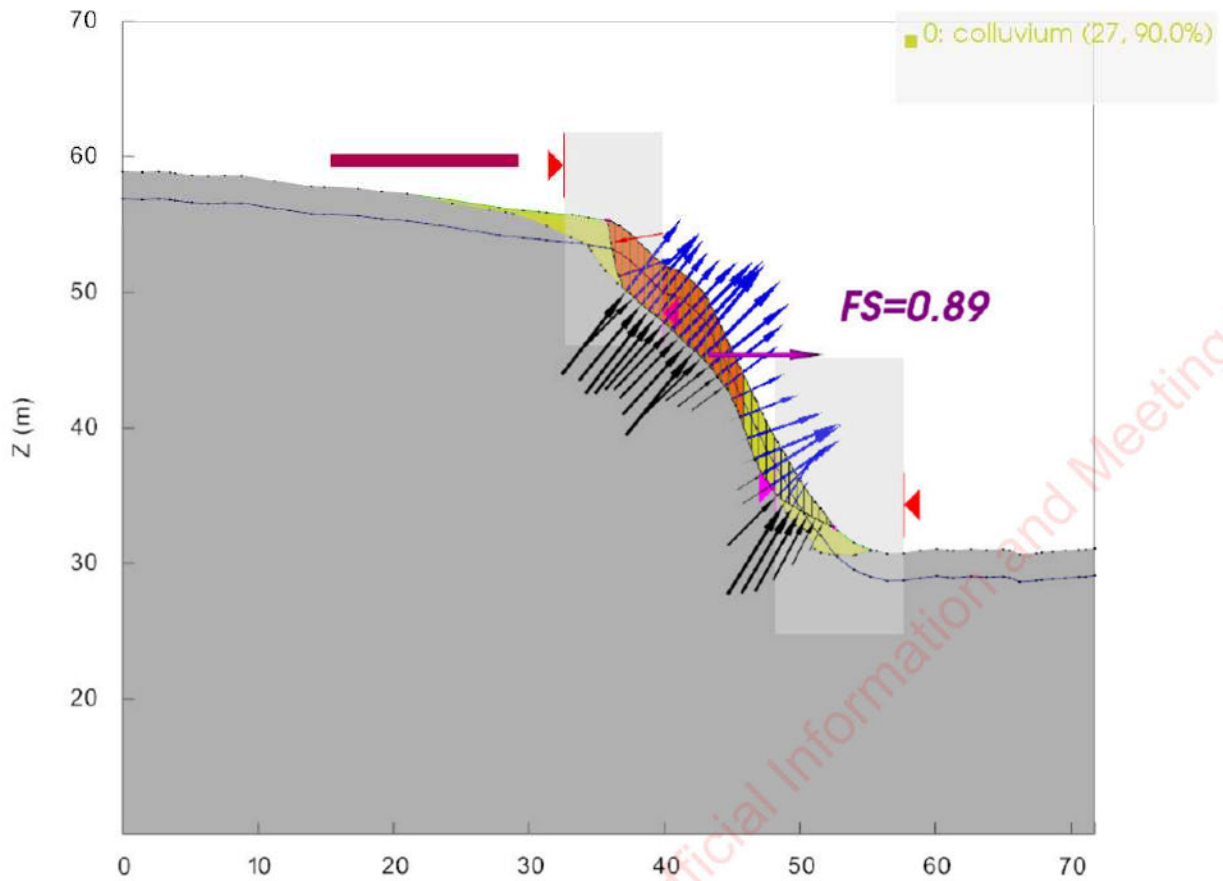
Figure A3 2D slope case, July 2022 landslide

The slope model that applied at the time of the July 2022 landslide comprised a thin layer of colluvium and fill overlying a steeply dipping rock surface. The landslide coincided with a period of heavy rainfall that led to high pore water pressures at the rock/colluvium interface. The resulting increase in effective stress then caused shear failure in the colluvium.

FS (factor of safety) calculated at 0.89

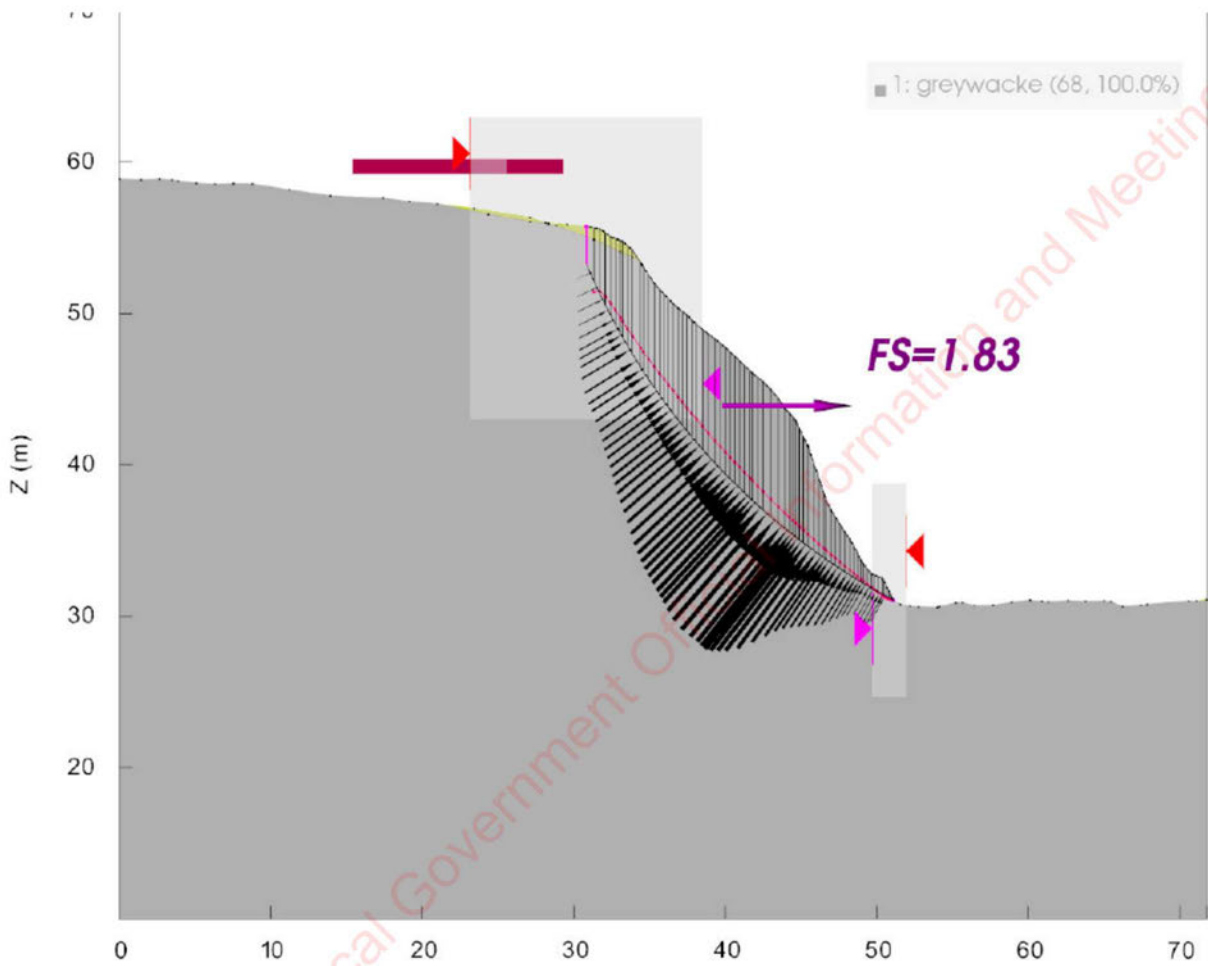
Figure A4 2D slope case, January 2023 topography

FS (factor of safety) calculated at 1.83

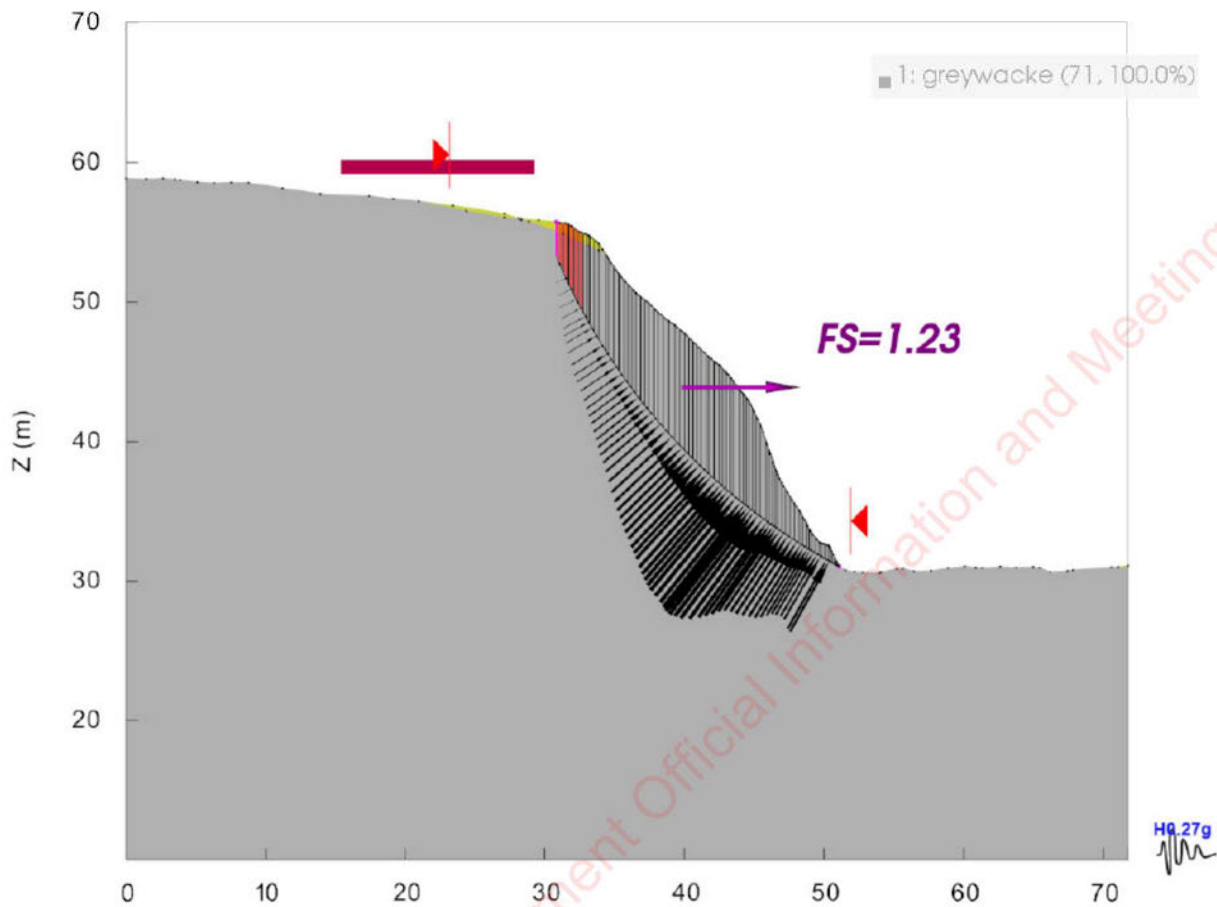
Figure A5 2D slope case, January 2023 topography, ULS earthquake

FS (factor of safety) calculated at 1.23

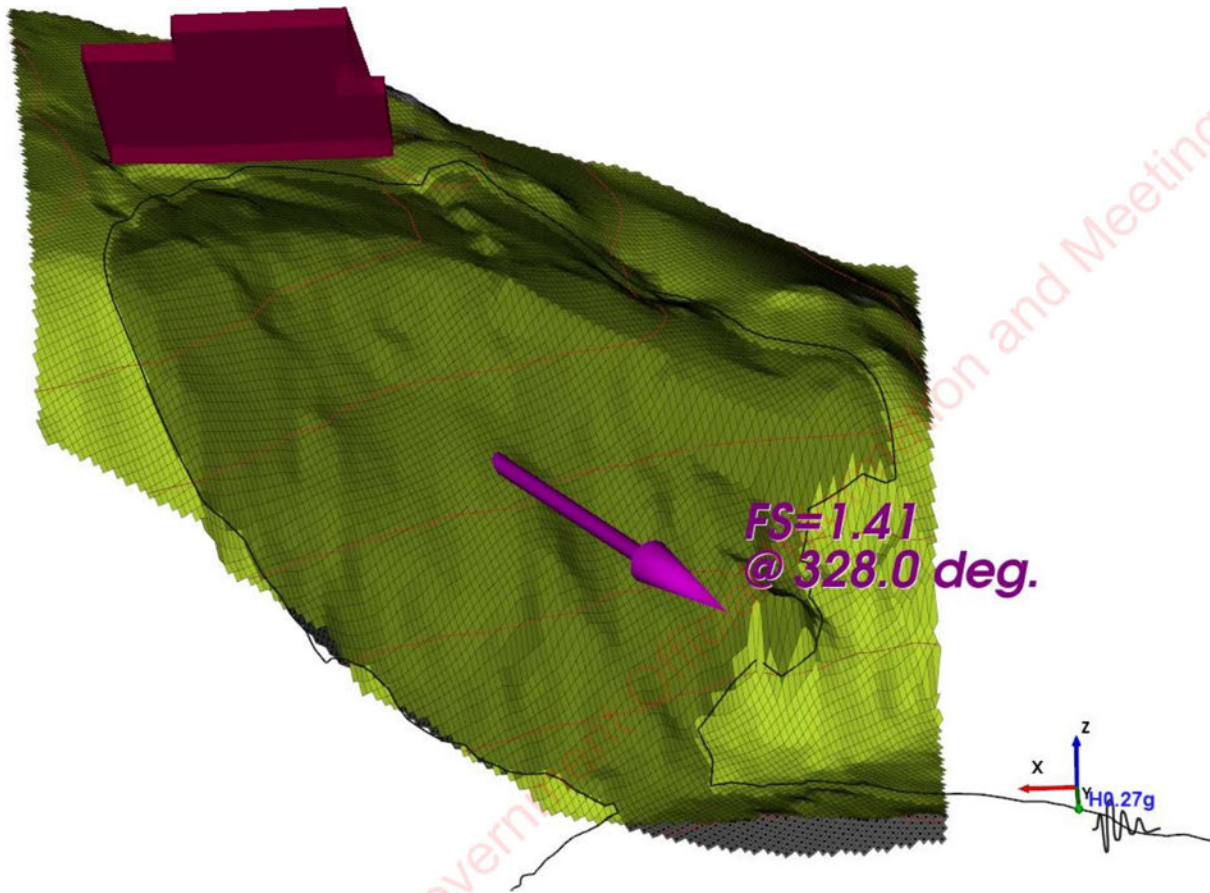
Figure A6 3D slope case, January 2023 topography, ULS earthquake

FS (factor of safety) calculated at 1.41 at a bearing of 328 degrees

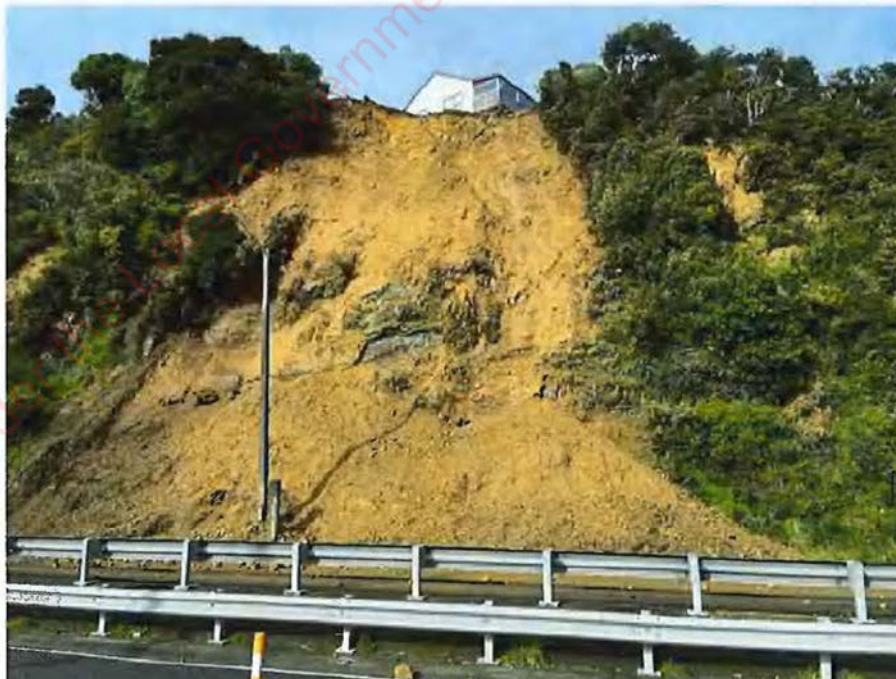
Photograph 4: View from Eastern Hutt Road looking up to the property. Taken 26 July 2022.

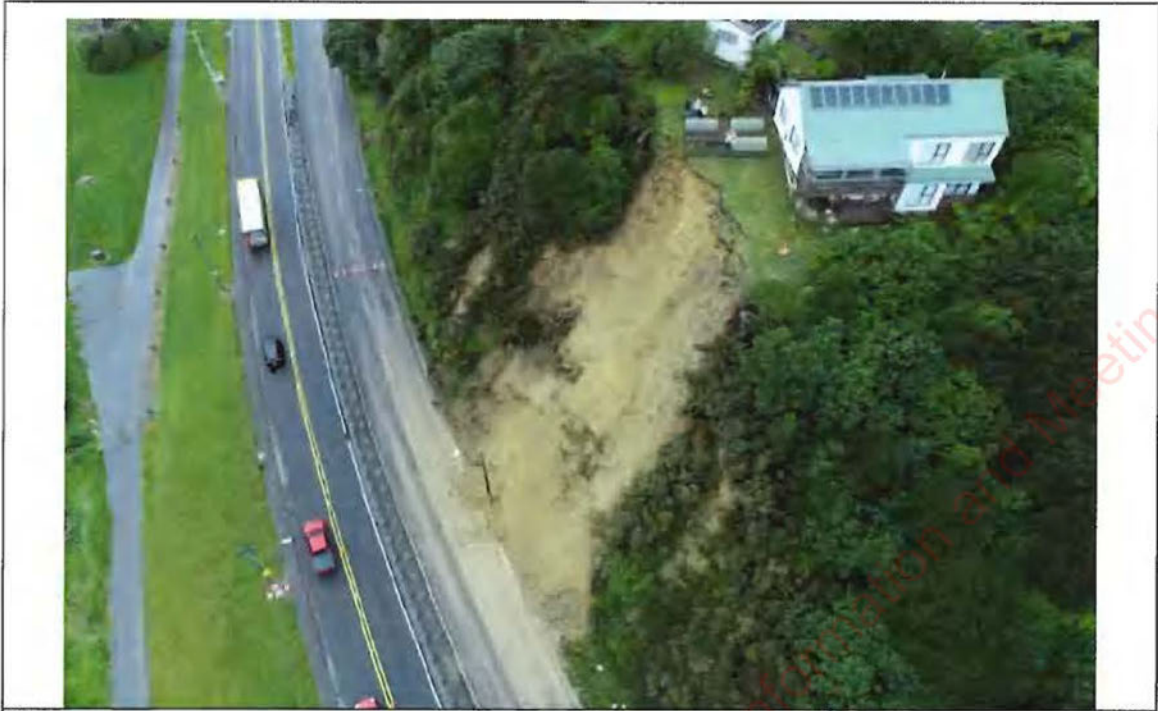
Photograph 5: View facing east from above, showing entire landslide. Taken 26 July 2022.

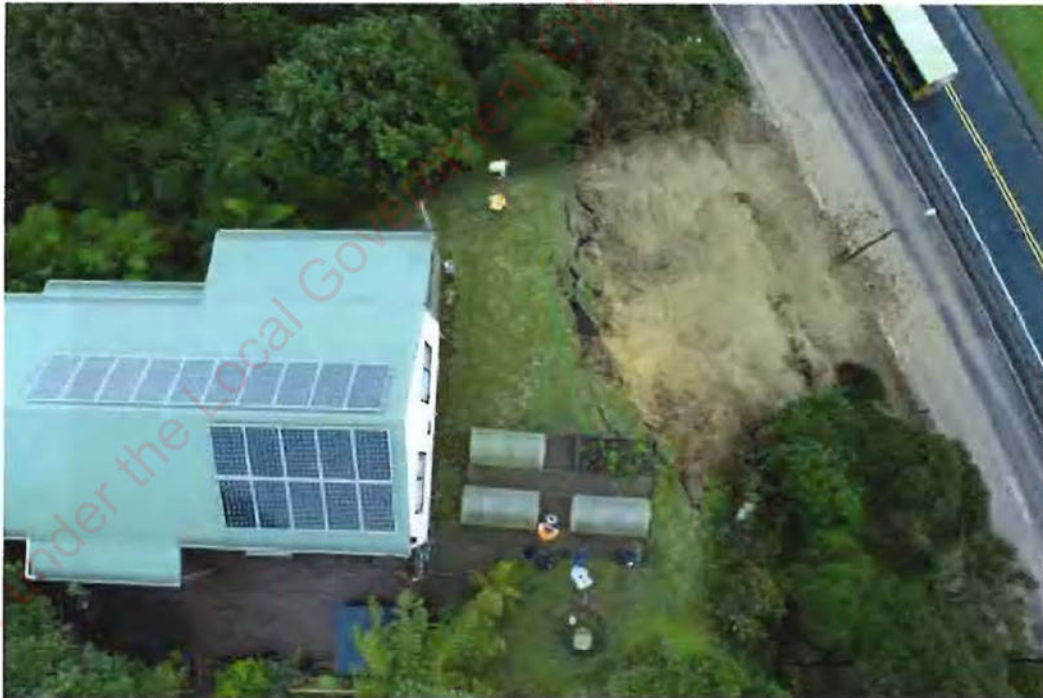
Photograph 6: View facing directly down from above, showing landslide headscarp. Taken 26 July 2022.

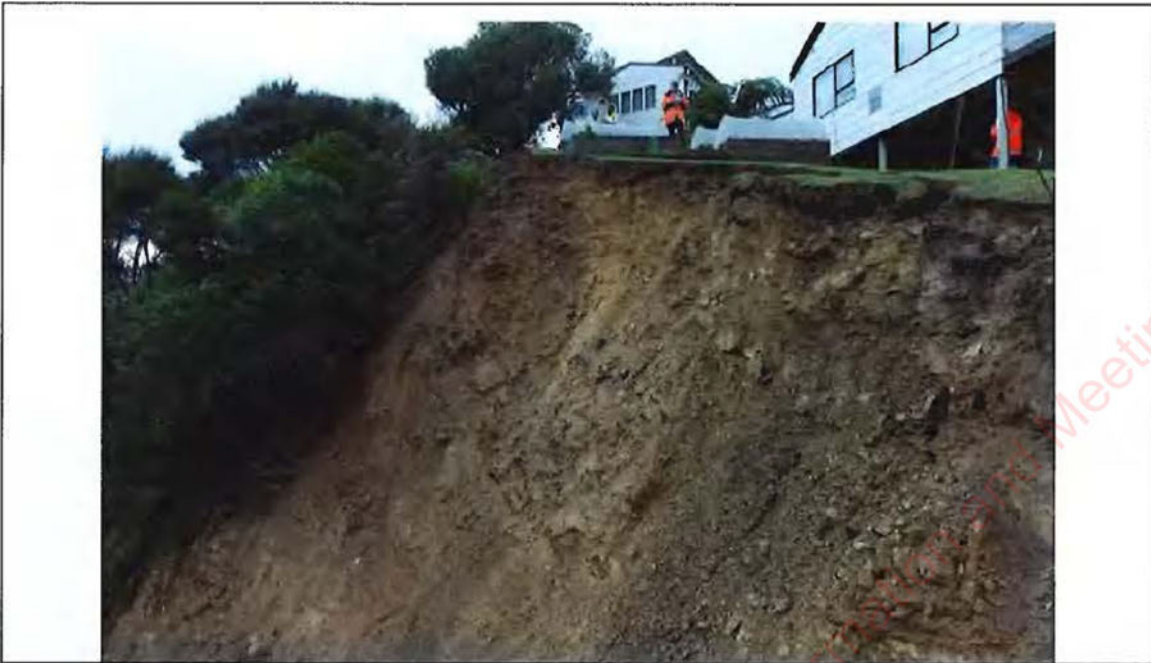
Photograph 7: View facing up to the east, showing landslip headscarp and material. Taken 26 July 2022.

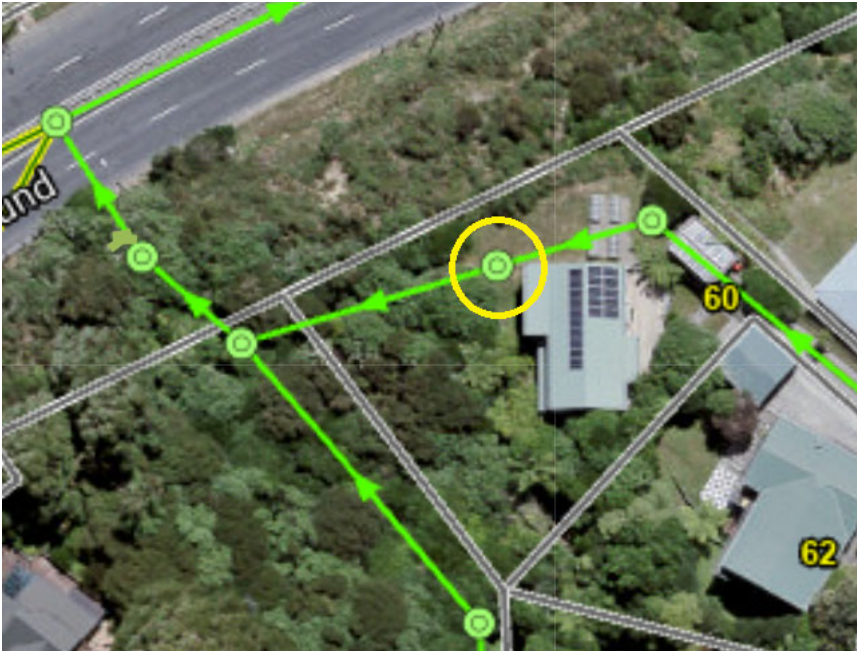
Agree as you mention there is one fault with the benching in the first s/w manhole. How soon can we get a repair
