Request for Information – Local Government Official Information and Meetings Act (LGOIMA) 1987

“...all information relating to slips, slip remediation and internal council correspondence relating to historical 2005 to the recent slips at 46 and 60 Holborn Drive or around that area facing the Eastern Hutt Road”

We have interpreted your request as applying to landslips occurring on or above Eastern Hutt Road, between the Stokes Valley roundabout and the intersection with High Street at Pomare. This covers properties at 46-92 Holborn Drive and 200-204 Eastern Hutt Road.

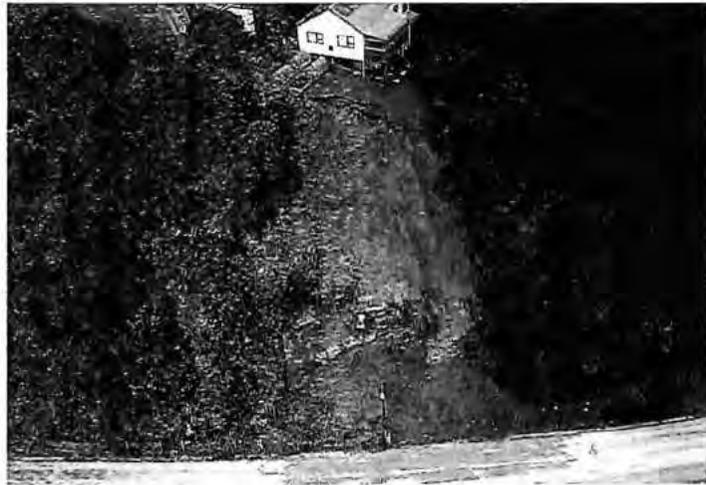
Figure 5 Aerial view of the slip

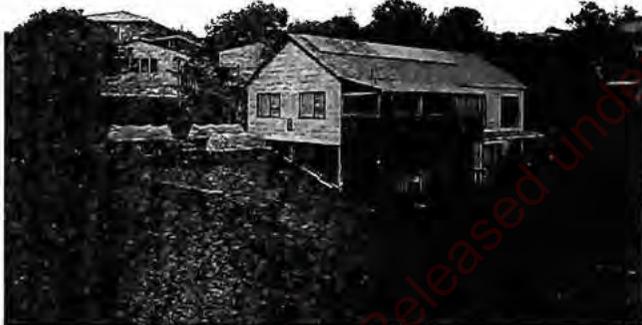
Figure 8 street property view

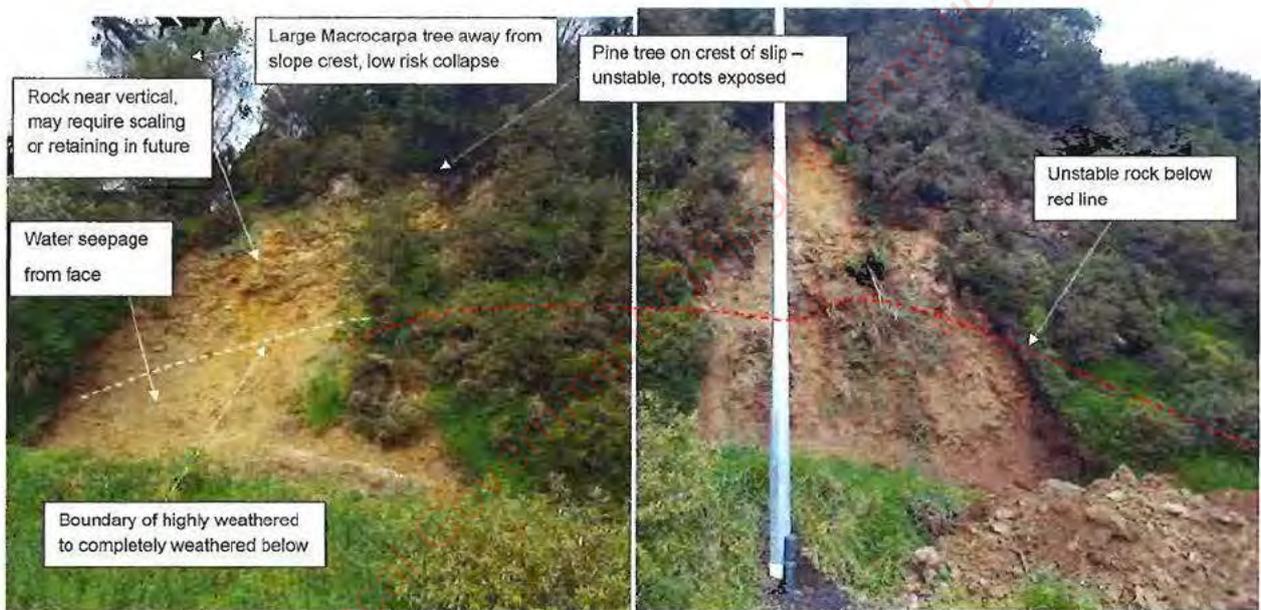
Photo 1: slip features

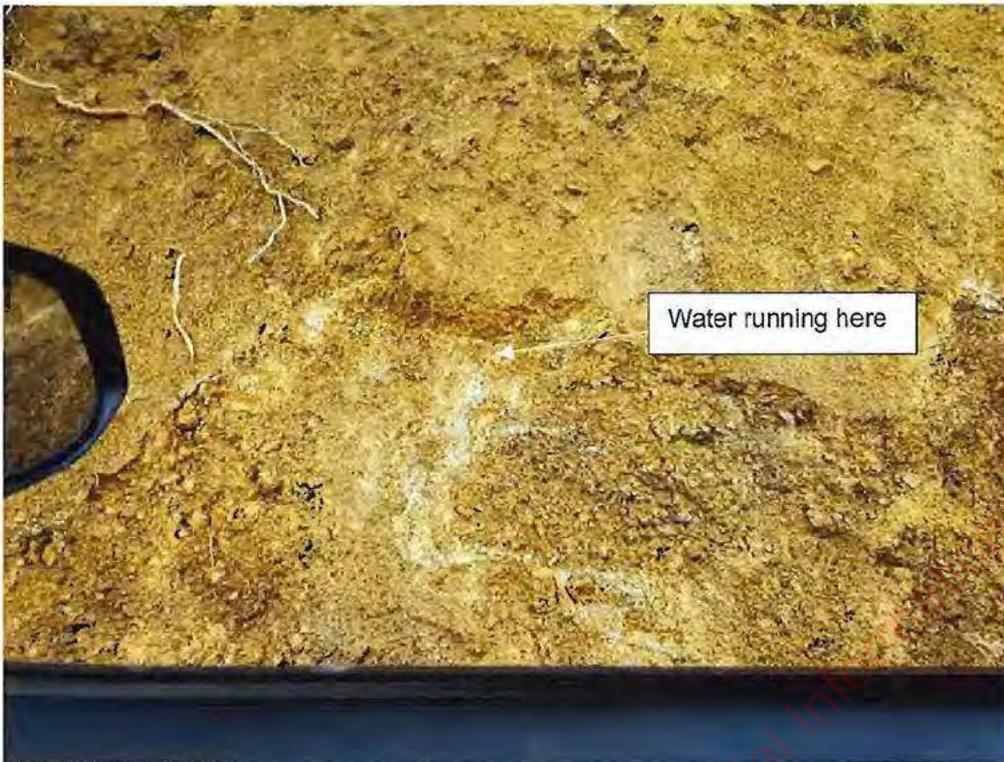
Photo 2: running water from lower slip face (see location Photo 1)

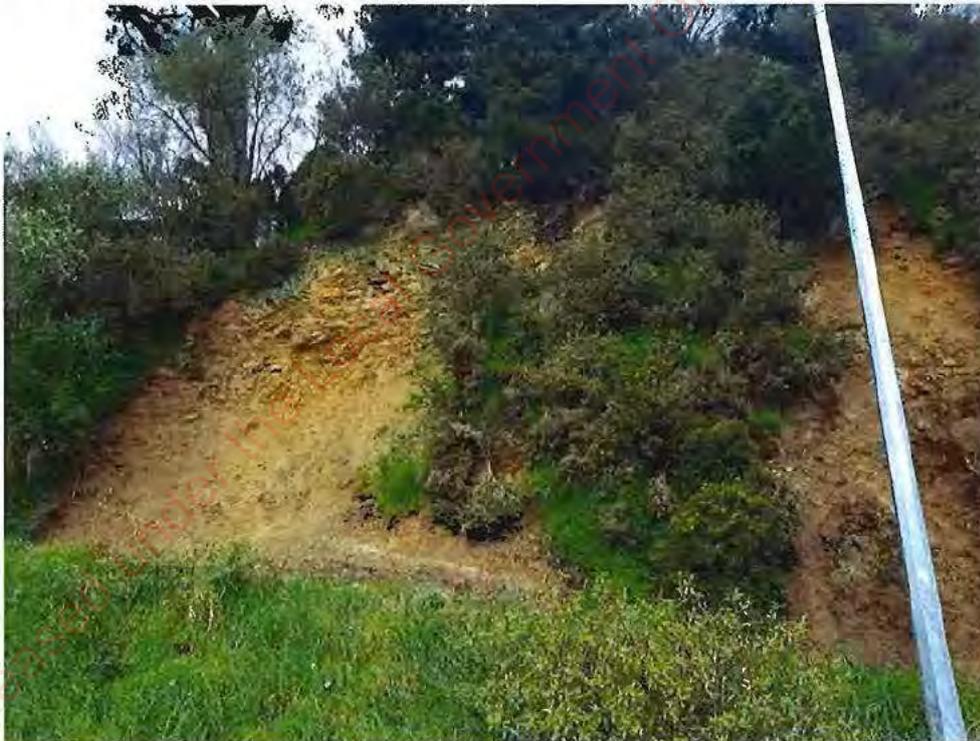
Photo 3: Slip at [REDACTED]

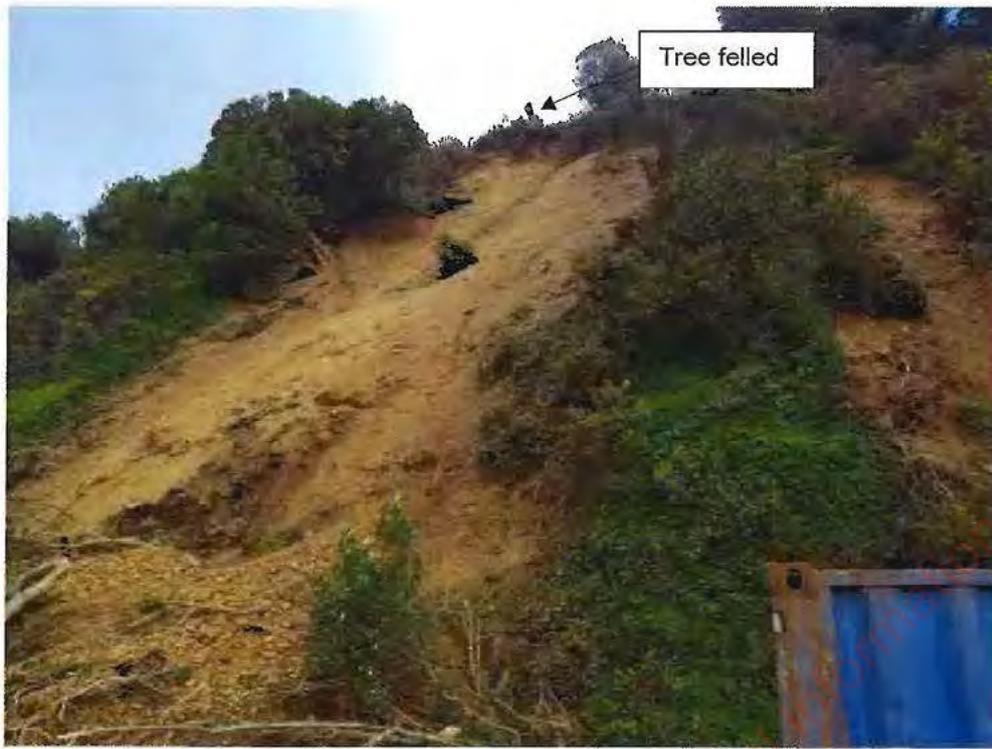
- Work is continuing to remove debris from slips further east along the slope. Tree has been felled at crest of a slip removing risk of collapse (see Photo 4 below). Slip headscarp is still over-steepened and may be unstable.

Photo 4 slip further east along road

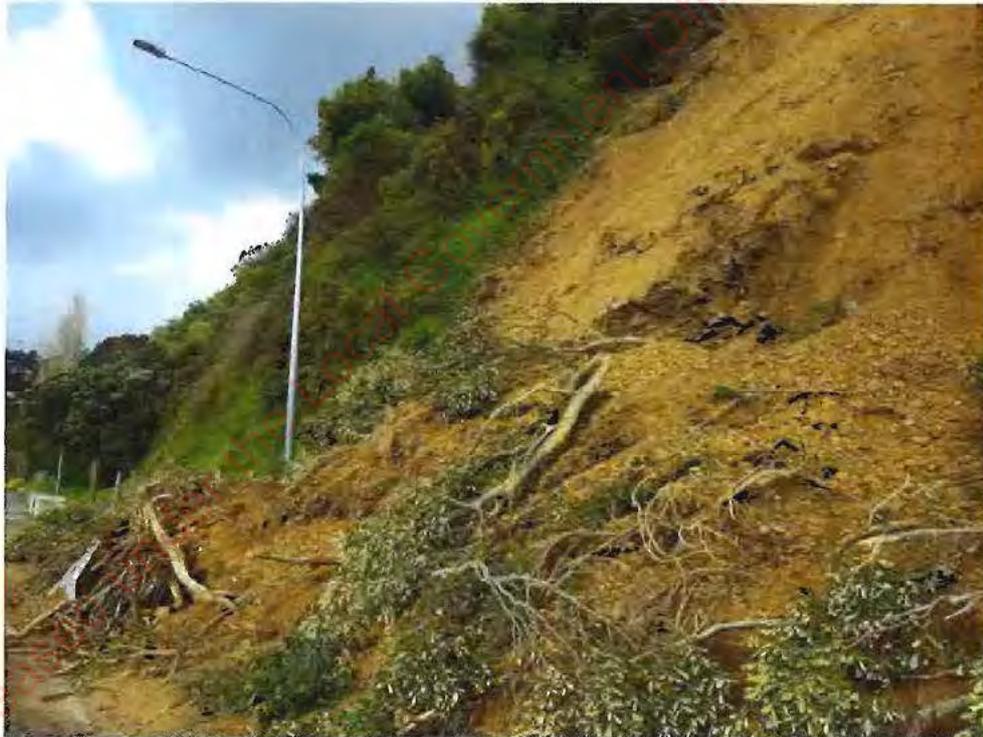
Photo 5 slip debris base of Photo 4

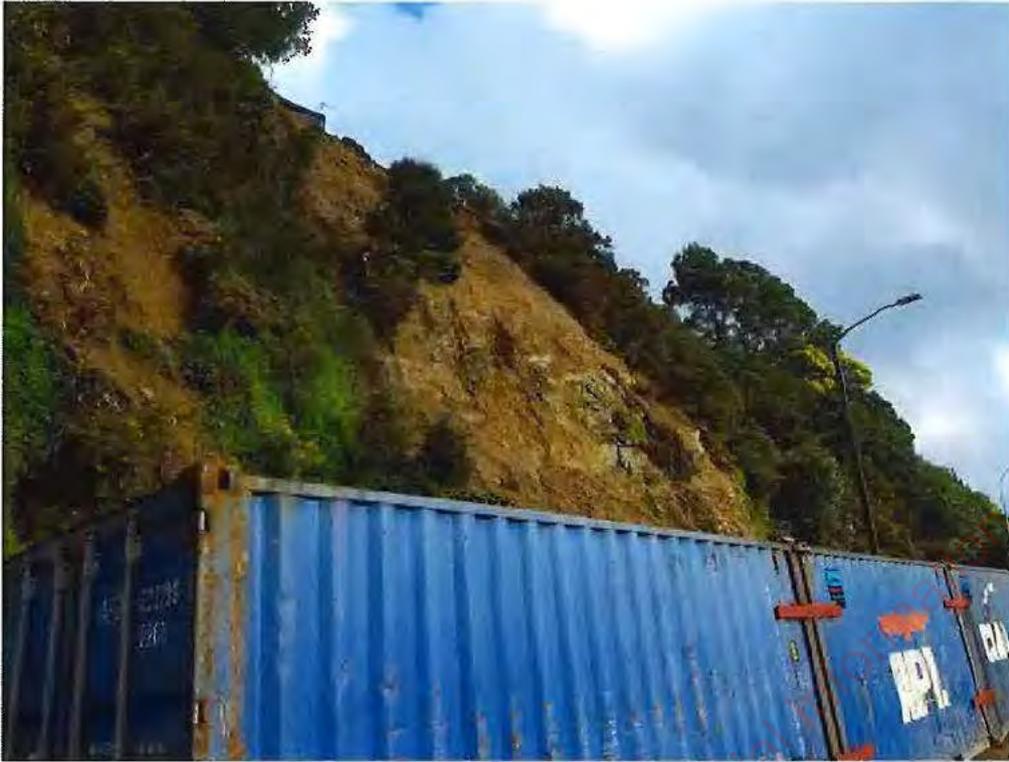
Photo 5: Slips east along slope

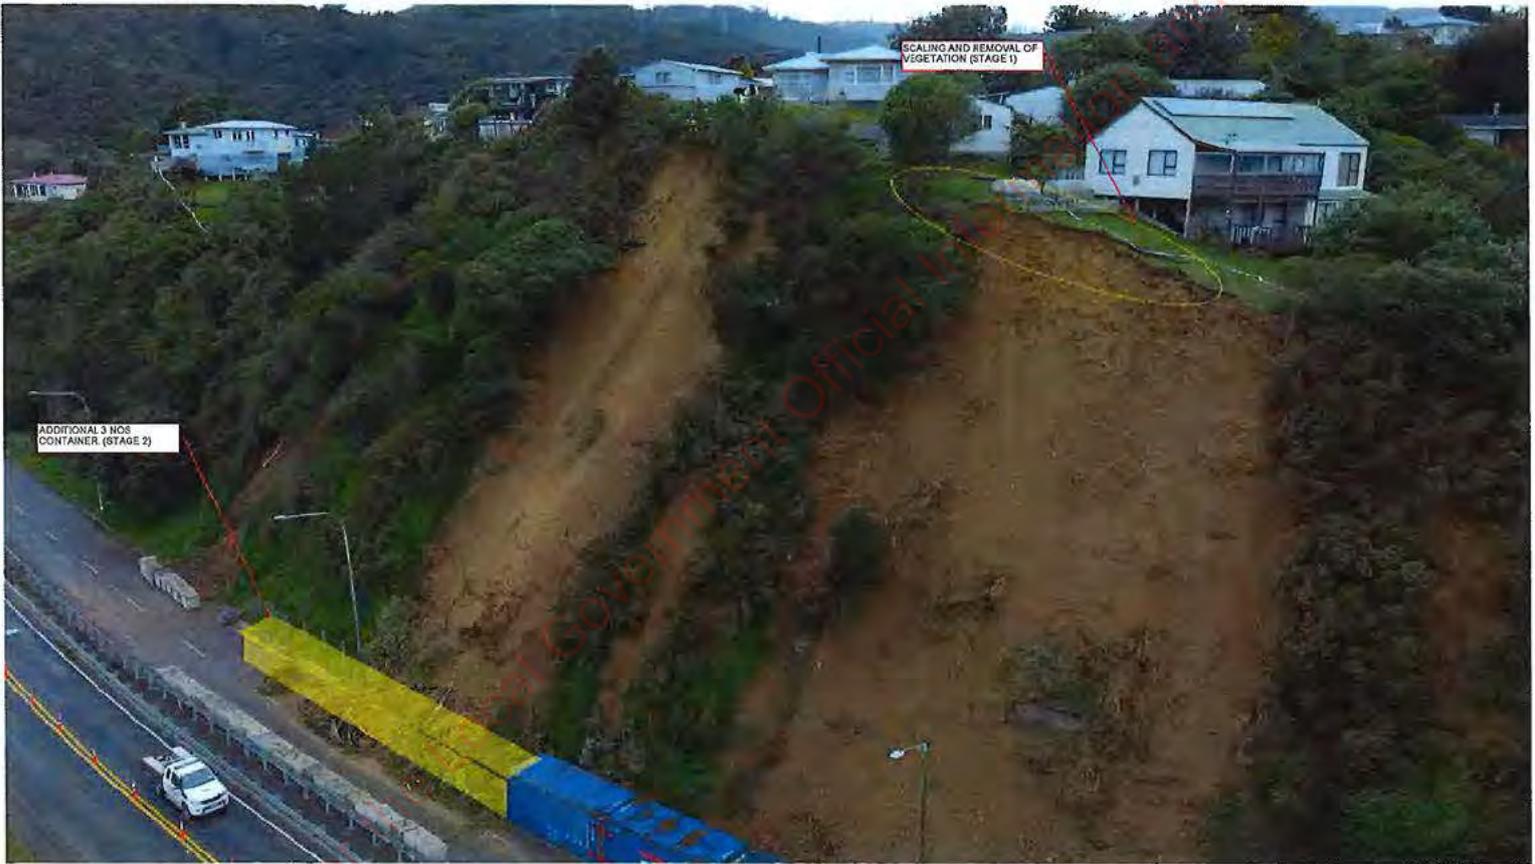
A marked-up photo is attached to show the stages of the work to be completed before one southbound lane will be opened. The extent of the scaling will be determined onsite by rope techs and I will come around midday Friday to do an assessment. In regard to the garden bed, I will leave this with you to communicate to the landowner that the one closest to the scarp will have to be removed.

SCALING AND REMOVAL OF VEGETATION (STAGE 1)

ADDITIONAL 3 NOS CONTAINER (STAGE 2)

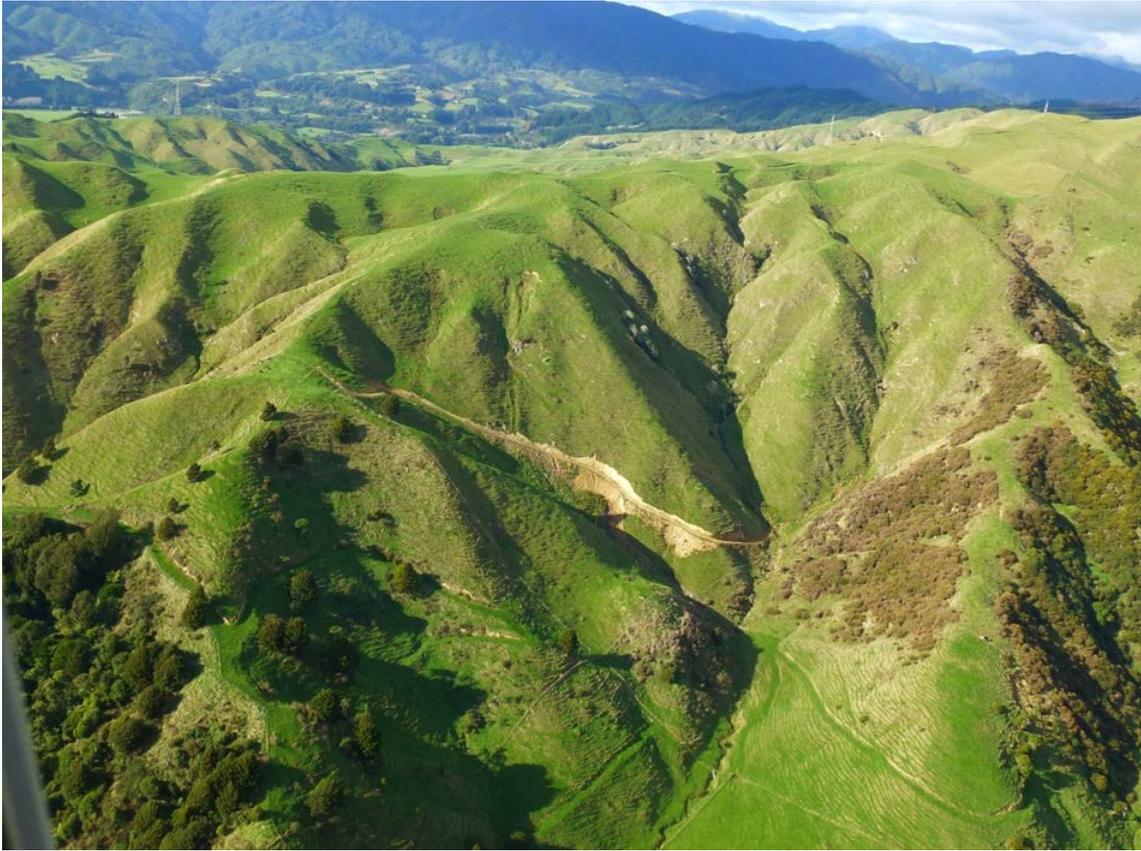
Figure 4.2 Hills at the end of Mickell Road, Te Horo. Note absence of landslides. Transmission Lines rain gauge 1.5 km south, recorded 81.5 mm in 24 hours and a maximum intensity of 19.5 mm in one hour. (GNS Photo: BR_P1140119).

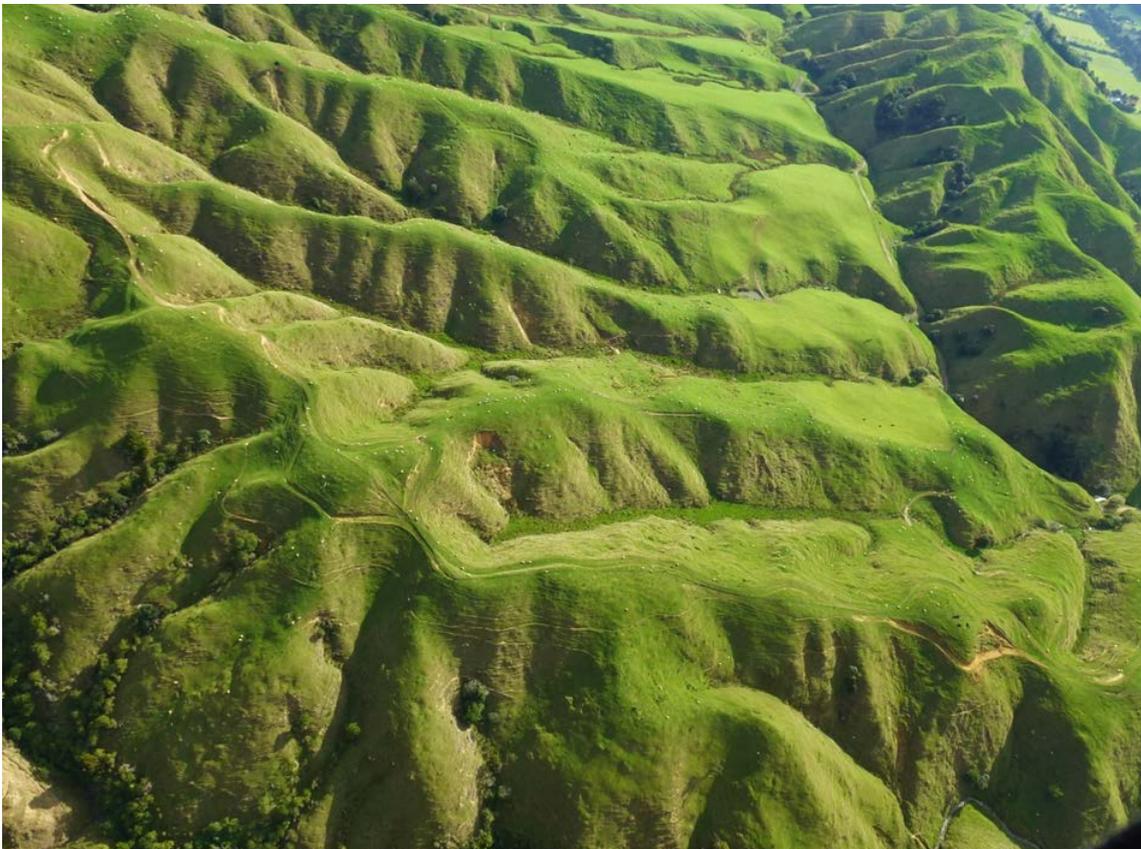
Figure 4.3 Hills south of Otaki Gorge Road. Note absence of landslides. The landslide in centre foreground is not the result of the May 2015 storm. (GNS Photo: BR_P1140130).

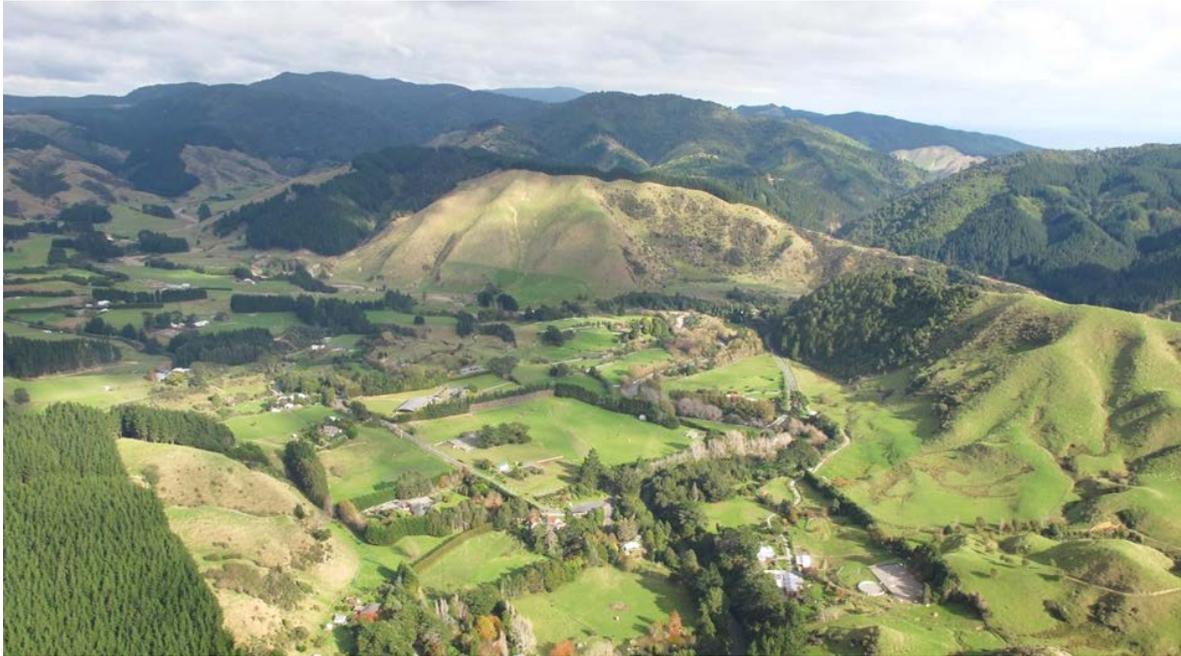
Figure 4.4 Low hills of Pleistocene weathered gravels with a loess mantle were unaffected by landslides in the Reikorangi Valley. The Waikanae rain gauge at the Water Treatment Plant recorded 101.5 mm in 24 hours and a maximum of 17.5 mm in one hour. (GNS Photo: MP_6350).

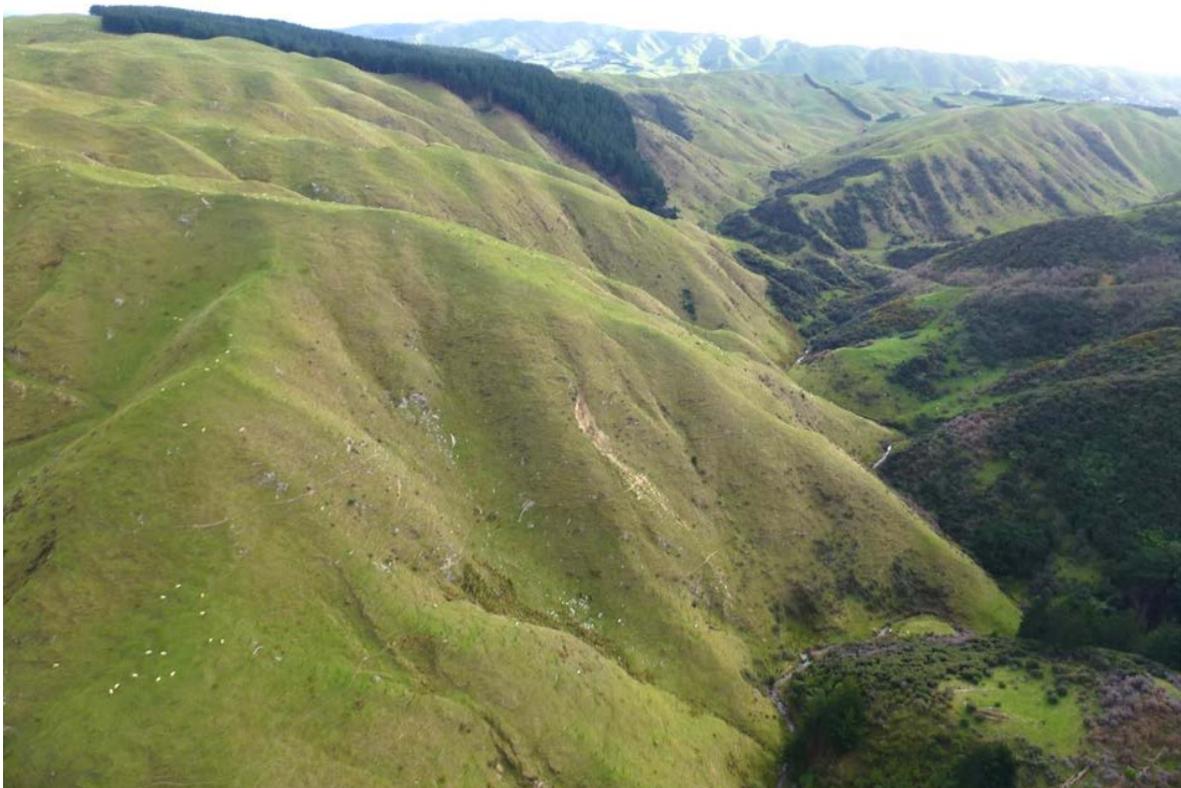
Figure 4.5 Looking northwest along Kakaho Stream. Plimmerton-Pukerua Bay ridge on skyline. Note lack of landslides. Battle Hill rain gauge recorded 144 mm rain in 24 hours and 31.5 mm in one hour. (GNS Photo: BR_P1140367).

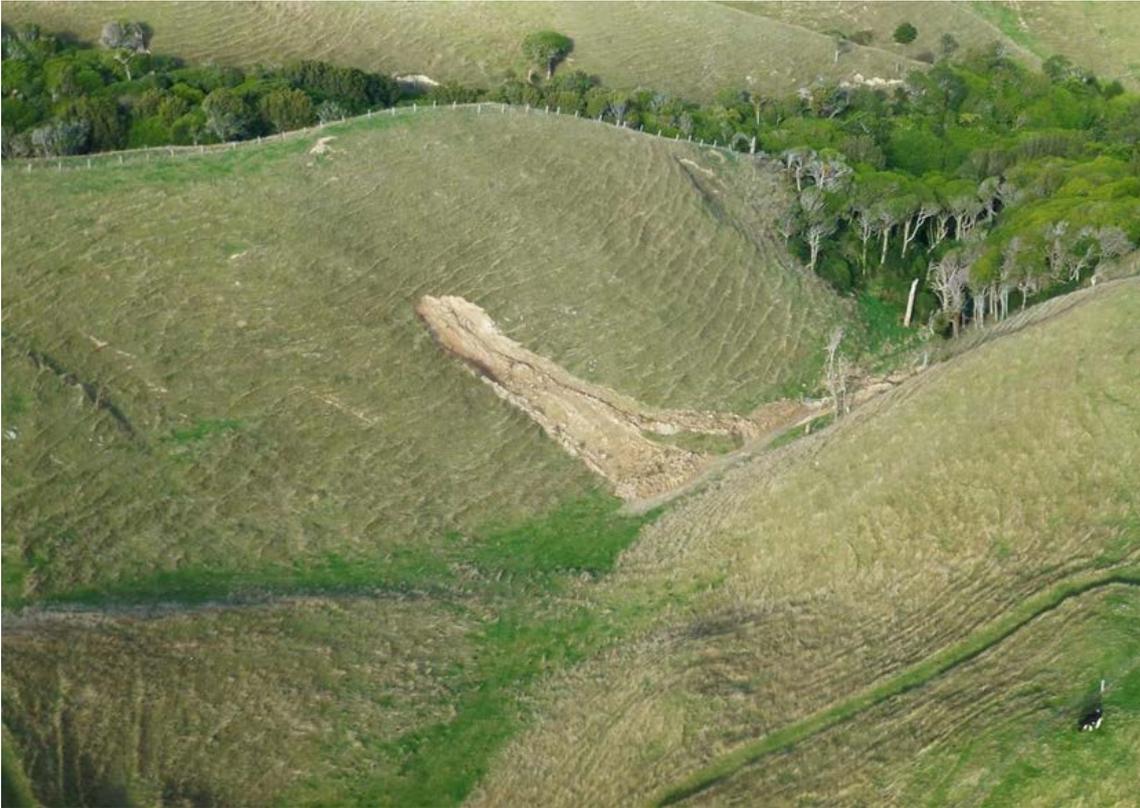
Figure 4.6 Landslide on moderate (20-25°) hill slopes, north of Waterfall Road. (GNS Photo: BR_P1140539).

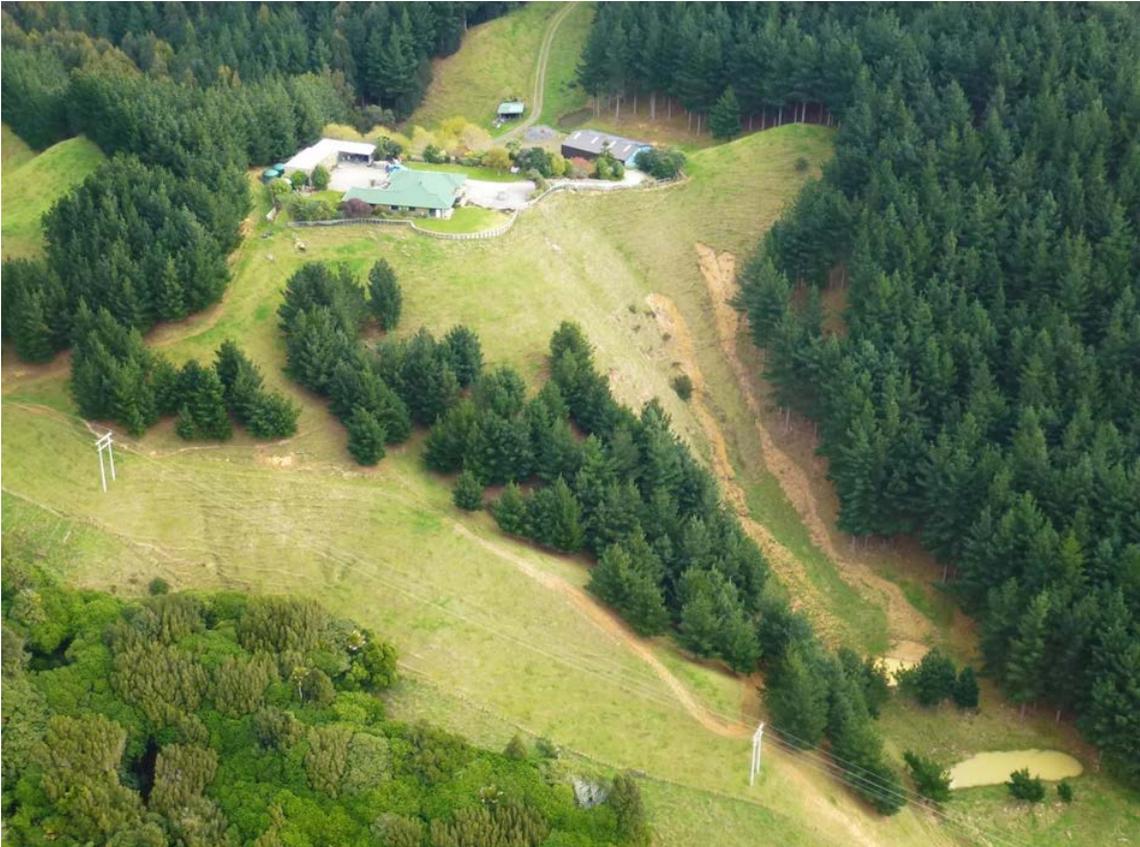
Figure 4.7 Landslides on hills south of Paraparaumu, along Valley Road. (GNS Photo: BR_P1140217).

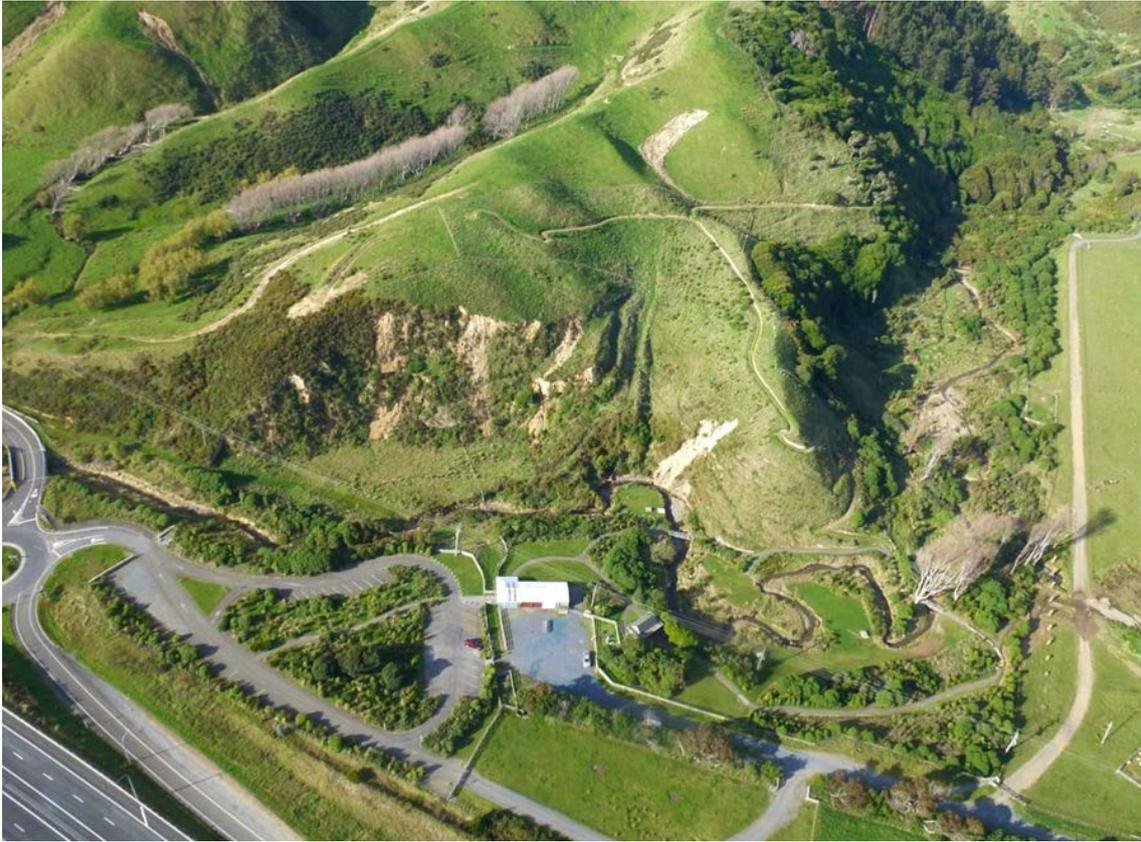
Figure 4.8 Entrance to Whareroa Station and Queen Elizabeth Park at MacKays Crossing. Landslides among scrub are on the back slope of an old quarry site. (GNS Photo: BR_P1140526).

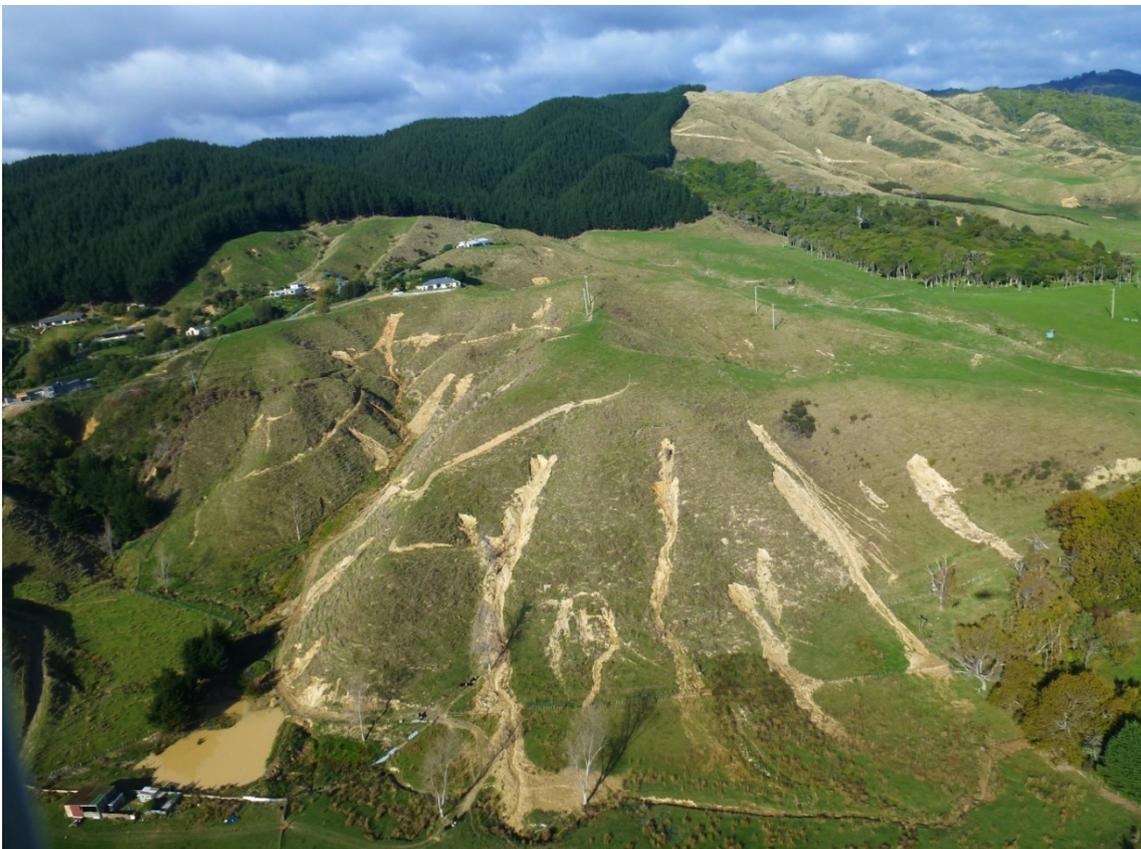
Figure 4.9 Hills east of SH1 between Waikanae and Otaihang roundabout. The maximum landslide density observed during the helicopter reconnaissance flight occurred in this area. (GNS Photo: BR_P1140075).

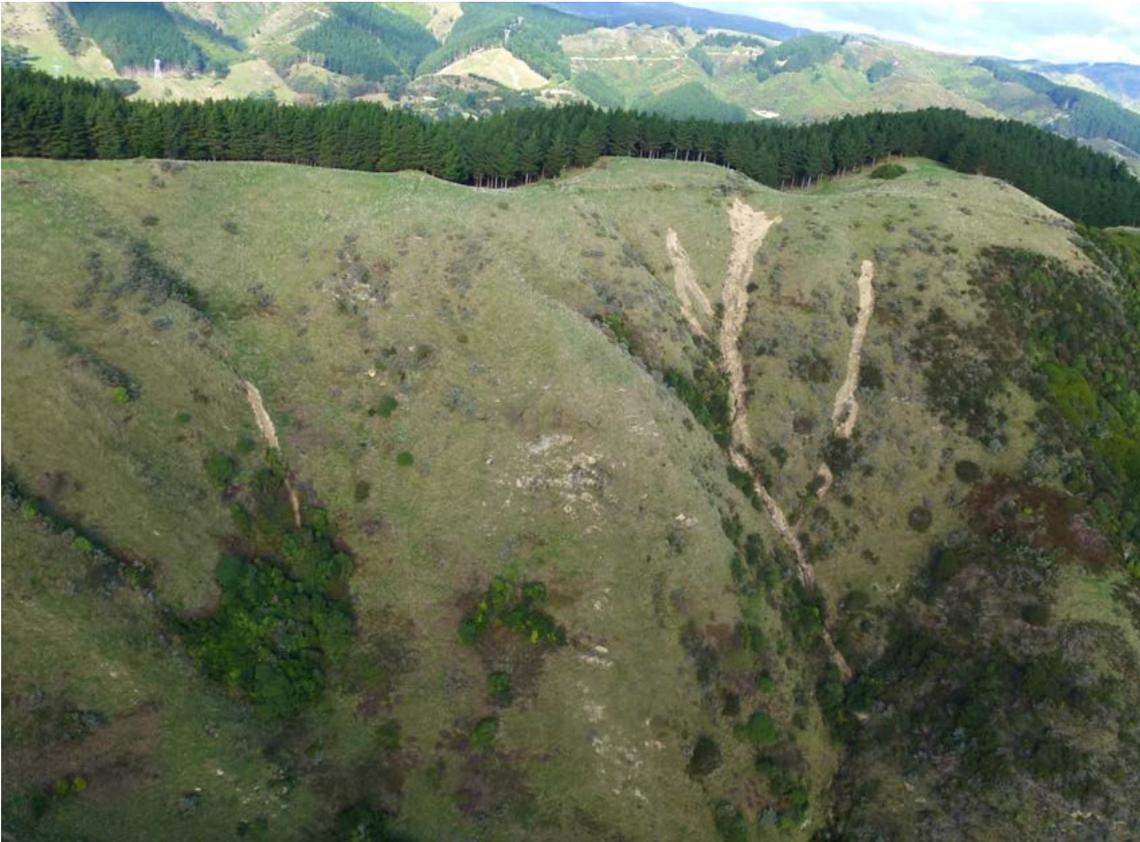
The majority of landslides were small (<100–500 m³) soil and debris slides and/or flows depending on the nature of the slope and thickness of the regolith (Figure 4.10). In addition there was some channel erosion, where narrow, linear gullies occurred in swales and along channels where the concentration of water was sufficient to incise into the sediments that have accumulated at these sites since the last glaciation (Figure 4.11).

Figure 4.10 Typical shallow landslides on greywacke hills, opposite Poplar Avenue, south of Paraparaumu. (GNS Photo: BR_P1140559).

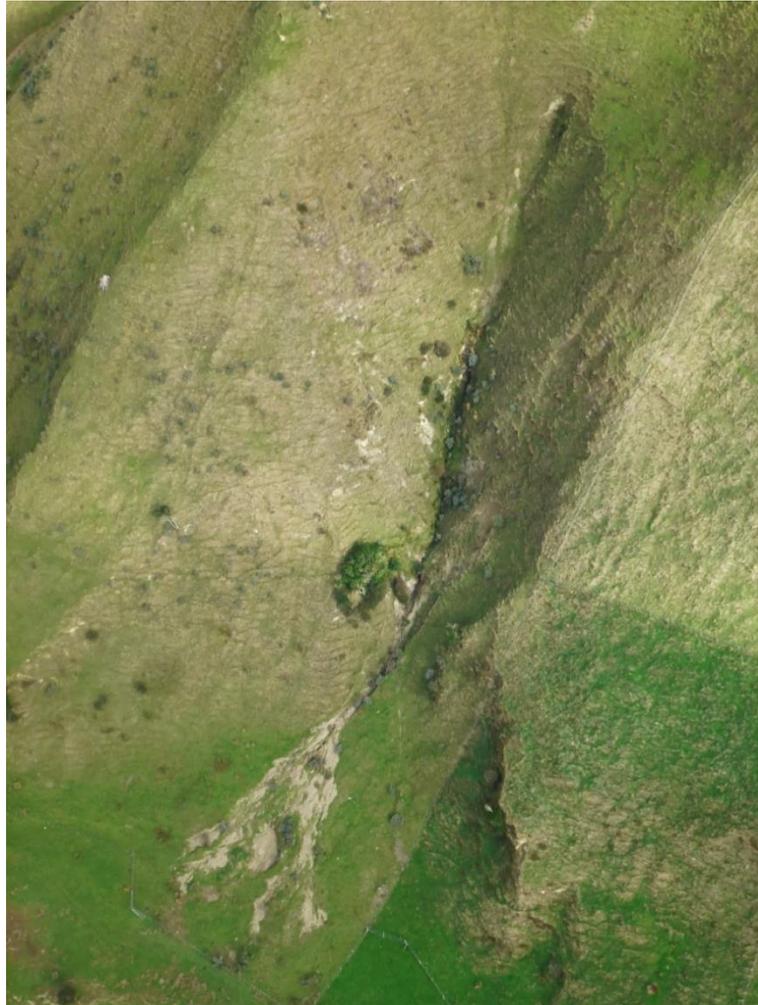
Figure 4.11 Channel-sourced sediment deposited on fan. Note absence of hill slope landslide source. Reikorangi Valley. (GNS Photo: BR_P1140172).

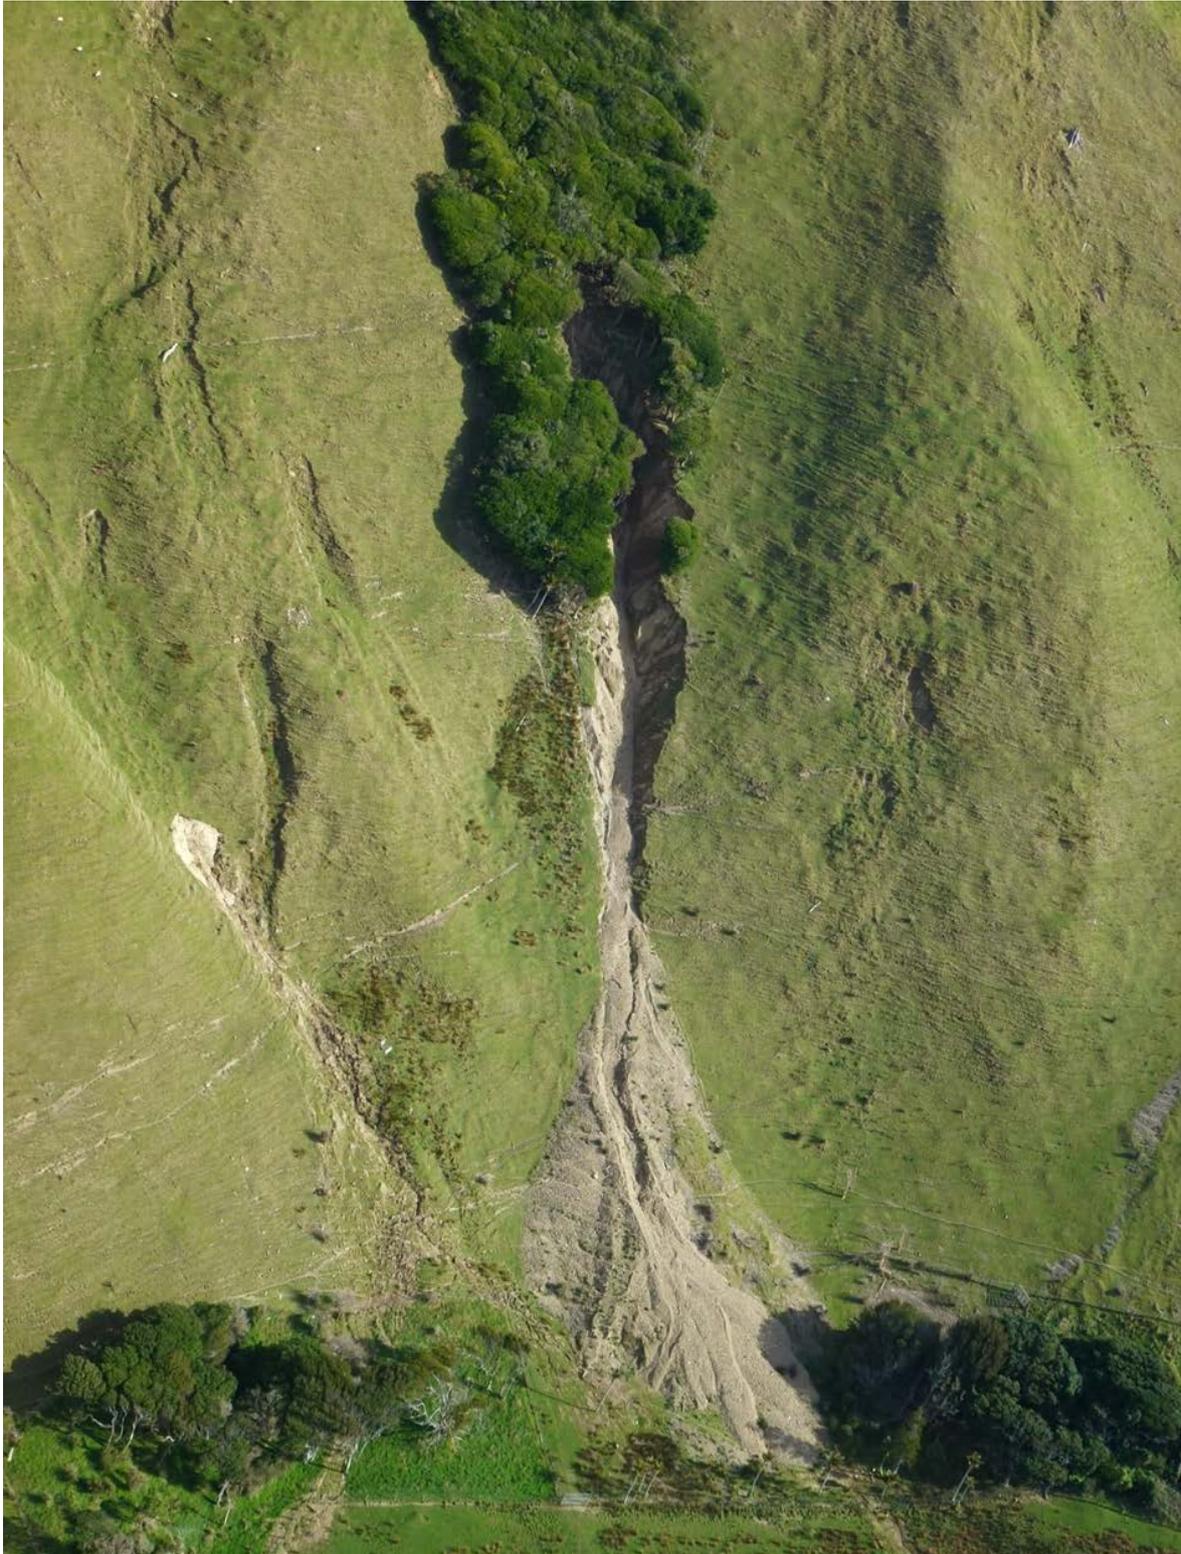
Some of these linear gullies were subsequently found to be pre-existing features. The gully in Figure 4.12 and Figure 4.13 appears to be fresh, but was present on 2013 and 2005 Google Earth imagery (Figure 4.14 and Figure 4.15). However, the gully does appear to have extended headwards as a result of the May 2015 storm. The 2013 Google Earth image shows that small trees/bushes visible on the fan deposit in 2005 were already buried by 2013.

Figure 4.12 Gully erosion along an ephemeral channel in the Reikorangi Valley, 0.5 km south of Water Treatment Plant. This erosion feature was present prior to the 14 May 2015 storm. In the 14 May storm the gully has extended headwards and fresh sediment has been deposited on the fan. (GNS Photo: BR_P1140158).

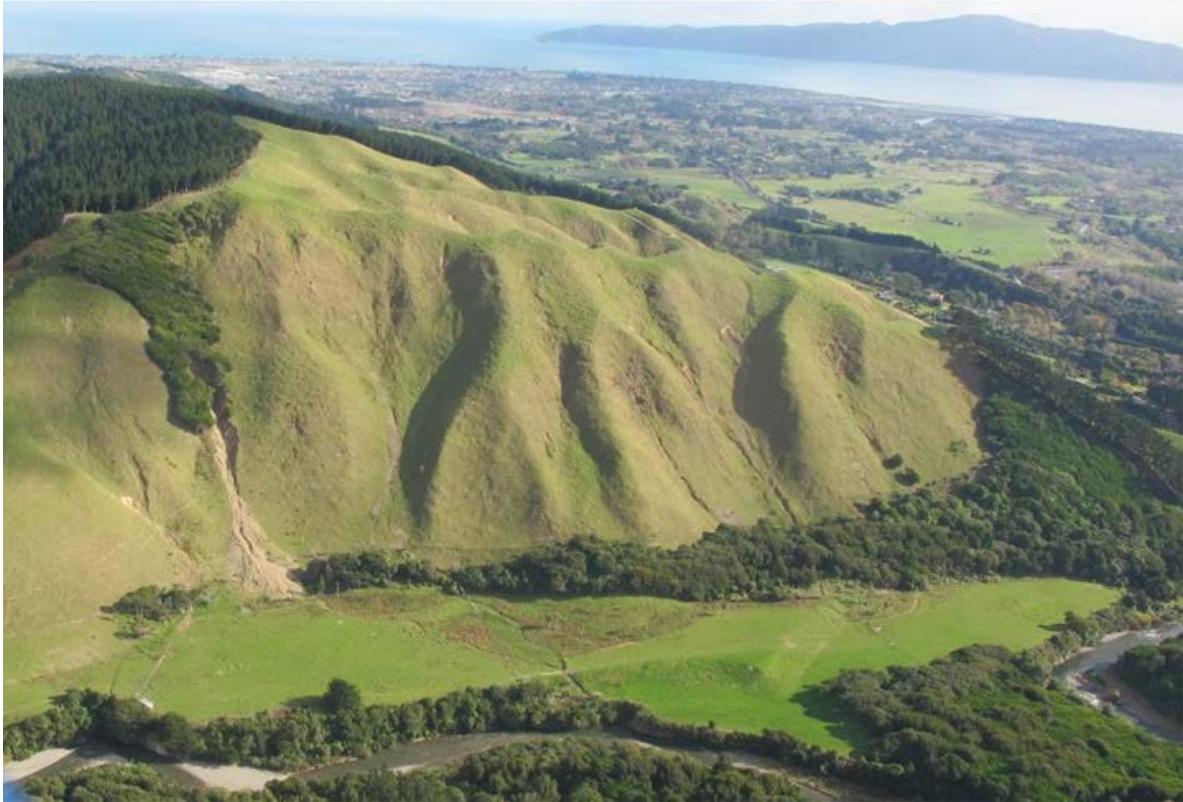
Figure 4.13 Distant view of gully feature in Figure 4.12. The gully head has extended upslope since 2013 (c.f. Figure 4.14). (GNS Photo: MP_6351).

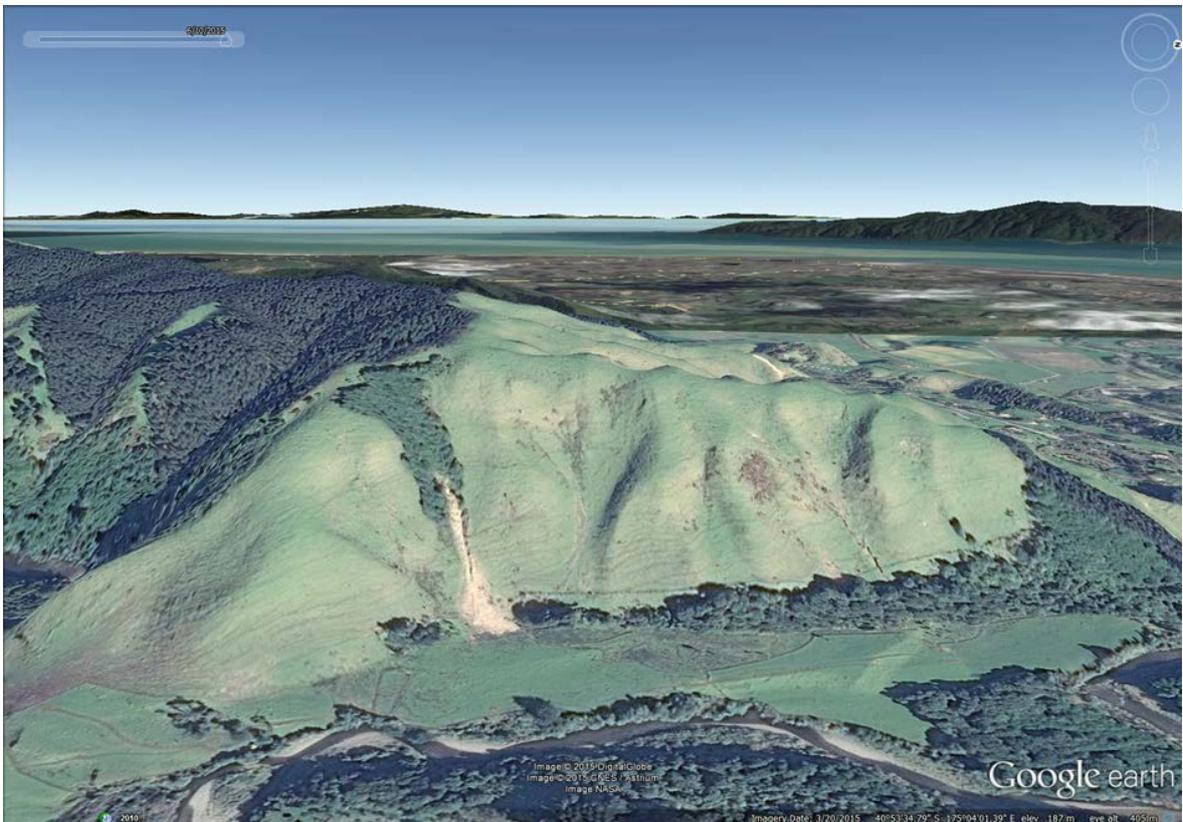
Figure 4.14 Google Earth view of gully feature on 18/8/2013. Small trees/bushes visible on fan deposit in 2005 have now been buried. (GoogleEarth Image).

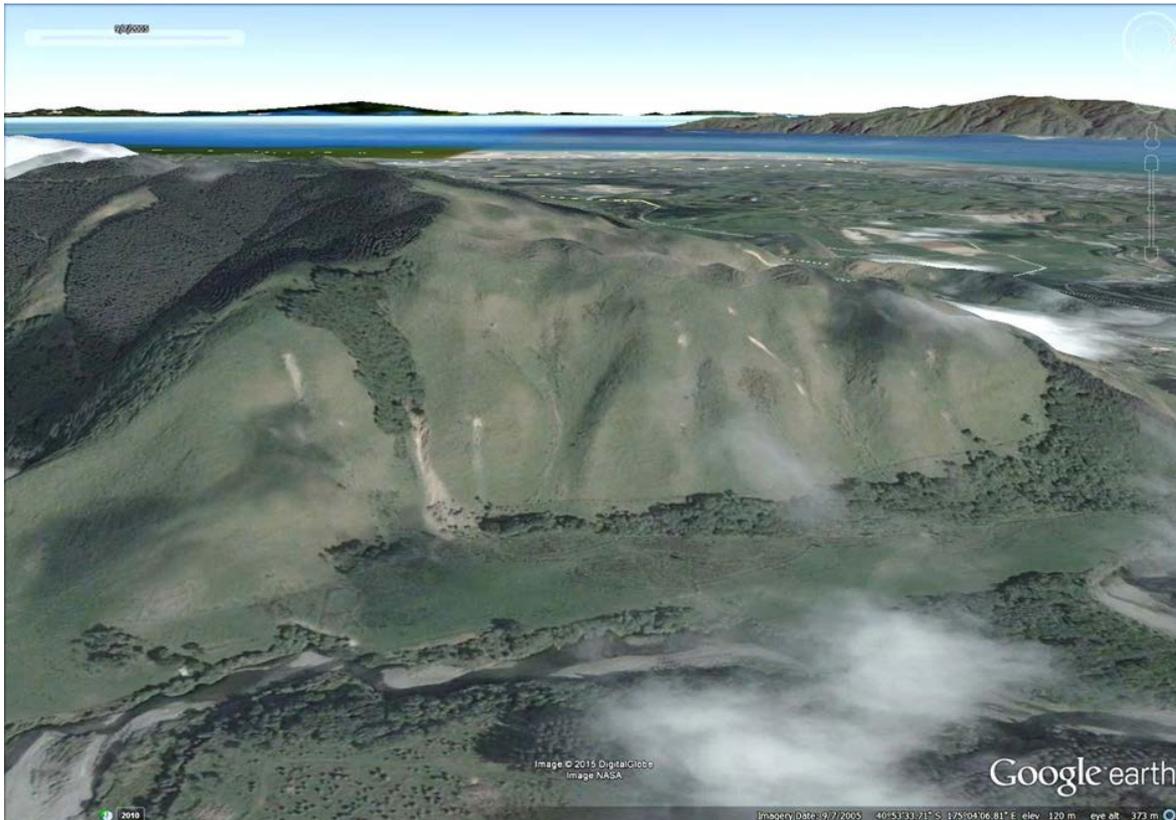
Figure 4.15 Google Earth view of gully feature on 7/9/2005. Note small trees/bushes on fan deposit. (GoogleEarth Image).

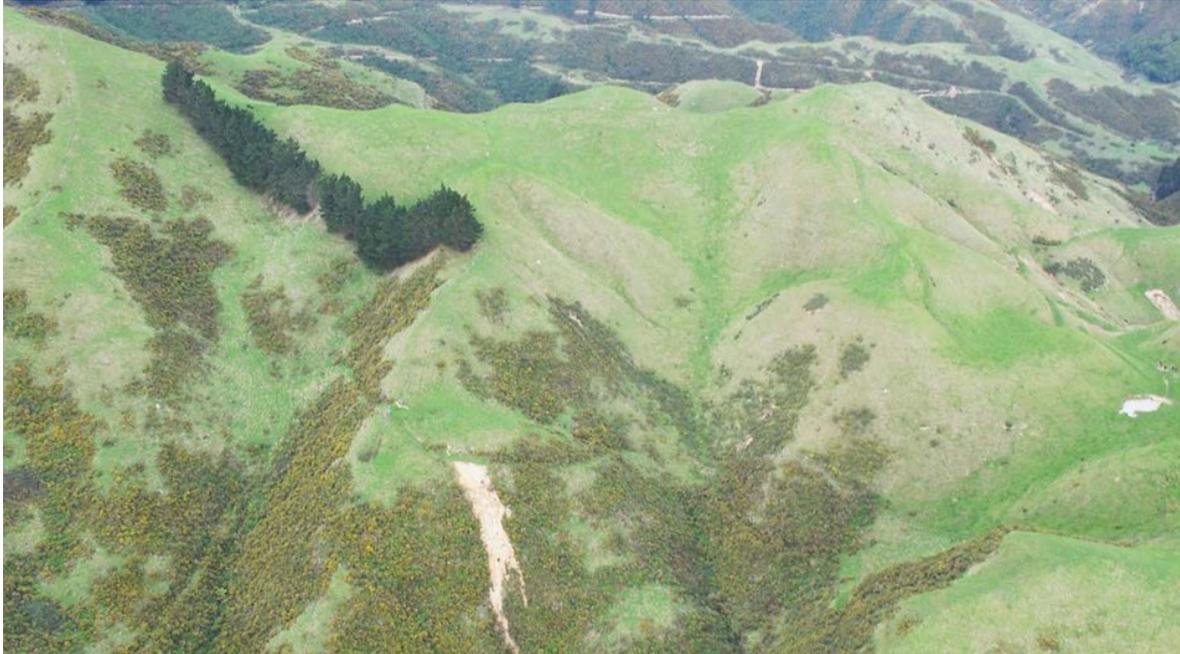
Figure 4.16 Landslide in gorse on hills east of Emerald Glen Road, MacKays Crossing. (GNS Photo: MP_6364).

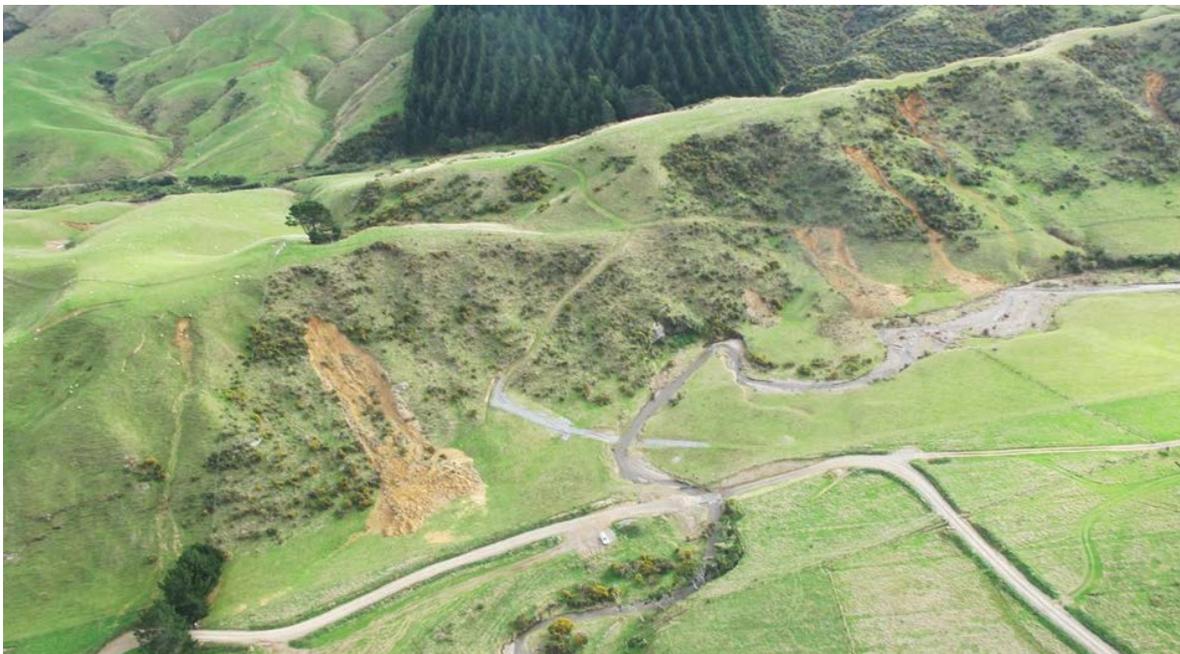
Figure 4.17 Landslides on undifferentiated, weathered gravels and silts. North of Battle Hill. (GNS Photo: MP_6445).
