Request for Information – Local Government Official Information and Meetings Act (LGOIMA) 1987

“...all information relating to slips, slip remediation and internal council correspondence relating to historical 2005 to the recent slips at 46 and 60 Holborn Drive or around that area facing the Eastern Hutt Road”

We have interpreted your request as applying to landslips occurring on or above Eastern Hutt Road, between the Stokes Valley roundabout and the intersection with High Street at Pomare. This covers properties at 46-92 Holborn Drive and 200-204 Eastern Hutt Road.

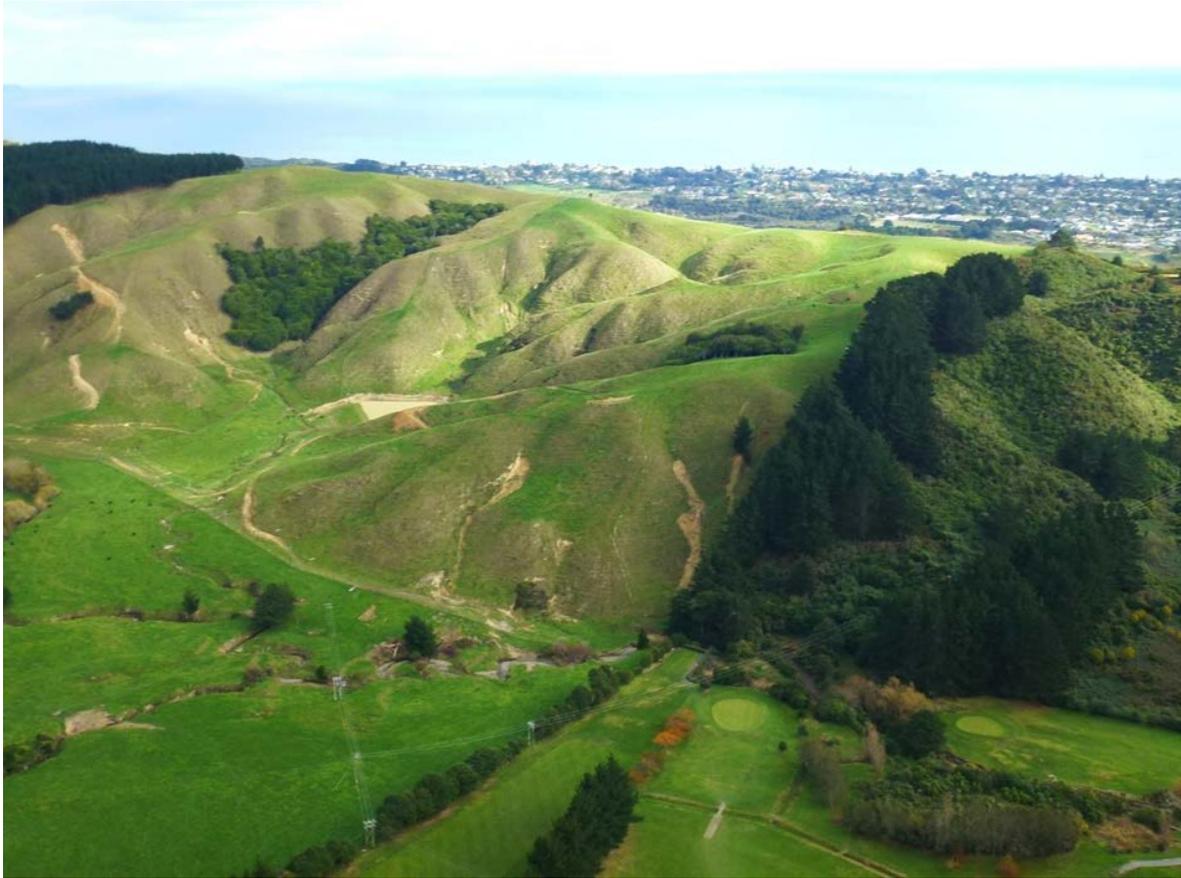
Figure 4.20 Landslides on hills south of Paraparaumu, along Valley Road. Raumati in distance. Note absence of landslides in area of scrub to right of photo. (GNS Photo: BR_P1140209).

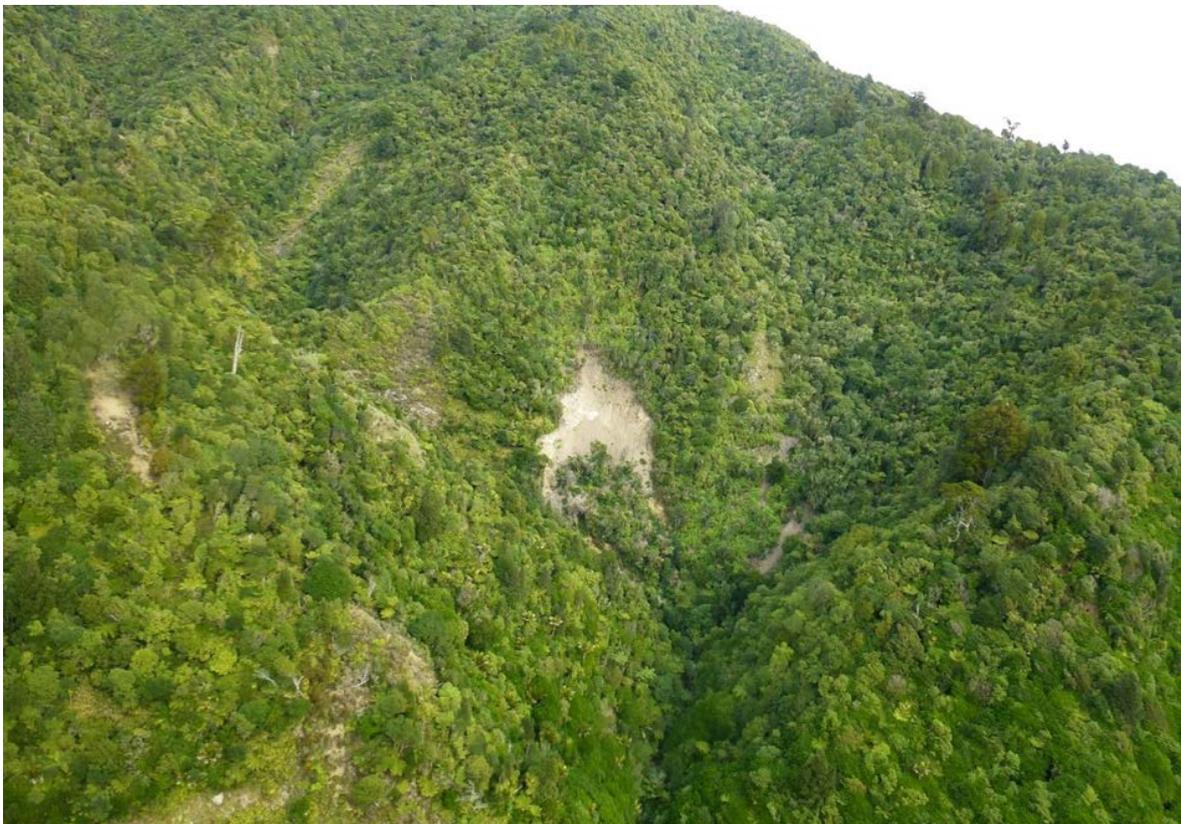
Figure 4.21 Indigenous forest on slopes of Wainui Hill, near Transmission Gully. This landslide was present prior to the 14 May 2015 storm, and appears to have occurred after January 2013. (GNS Photo: BR_P1140236).

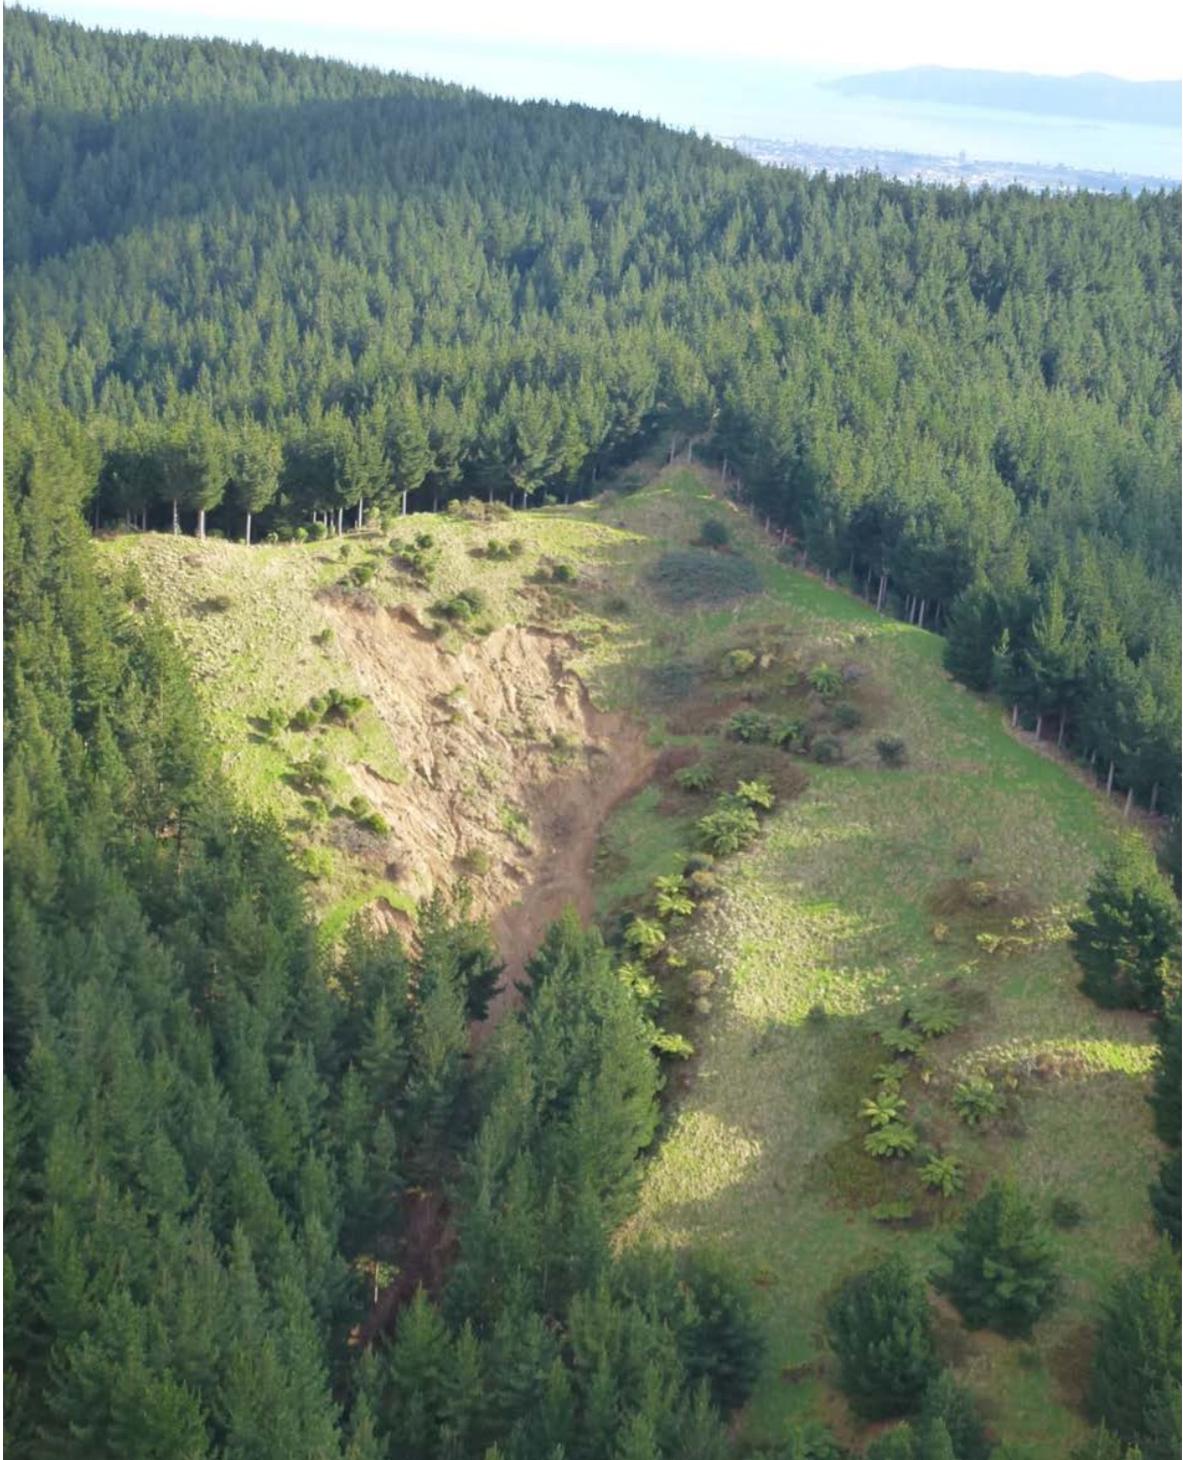
Figure 4.23 Landslide in pasture between pine plantation, above Reikorangi Valley. (GNS Photo: BR_P1140165).

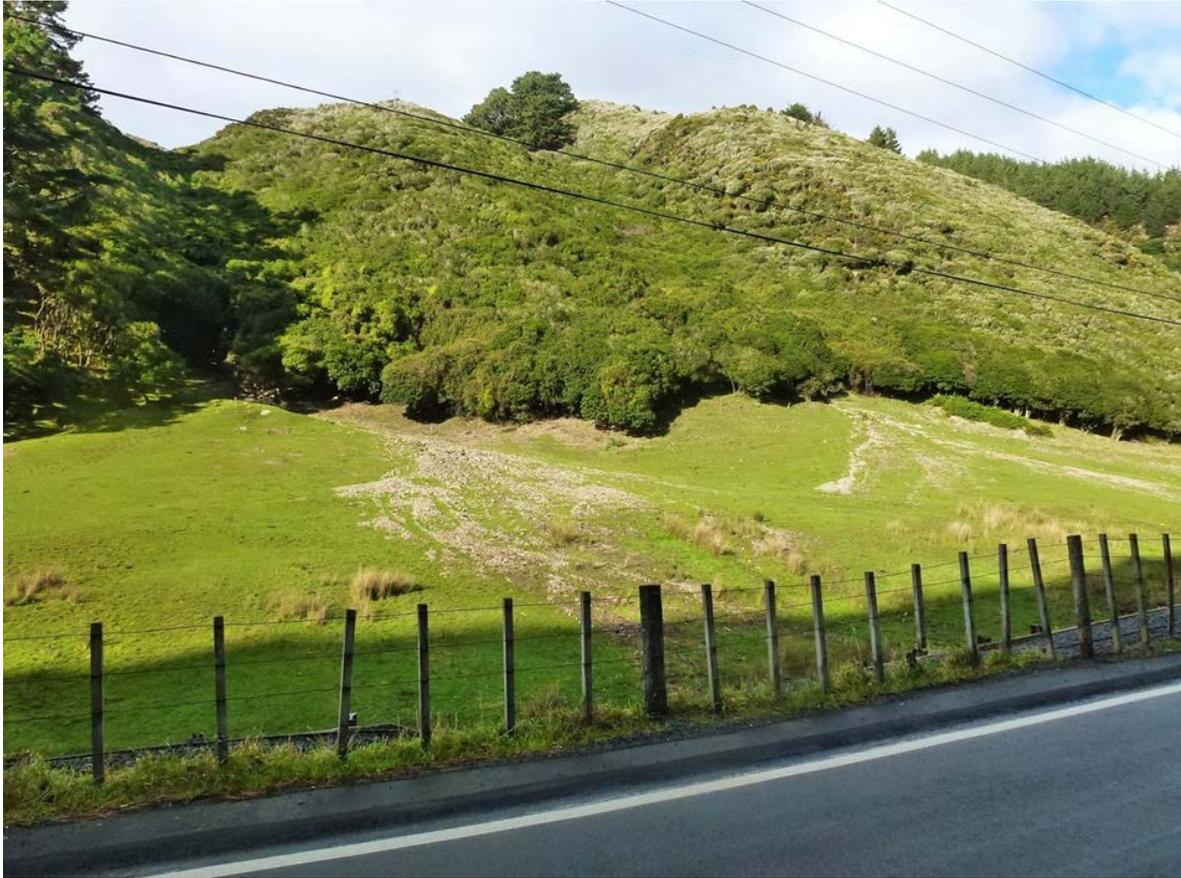
Figure 4.24 Sediment deposited on old, grass-covered debris fans at the base of small, scrub covered catchments. Sediment is derived from channel sources in the absence of landslides. Paekakariki Hill Road.

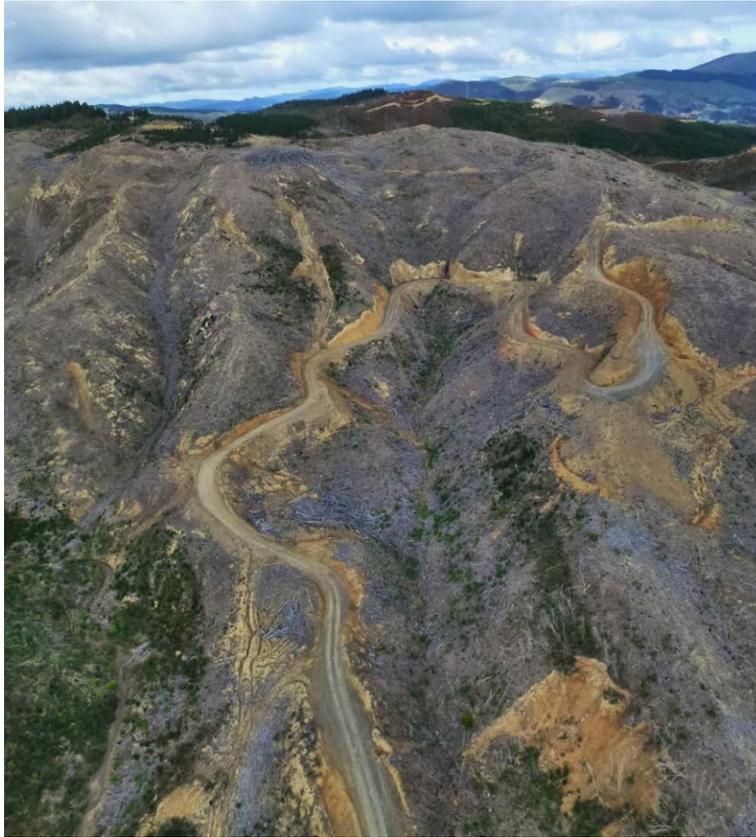
Figure 4.25 Recently logged forest (2011/2012) at end of Flightys Road. Landslide at bottom right occurred in the May 2015 storm. However, while other landslides and bare areas were present prior to the storm, these surfaces will have been the sources of sediment eroded by sheet wash and rill erosion. (GNS Photo: BR_P1140408).

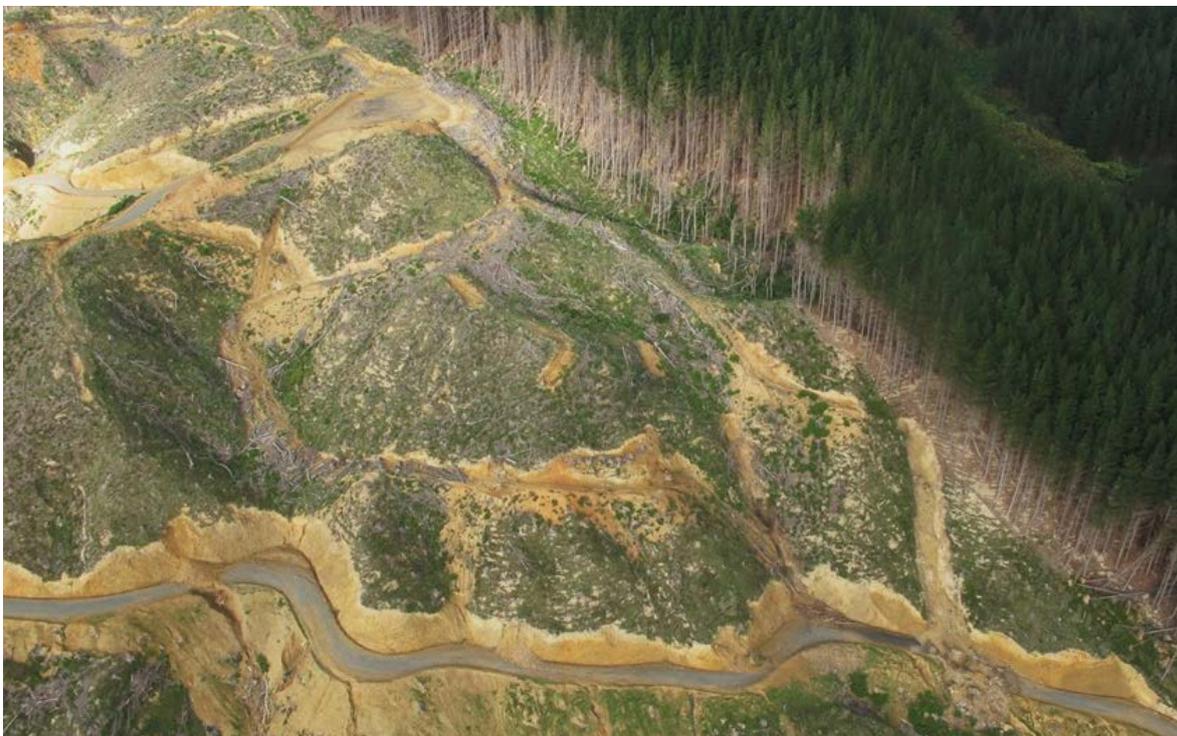
Figure 4.26 Recently logged forest, in tributary of Horokiri Stream. Note new landslide with debris on the track at right of photo. (GNS Photo: MP_6420).

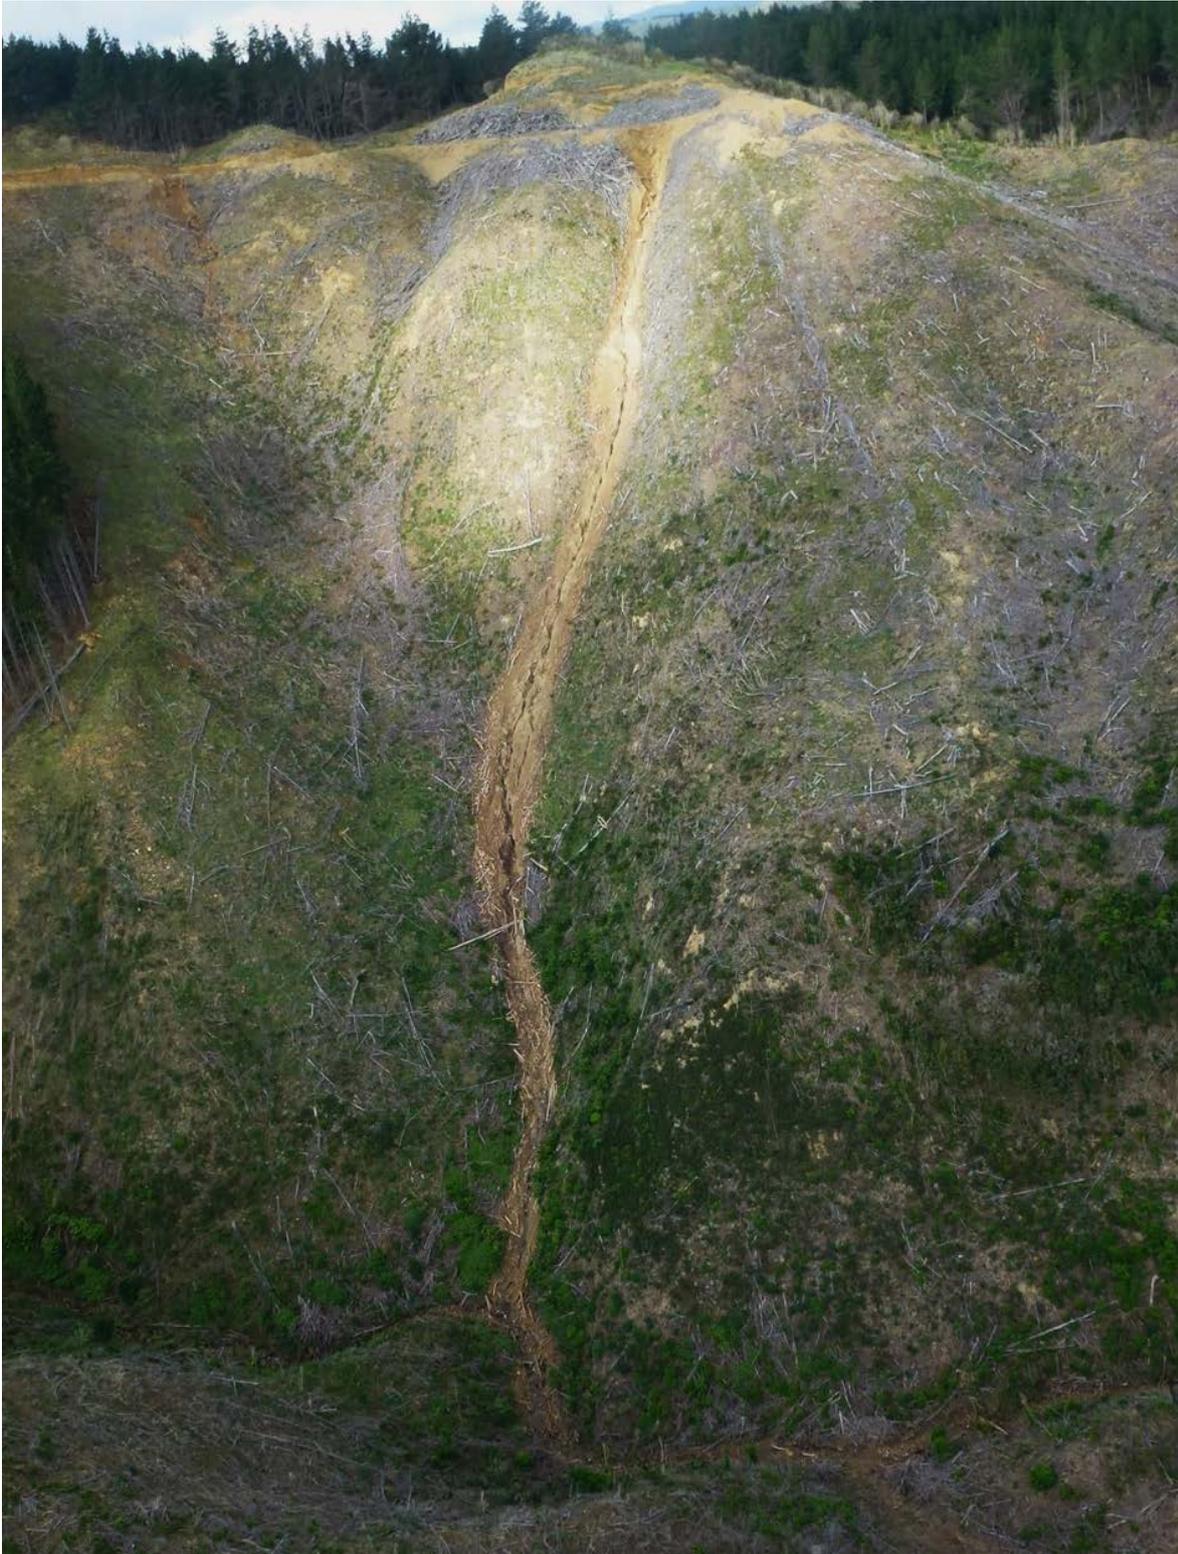
Figure 4.27 Landslide (debris avalanche) in area logged in 2011/2012. Landslide has originated from fill along a forestry track. Note gully within debris tail, indicating concentration of water supplied from track. End of Flightys Road. (GNS Photo: BR_P1140402).

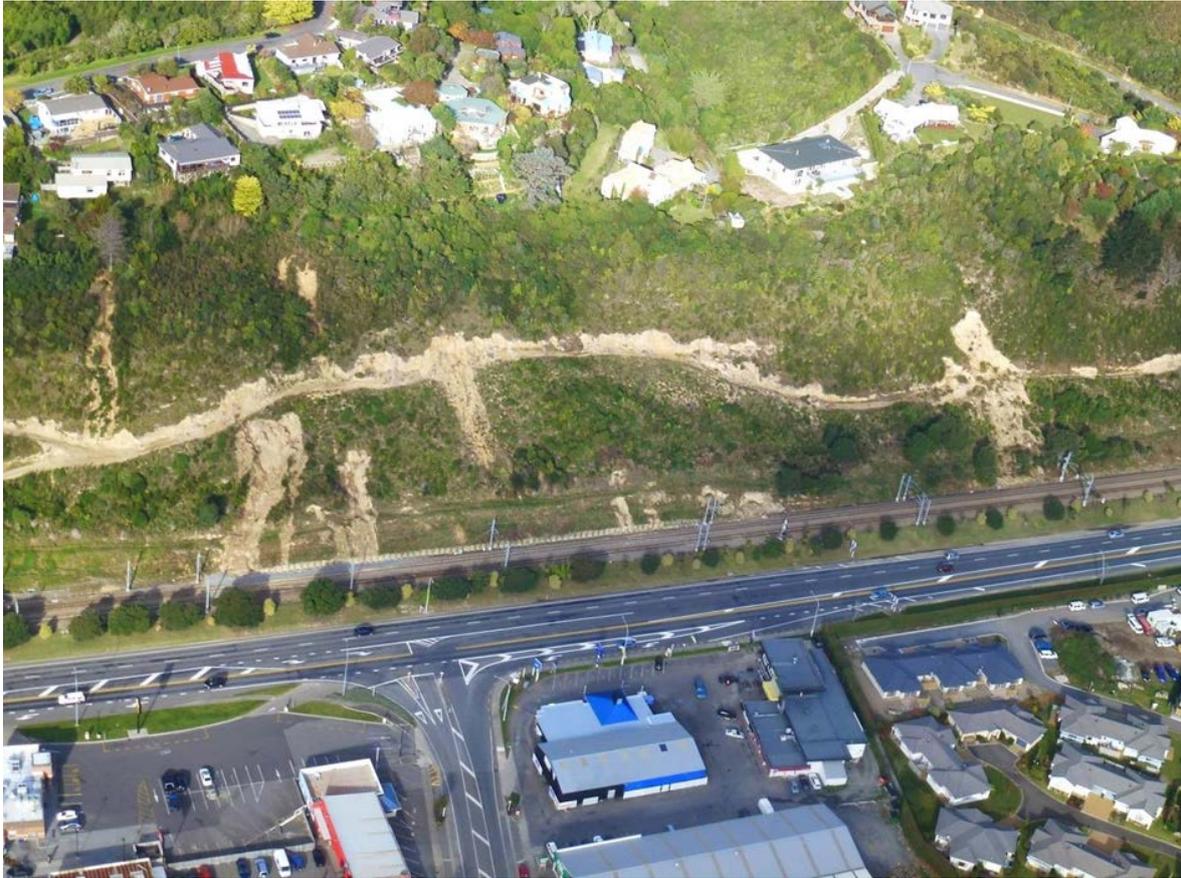
Figure 4.28 Landslides on a scarp where pine trees have recently been logged. Note the association of landslides with the recently formed track. SH1 in foreground at southern entry to Paraparaumu. (GNS Photo: BR_P1140571).

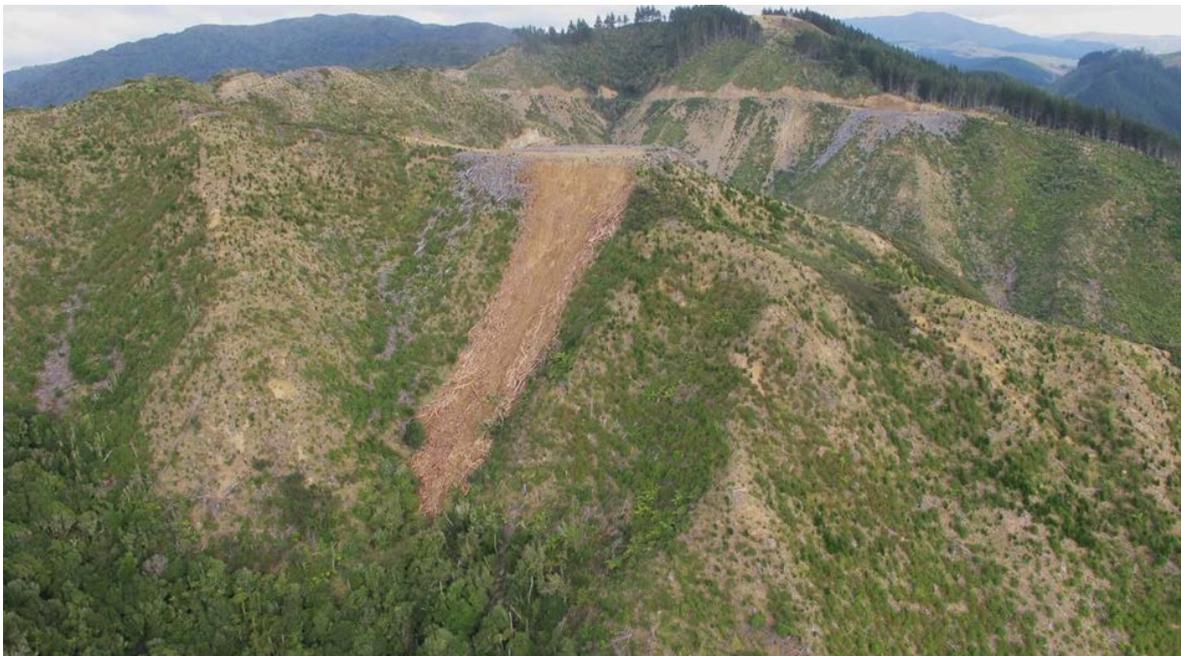
Figure 4.29 Landslide from forestry landing in Maungakotukutuku catchment, south of Nikau Valley. Note large quantity of logs in debris tail. (GNS Photo: MP_6352).

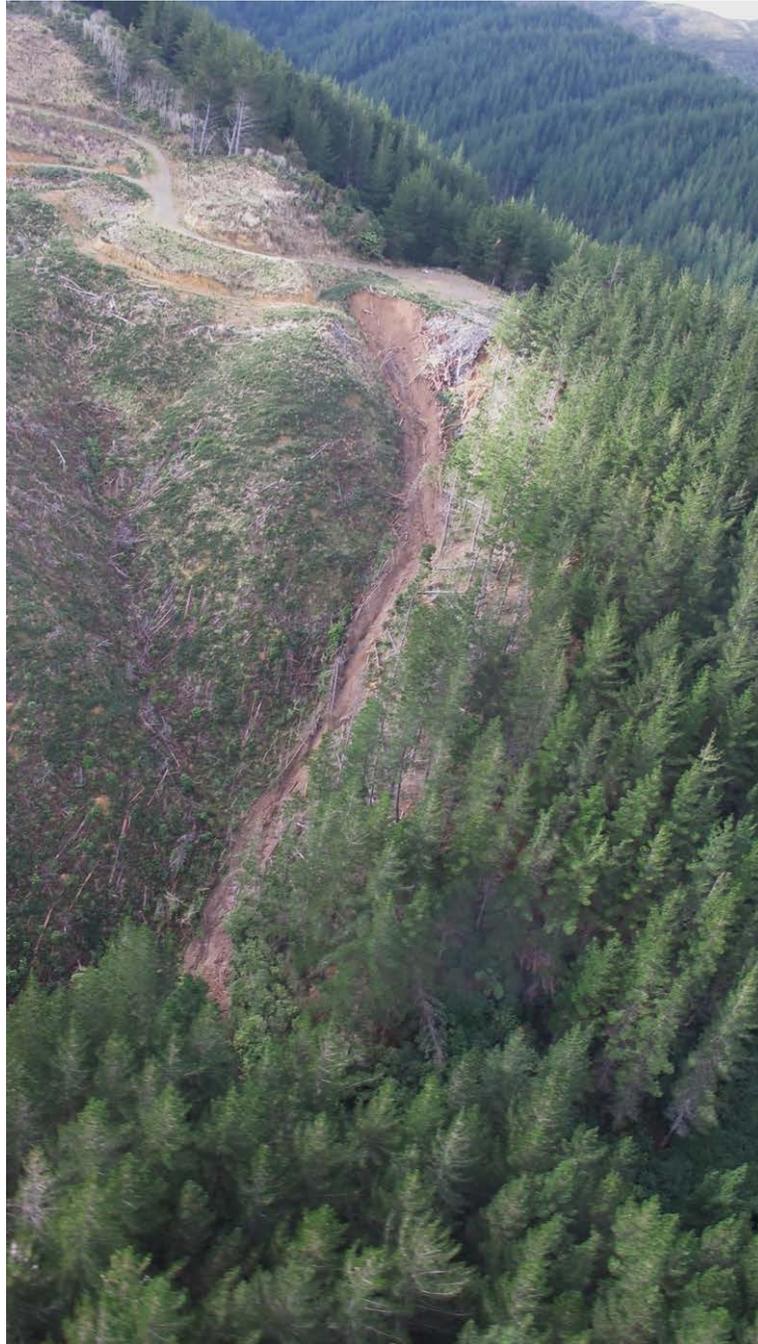
Figure 4.30 Landslide originating from a forestry landing in recently logged forest, Moonshine Valley. (GNS Photo: MP_6428).

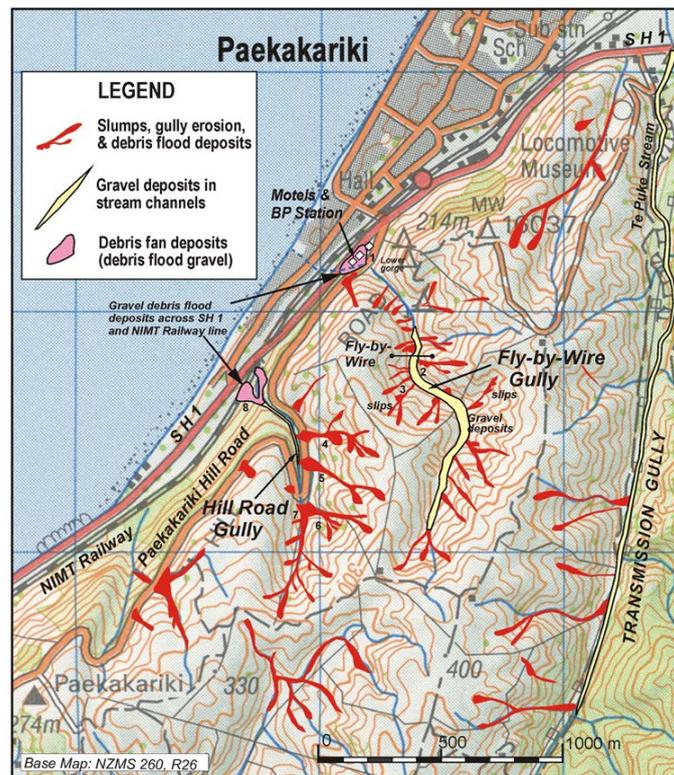
Figure 4.32 Map of the Paekakariki area showing the main landslide, gully erosion features and debris flood deposits resulting from the flood of 3 October 2003 (from Hancox 2003). These catchments were largely unaffected by landslides and gullies during the 2015 storm.

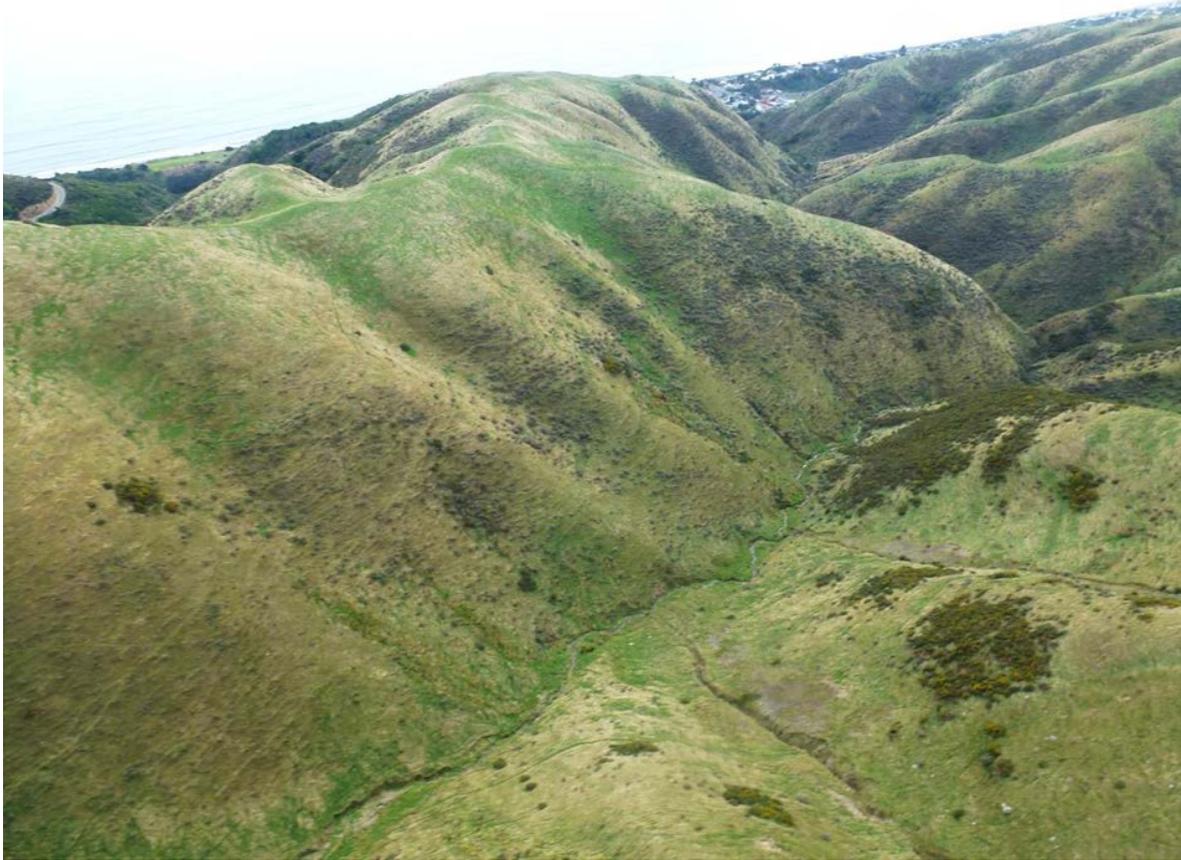
Figure 4.33 The upper Fly-by-Wire catchment, was unaffected by landslides and gullies during the 2015 storm. Gully in foreground has stabilised since formation during 2003 storm. GNS Photo: BR_P1140251).

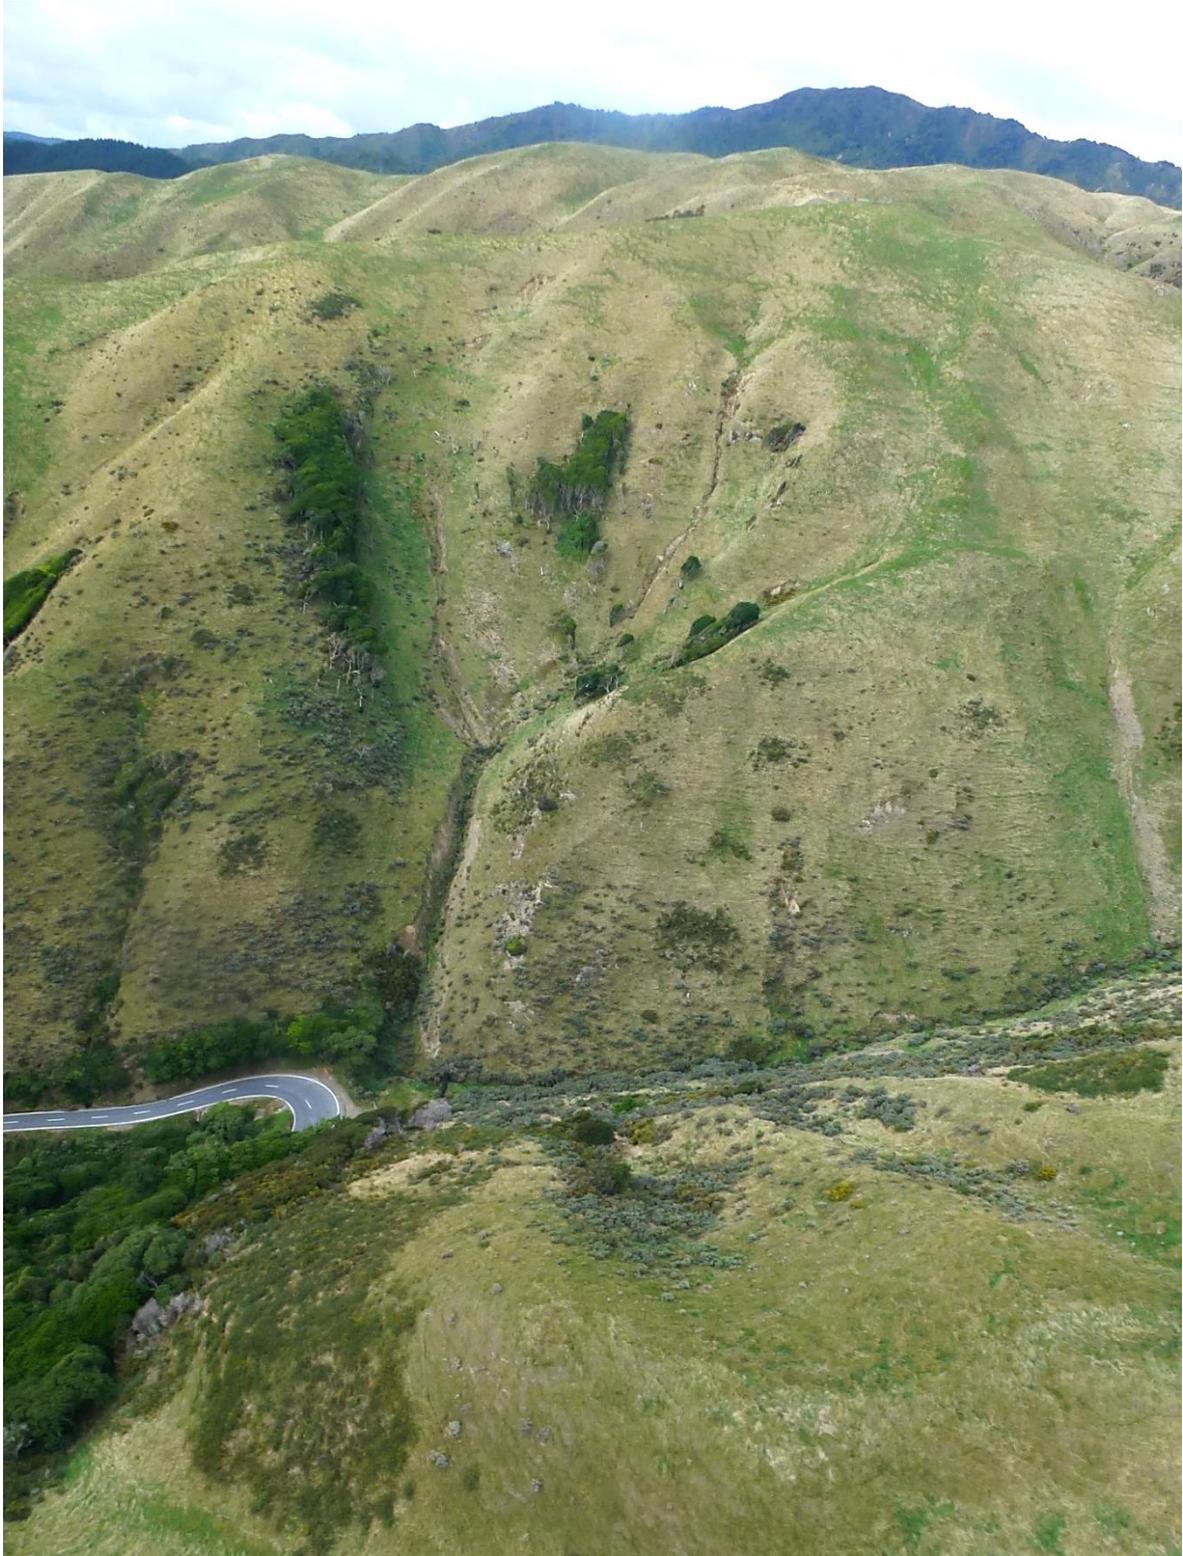
Figure 4.34 Paekakariki Hill Road, showing 2003 gullies (centre) which were unaffected by the 2015 storm, and gully (far right) showing some reactivation. GNS Photo: BR_P1140236).

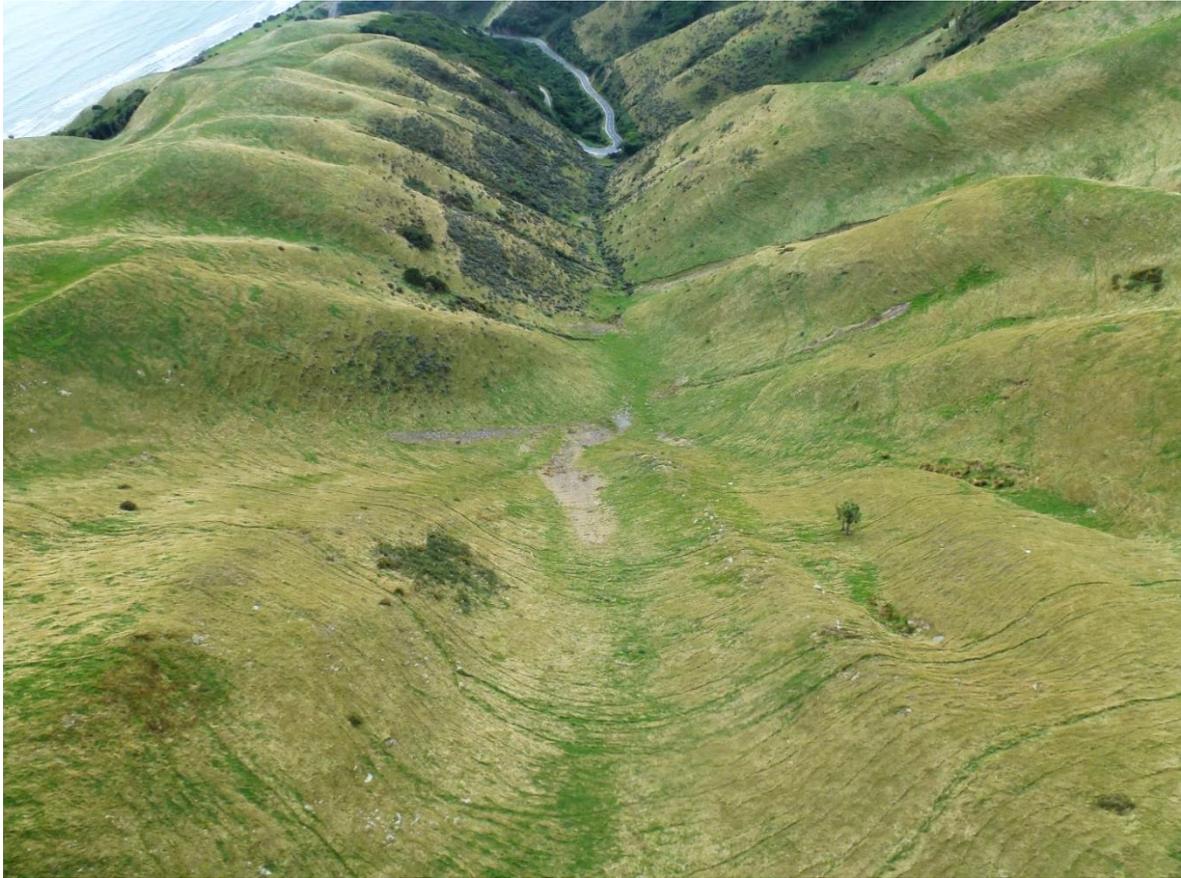
Figure 4.35 Accumulation of gravel in hill slope swales above the Paekakariki Hill Road. These deposits date from the 2003 storm. Compare with Figure 4.36, looking upstream. (GNS Photo: BR_P1140261).

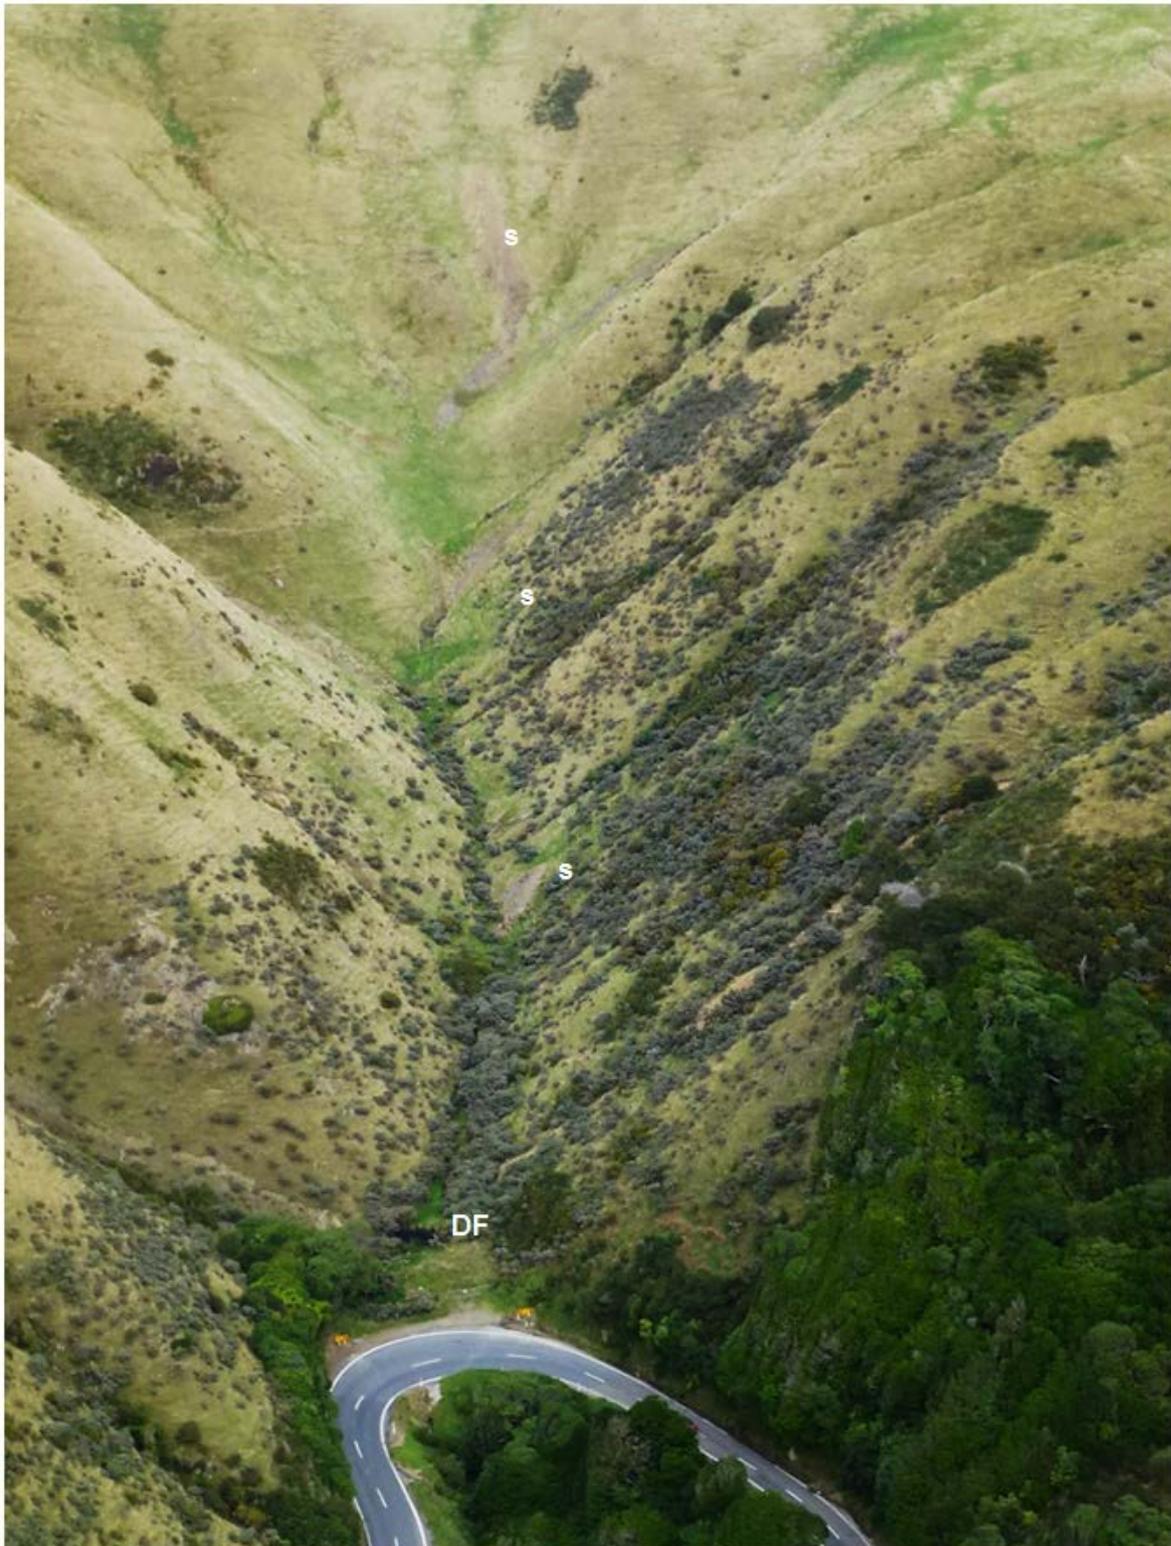
Figure 4.36 View from Paekakariki Hill Road, looking upstream. Compare with Figure 4.35, looking downstream. Several small landslides (s) occurred during the 2015 storm, but little or no channel erosion. A debris fence (DF) built at this site after the 2003 flood effectively controlled debris flood gravels during floods in 2004, 2005, and 2006 (Hancox et al. 2005) (GNS Photo: BR_P1140268).

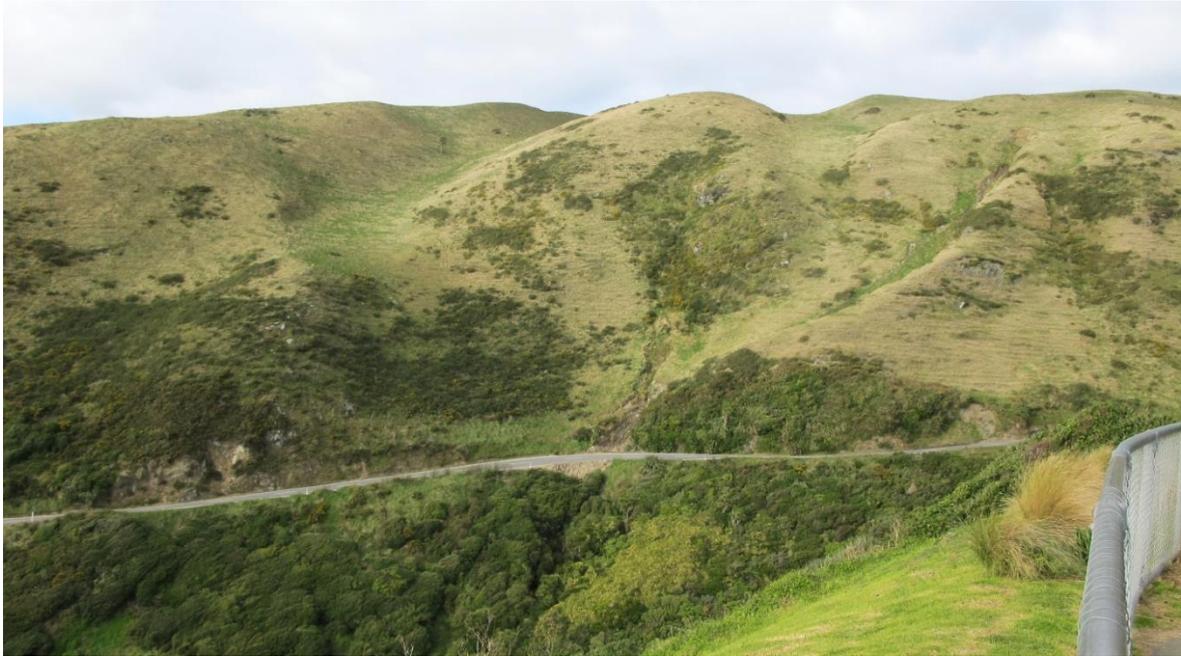
Very few landslides related to road cuts were observed anywhere within the area flown. Figure 4.31 shows one such instance on the Paekakariki Hill Road, just north of the Lookout. Another failure occurred on a steep cut on SH1 ~1 km south of Pukerua Bay. More common were minor rock falls and soil falls too small to block the road.

Figure 4.37 Paekakariki Hill Road from the lookout, showing landslide (centre) which blocked the road (compare with Figure 4.31). (GNS Photo: MP_6339).

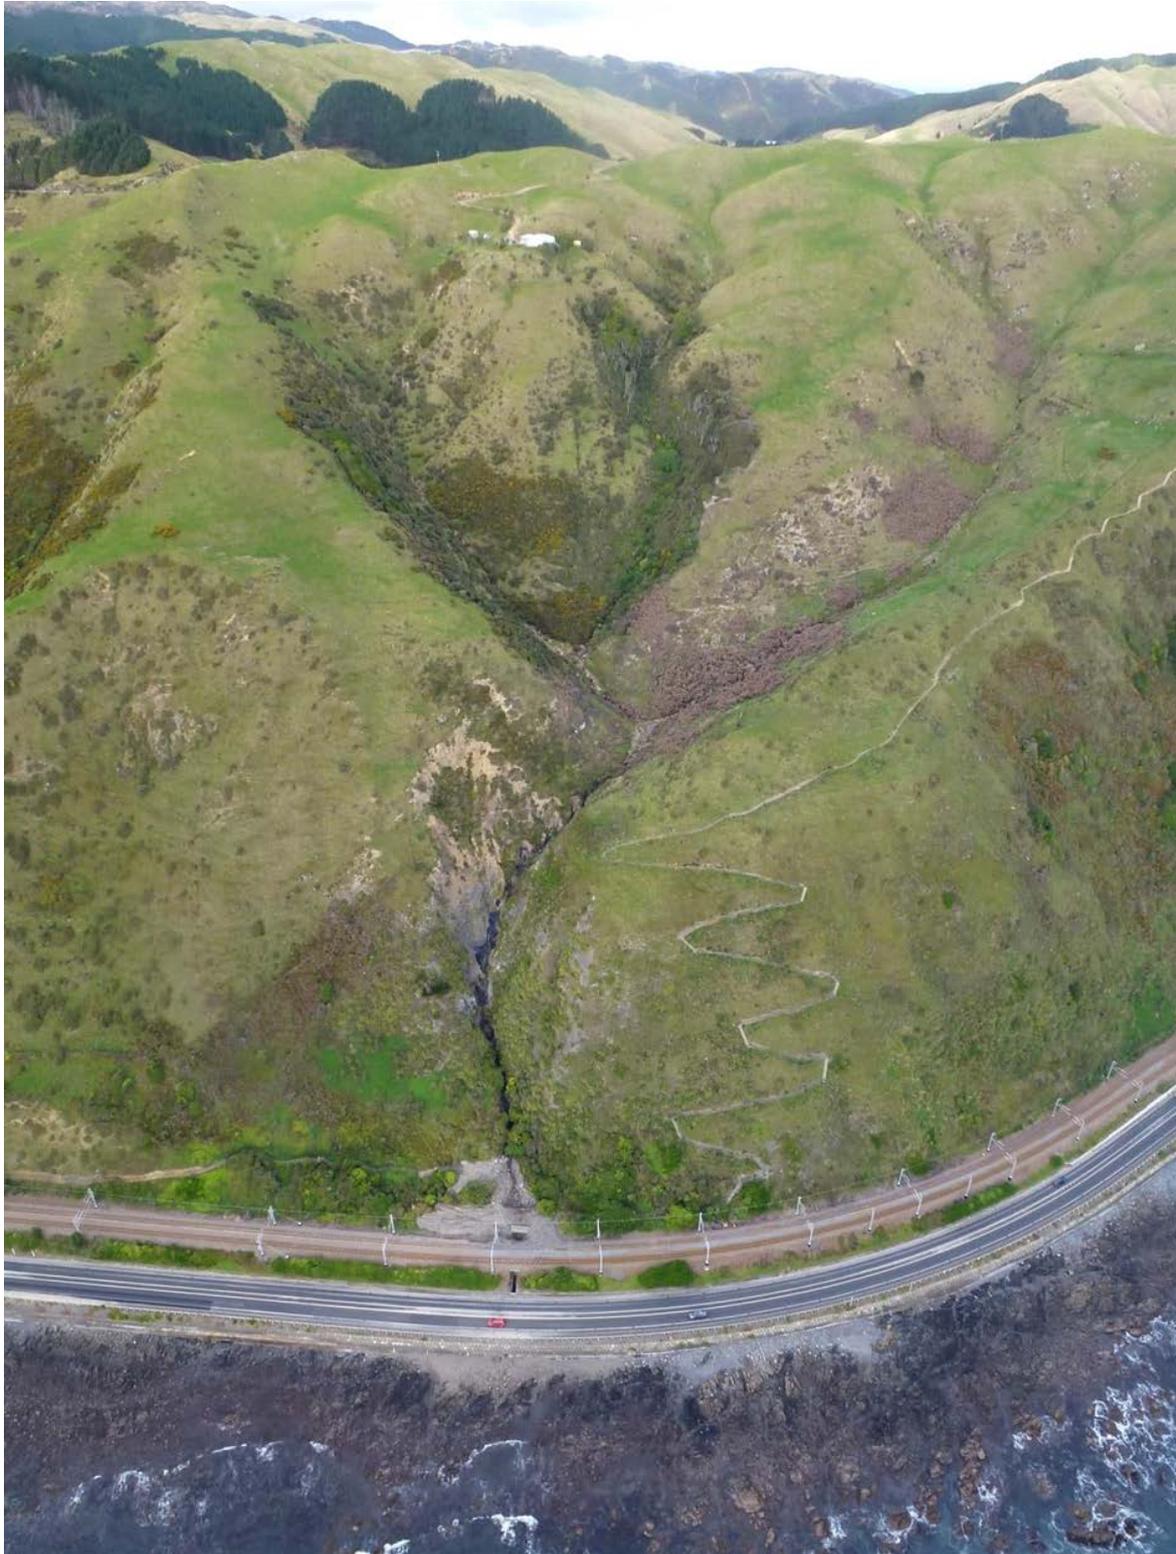
The two debris flood deposits that blocked the highway and railway were only small (~1000 m³), and were comprised of gravel, sand and silt. The catchments from which these deposits were derived were small and contained very few hill slope landslides (Figure 4.38). In fact very few landslides occurred along the escarpment above Centennial Highway during the 14 May 2015 storm (Figure 4.39 and Figure 4.40). Figure 4.41, Figure 4.42 and Figure 4.43 show examples of the landslides that did occur. The source of the material that blocked the highway was mainly in- and near-channel sediment that had built up/accumulated from hill slope sources over hundreds of years. This condition occurs in many catchments in the greywacke hills around Wellington. During the storm, water was observed flowing in swales/ephemeral channels high up in catchments, and cascading over bluffs above Centennial Highway. This concentration of water was sufficient to form the gullies that scoured this in-channel sediment. It was quite revealing that such a small amount of sediment could cause such disruption to road and rail. This highlights again the vulnerability of Wellington's major transport corridors, and the need for the alternative route along Transmission Gully.

Figure 4.38 Bartons Corner, 2.5 km south of Paekakariki. Site of the debris flood deposit that closed SH1 (see Figure 2.2). Note lack of fresh landslides, indicating the debris flood sediment that closed the road was largely derived from in- or near-channel sources, where the concentration of water was sufficient to incise into the sediments that have accumulated at these sites since the last glaciation. (GNS Photo: BR_P1140274).

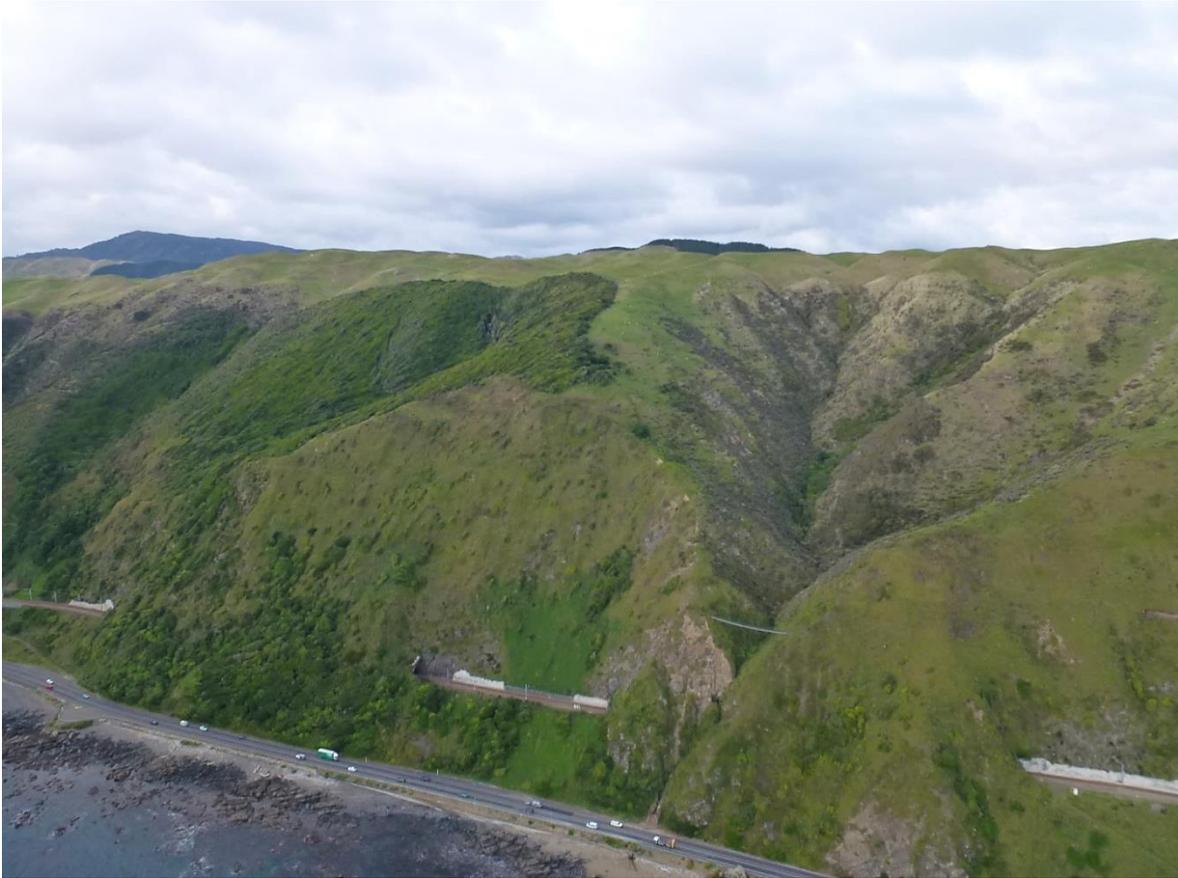
Figure 4.39 There was a general absence of landslides along the Pukerua Bay to Paekakariki coastal escarpment. (GNS Photo: BR_P1140283).
