Request for Information – Local Government Official Information and Meetings Act (LGOIMA) 1987

“...all information relating to slips, slip remediation and internal council correspondence relating to historical 2005 to the recent slips at 46 and 60 Holborn Drive or around that area facing the Eastern Hutt Road”

We have interpreted your request as applying to landslips occurring on or above Eastern Hutt Road, between the Stokes Valley roundabout and the intersection with High Street at Pomare. This covers properties at 46-92 Holborn Drive and 200-204 Eastern Hutt Road.

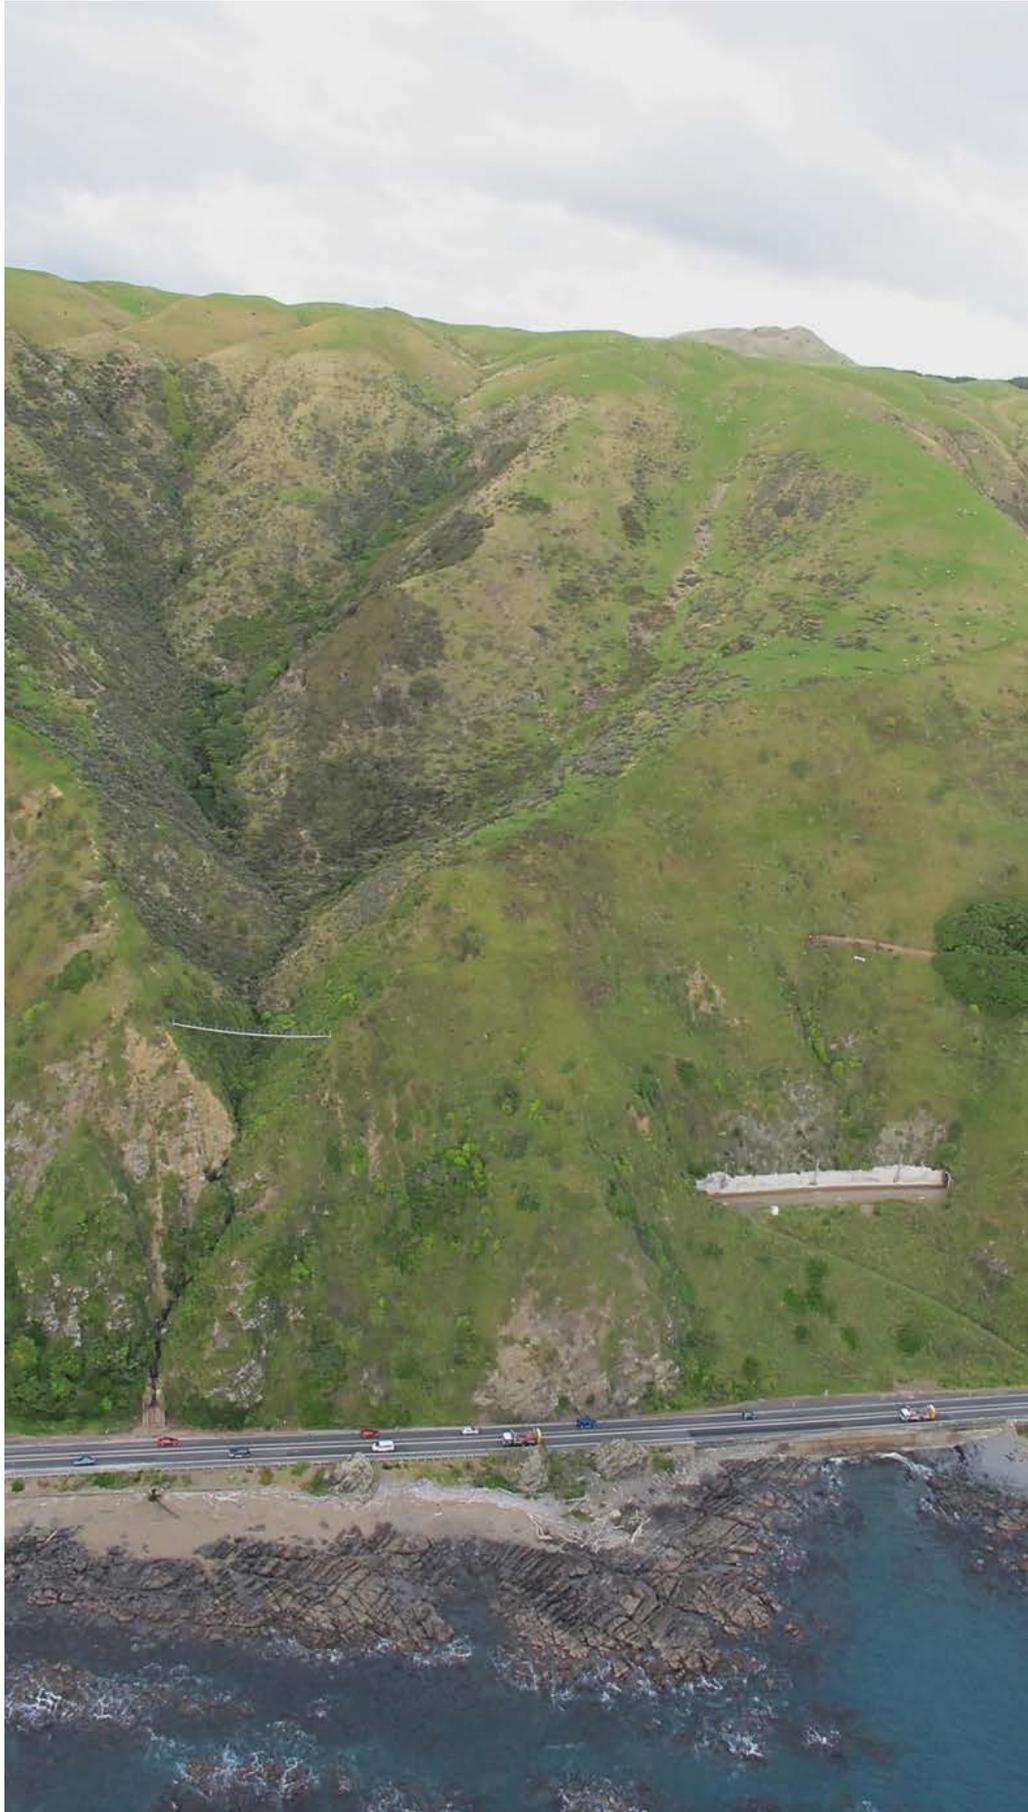
Figure 4.40 General absence of landslides along the Pukerua Bay to Paekakariki coastal escarpment. (GNS Photo: MP_6384).

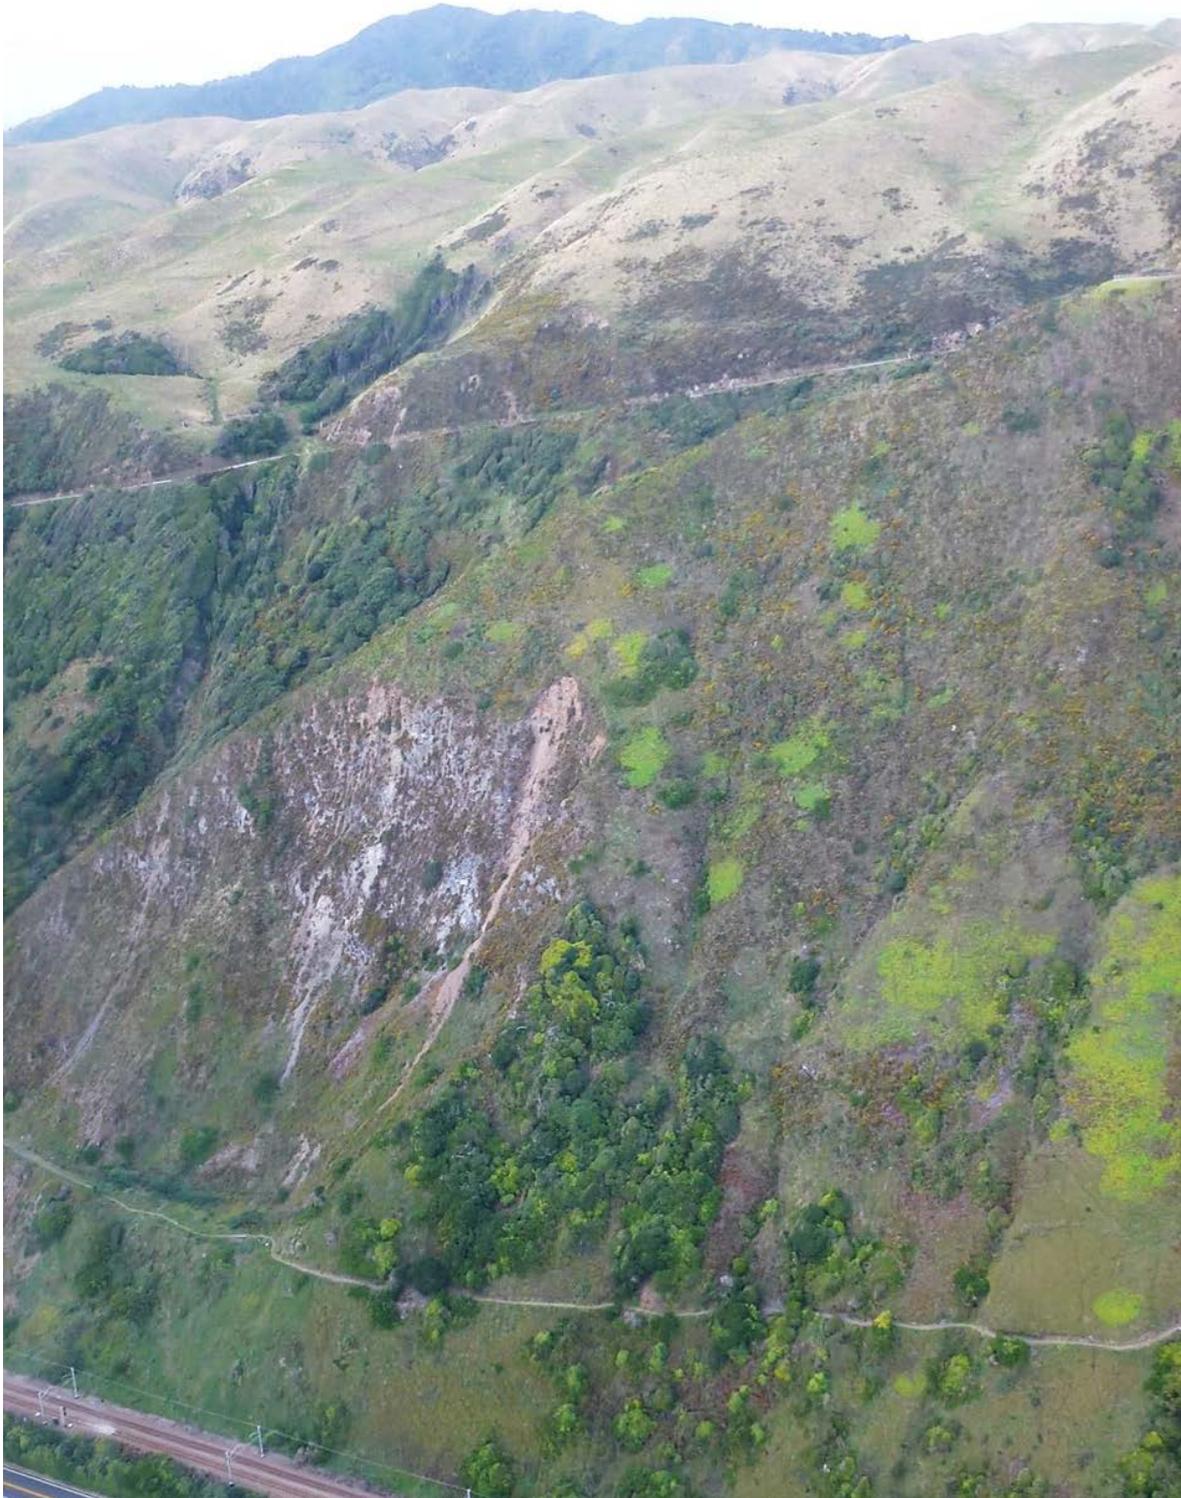
Figure 4.41 Landslide at head of former quarry ~1 km south of Paekakariki. Centennial Highway and North Island Main Trunk Railway (foreground) and Paekakariki Hill Road (background). (GNS Photo: BR_P1140272).

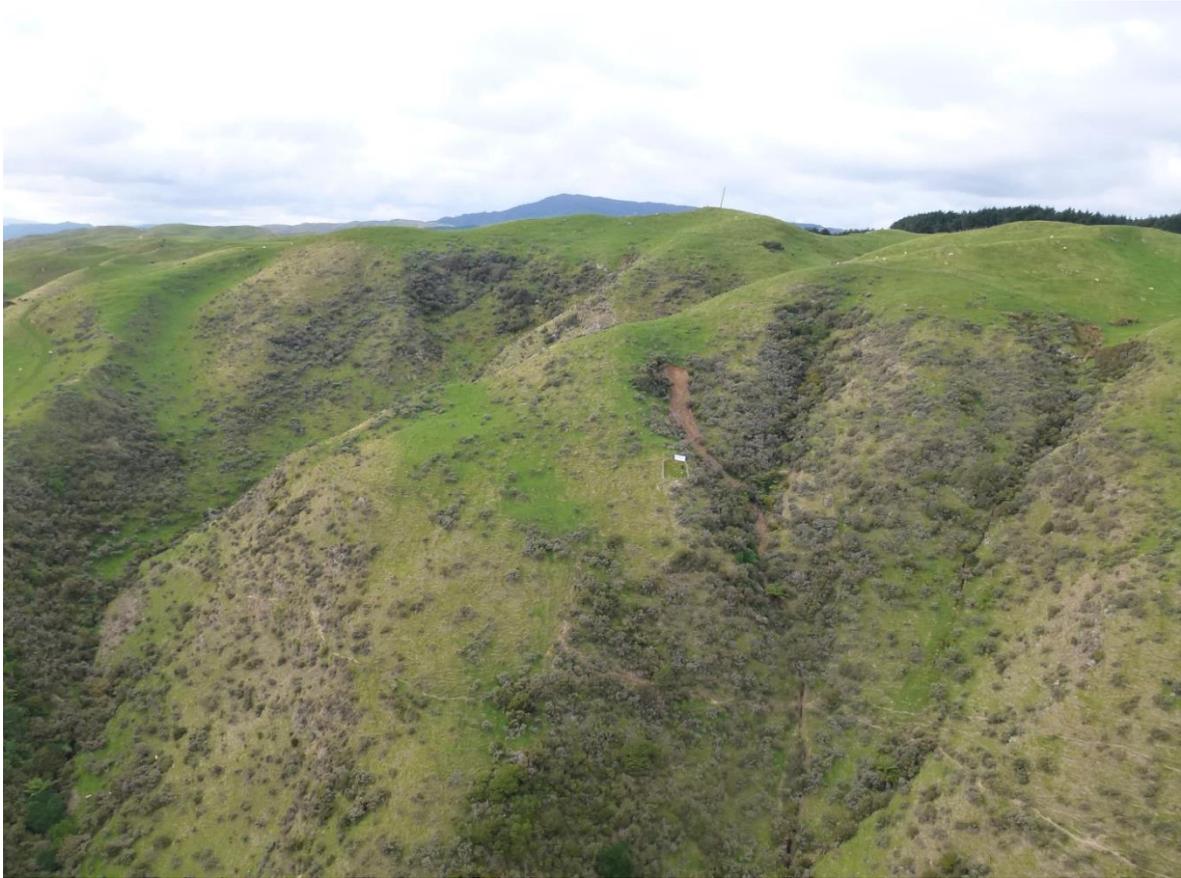
Figure 4.42 Single landslide in catchment above Centennial Highway, just north of Pukerua Bay. Note memorial at crash site, to three NZ Air Force helicopter crew, killed on ANZAC Day 2010. (GNS Photo: BR_P1140301).

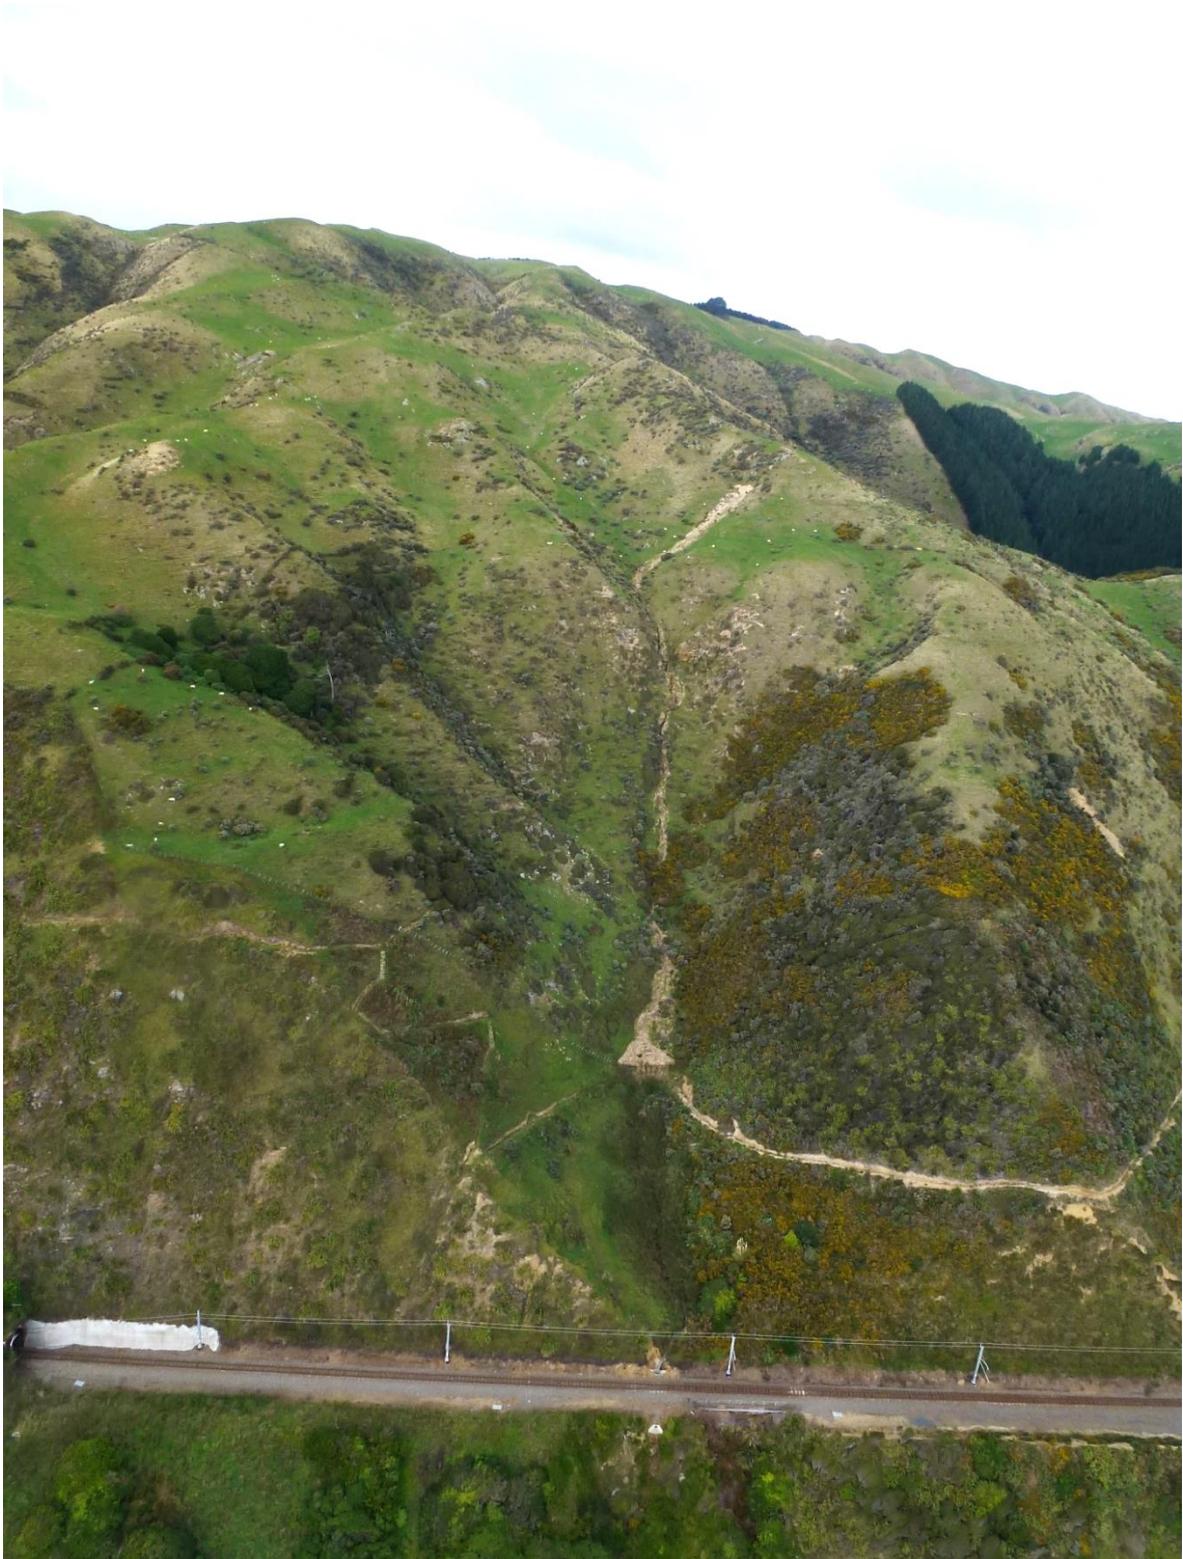
Figure 4.43 NIMTL, 1 km north of Pukerua Bay. Landslide debris has accumulated directly above the walking track, possibly caused by constriction of the channel by a culvert under the track. (GNS Photo: BR_P1140297).

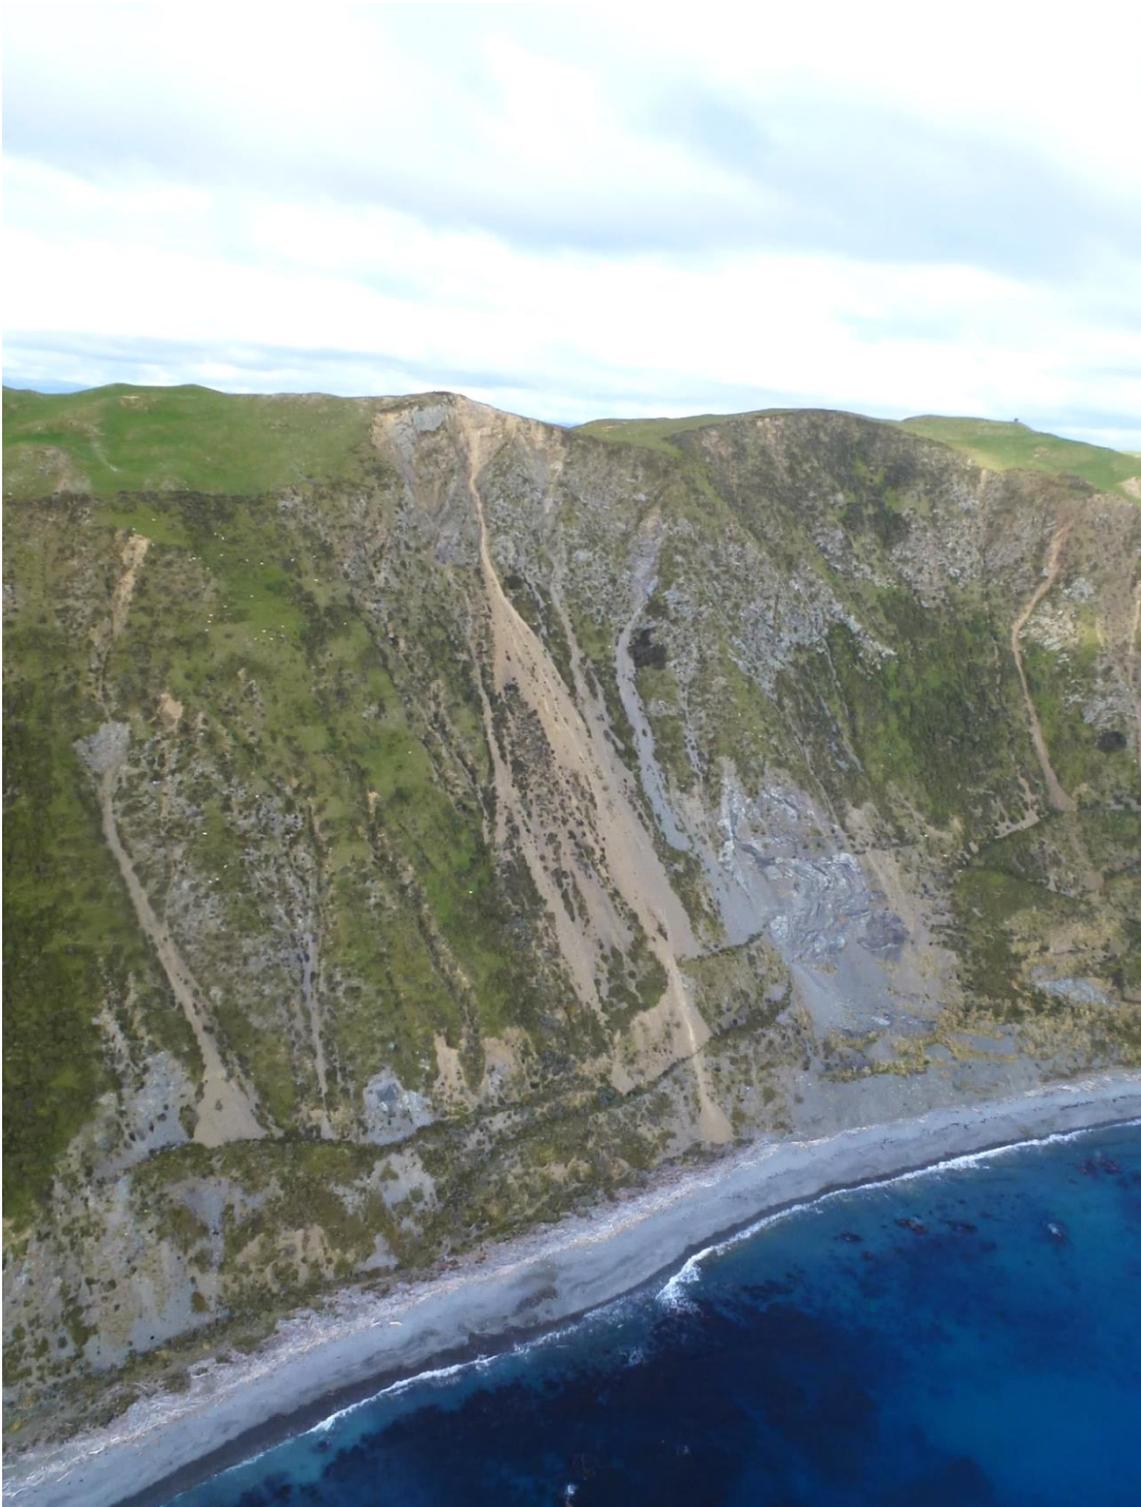
There are significant pre-existing areas of scree, gullies and debris avalanches along the coastal cliffs between Pukerua Bay and Plimmerton, especially just north of the quarry at the end of Hongoeka Bay Road. In the May 2015 storm a few of these features were enlarged or reactivated (Figure 4.44, Figure 4.45 and Figure 4.46).

Figure 4.44 Coastal cliffs between Pukerua Bay and Plimmerton. Several pre-existing landslides and screens show minor increase in area and/or activity. (GNS Photo: BR_P1140325).

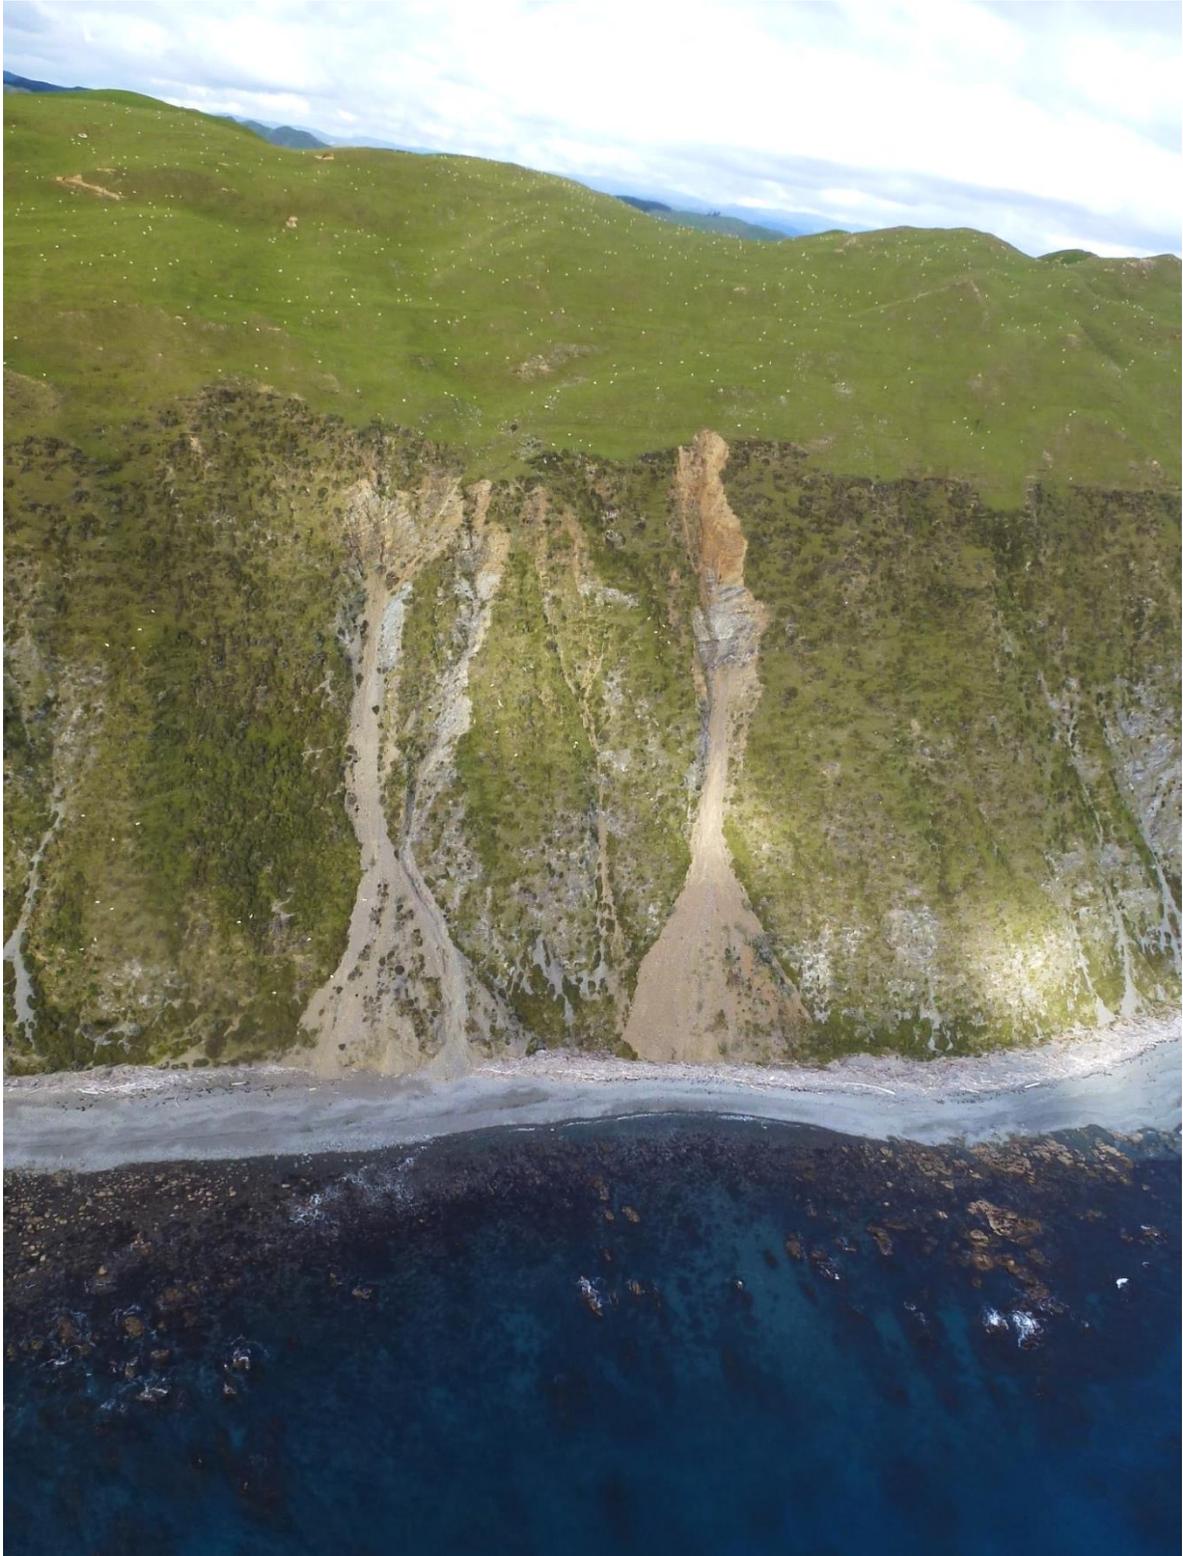
Figure 4.45 Coastal cliffs between Pukerua Bay and Plimmerton. These landslides (strictly rock avalanches) are pre-existing features that have not significantly increased in area during the 2015 storm, but may have shown minor increase in activity. (GNS Photo: BR_P1140321).

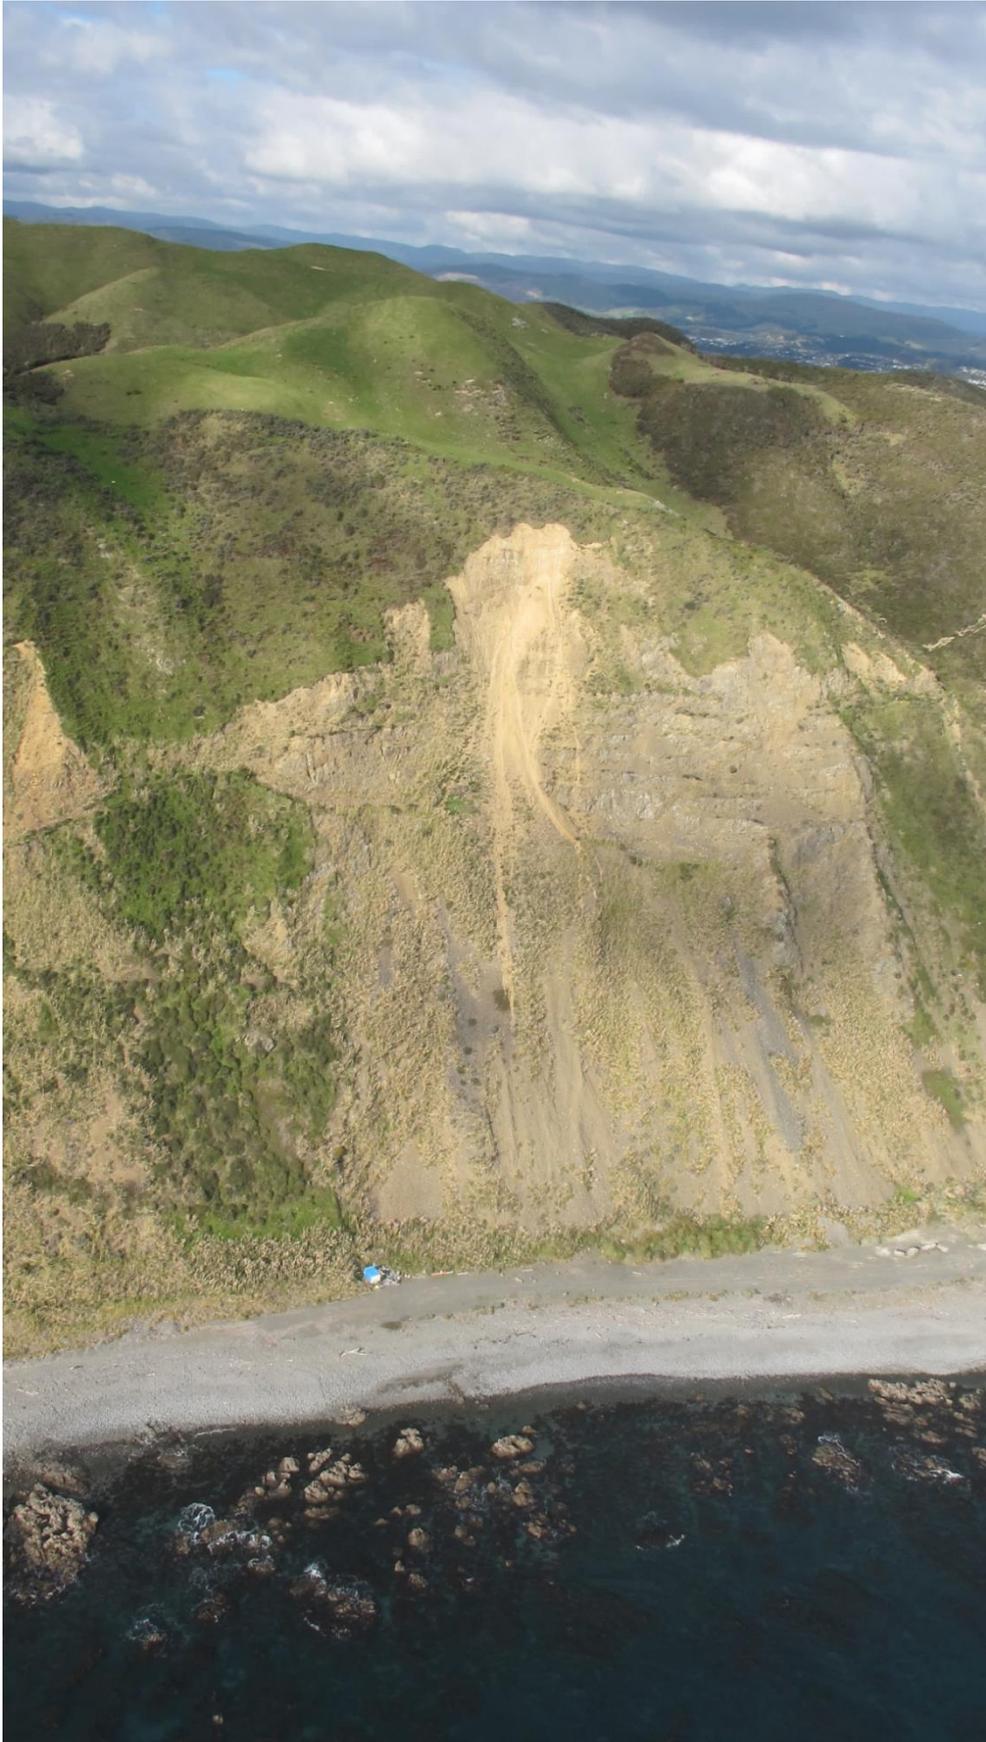
Figure 4.46 Coastal cliffs between Pukerua Bay and Plimmerton. The landslide (bare area in centre of photo) shows some activity (small debris run outs). (GNS Photo: MP_6405).

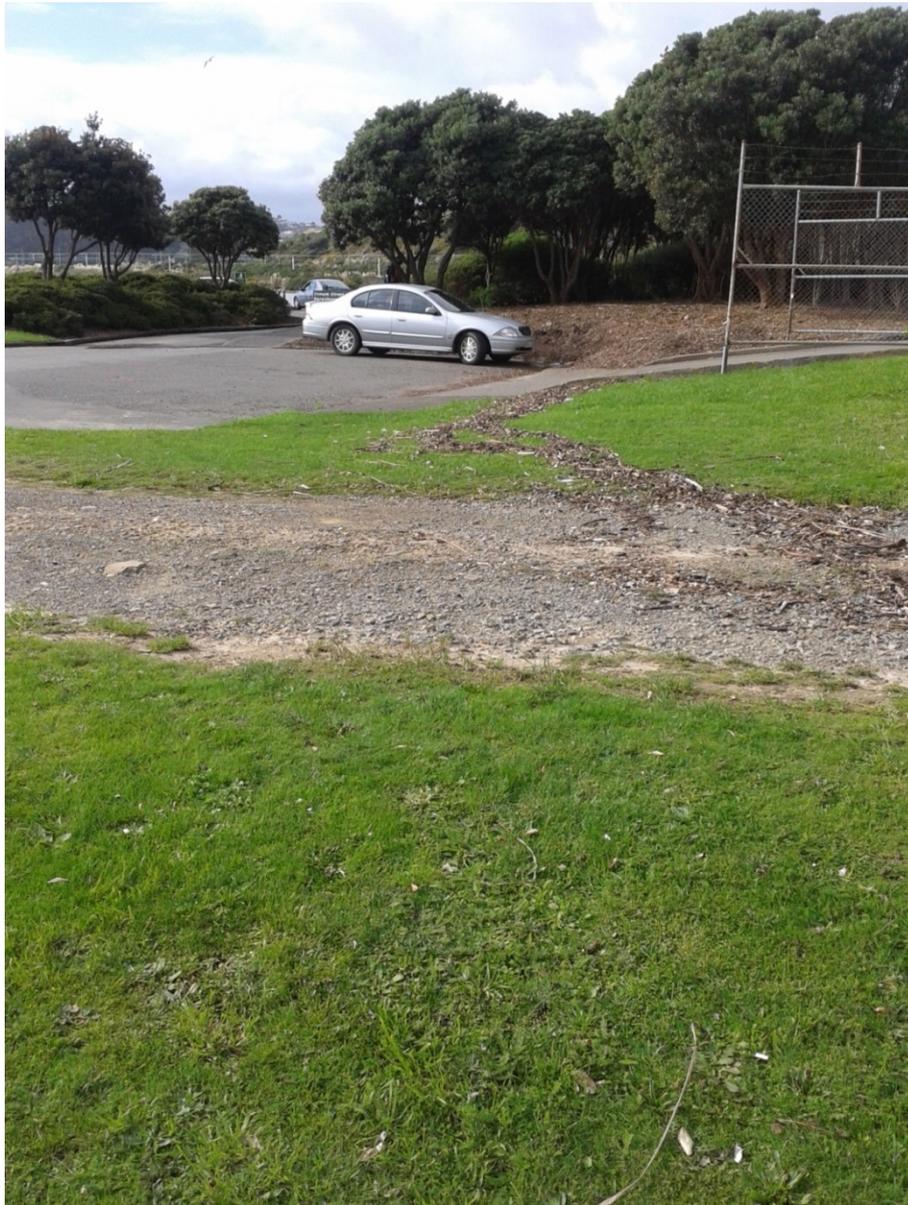
Figure 4.47 Flood debris from streams draining Colonial Knob, Porirua. Following blockage of stream culverts, the secondary flow path was through the car park off Wi Neera Drive where the flood debris line can be seen about 1.5 m above road level. The outlet to the Porirua Harbour is behind the car, only 100 m away. (Photo: Dave Peacock).

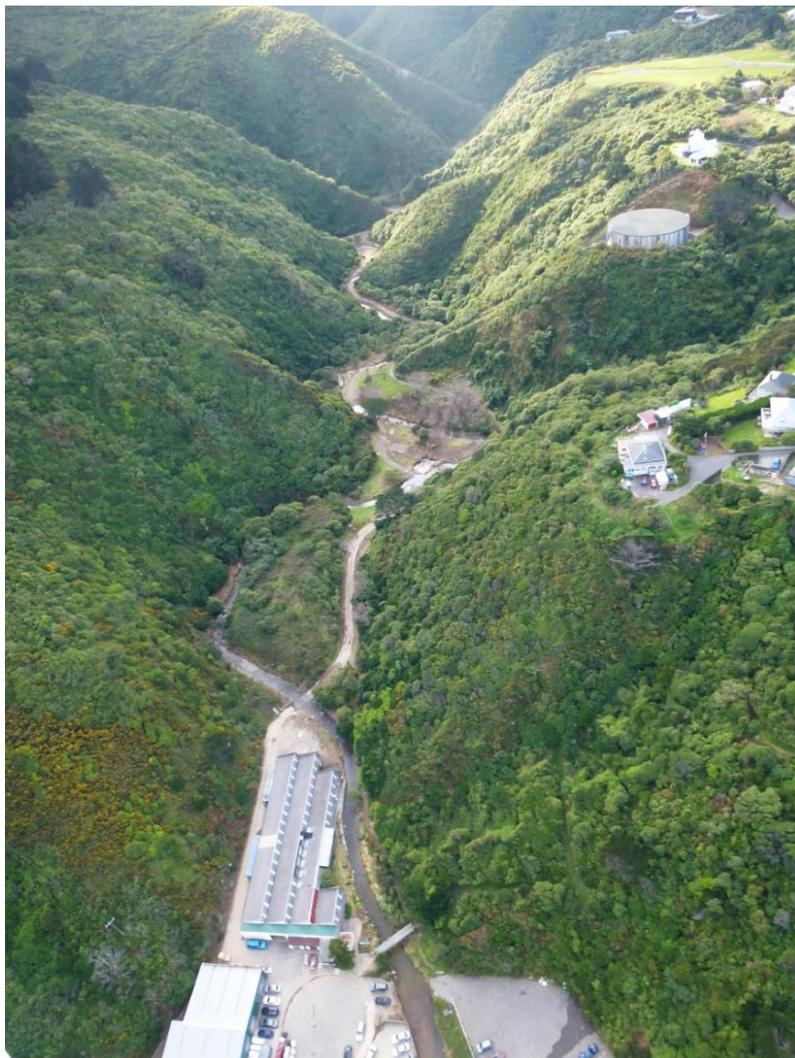
Figure 4.48 Light industrial buildings on the fan at the outlet of the Korokoro Stream. The stream meanders between alluvial terraces which were the source of most of the sediment that was deposited on the fan. Note the bridge across the stream, just upstream of the large industrial building, has collapsed. (GNS Photo: BR_P1140440).

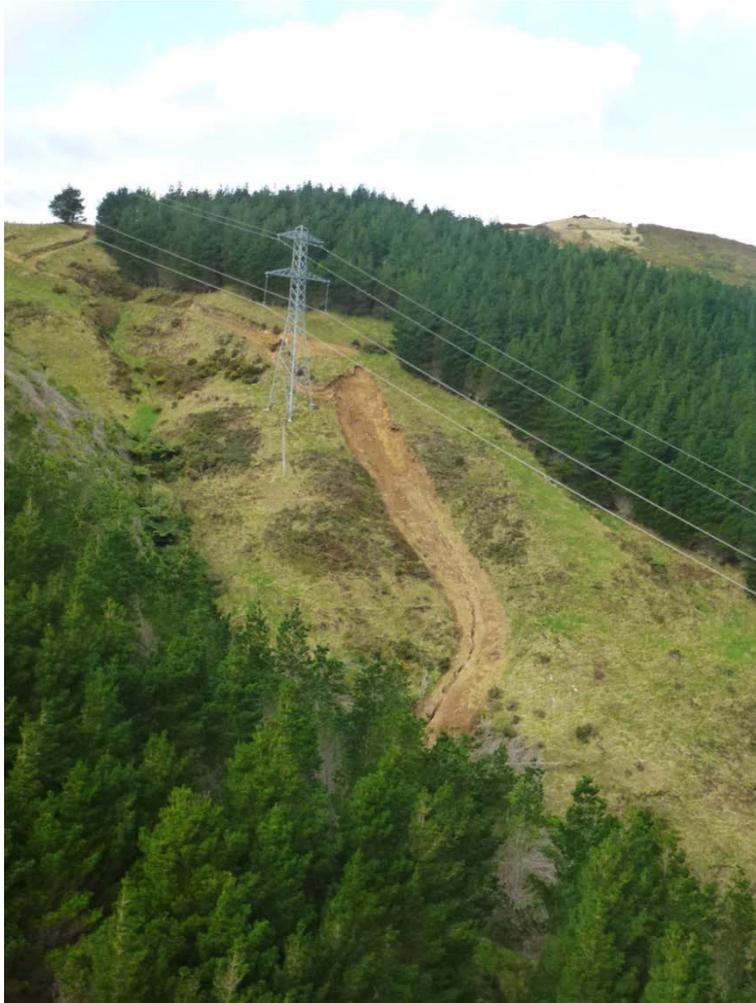
Figure 4.49 One of the few landslides in the Korokoro catchment, all of which were near the head of the catchment, and in pasture. (GNS Photo: BR_P1140464).

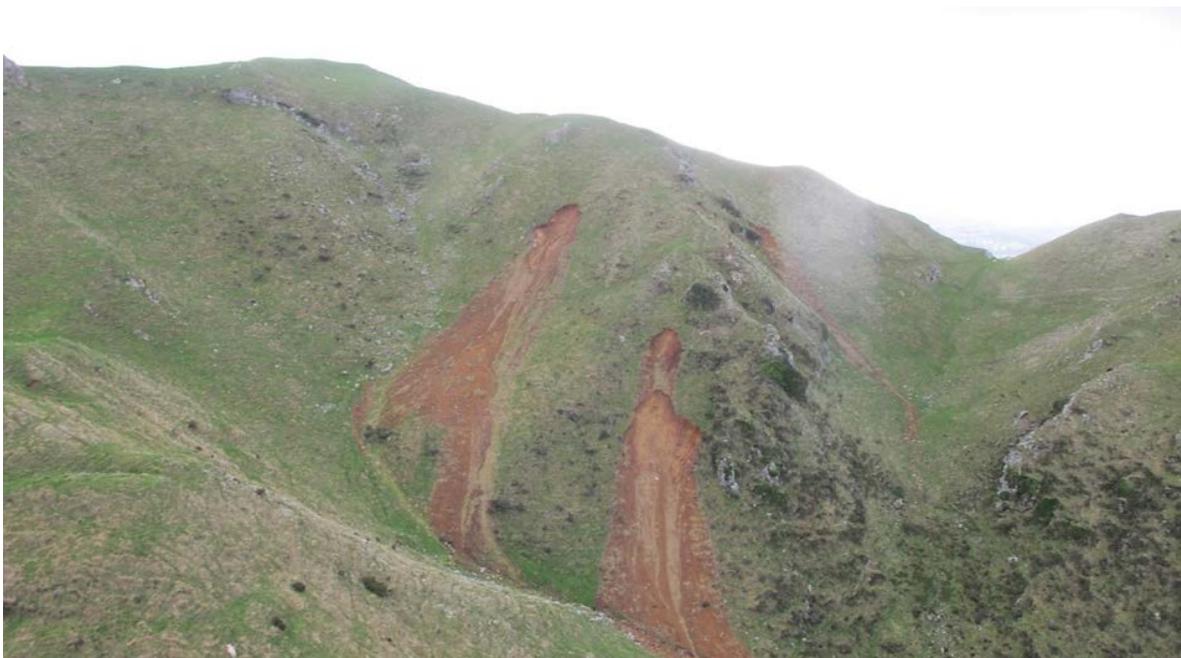
Figure 4.50 Landslides at head of Korokoro Stream near Cannons Head Trig. (GNS Photo: MP_6433).

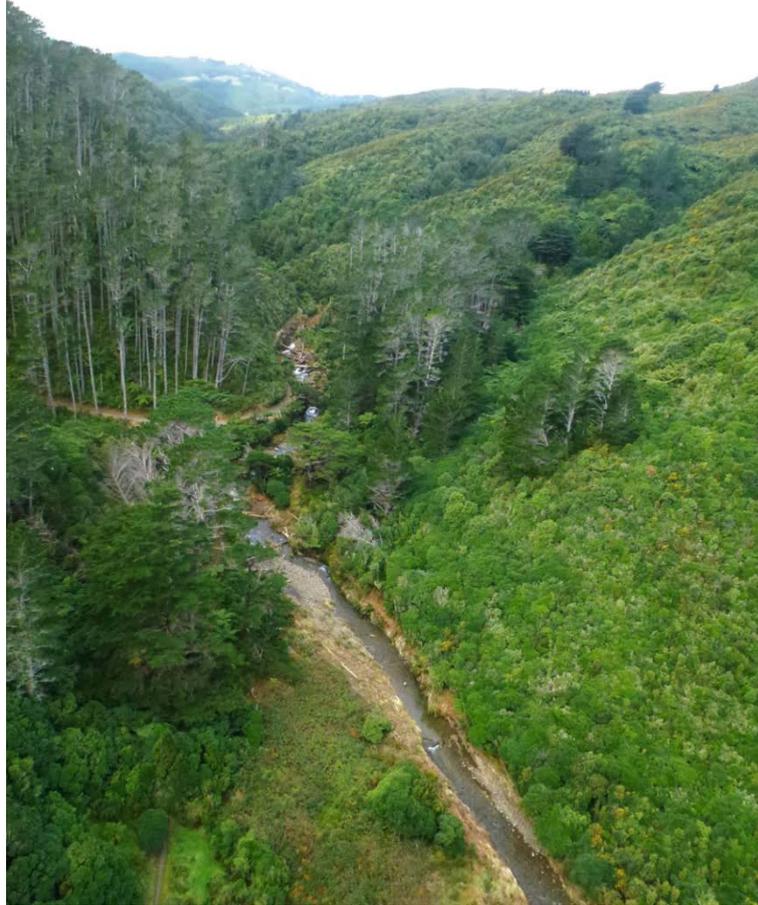
Figure 4.51 Pine plantation, ~2 km upstream of the Korokoro Stream fan. Some wind-throw occurred in 2013, and logs can be seen in several places along the channel. (GNS Photo: BR_P1140455).

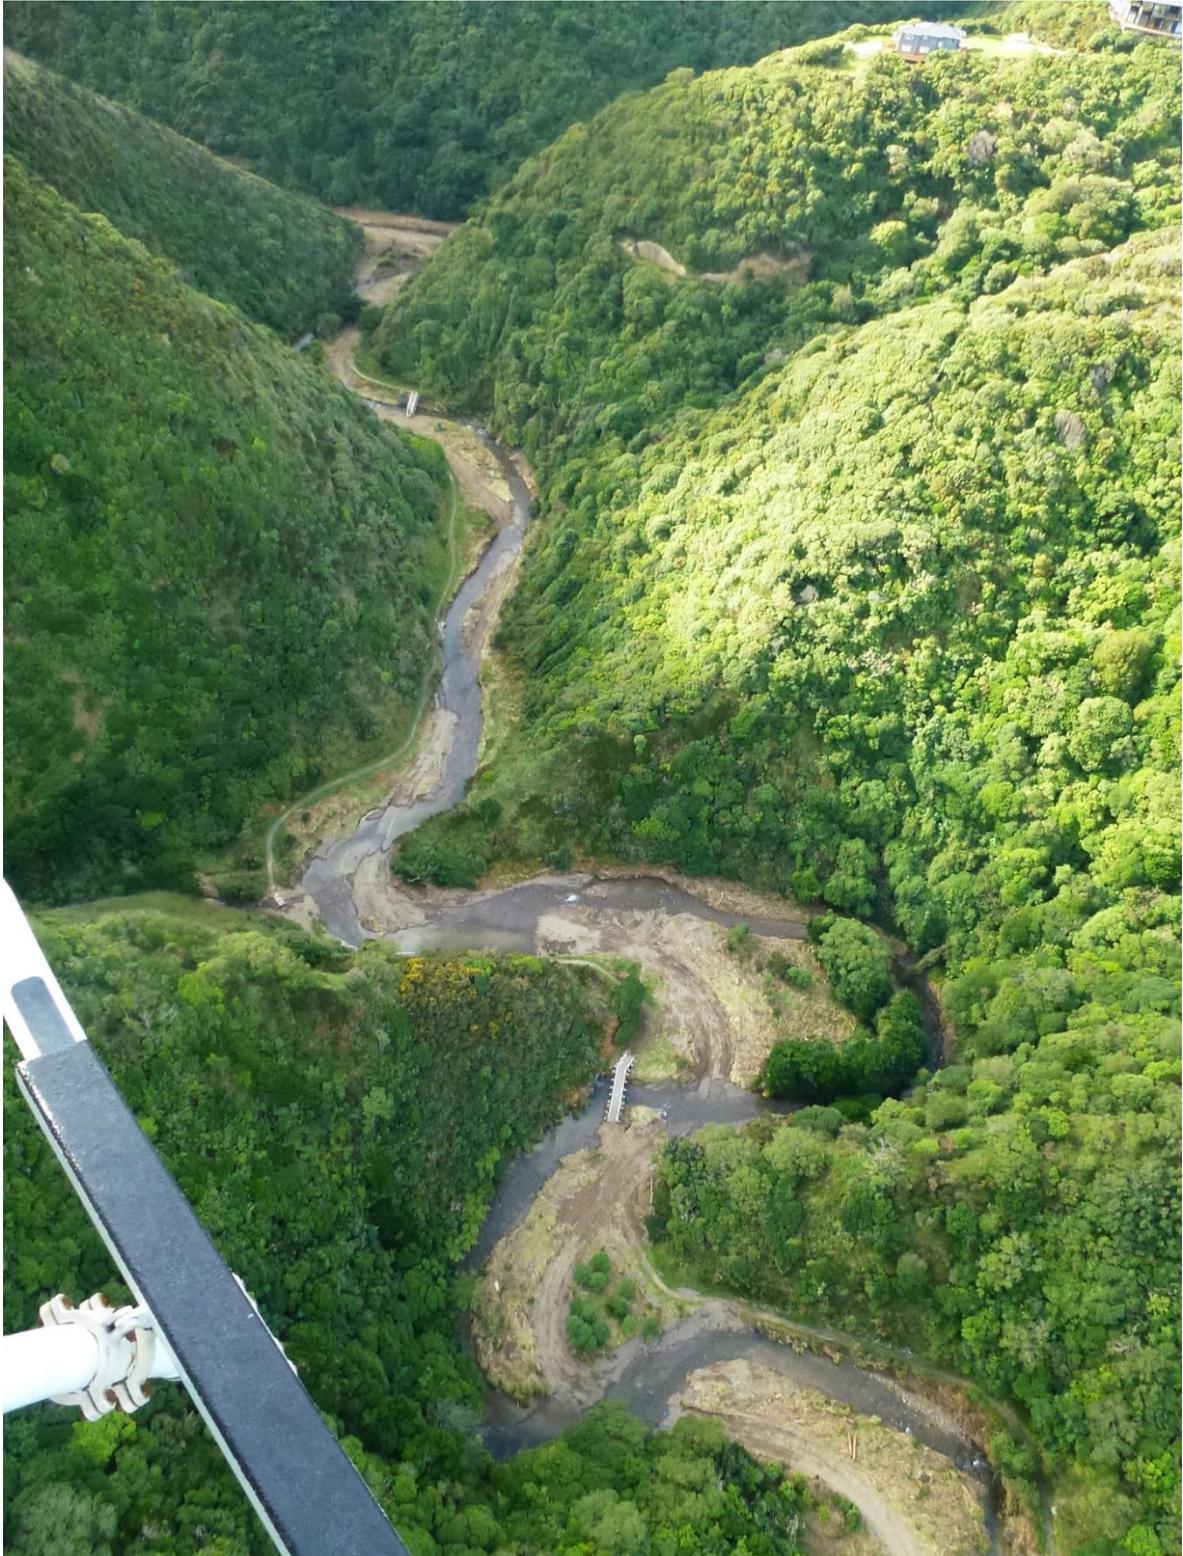
Figure 4.56 Terraces of the Korokoro Stream, 500 m upstream of the fan. Deposition of sediment, and streambank erosion are common in this reach of the stream. (GNS Photo: BR_P1140444).

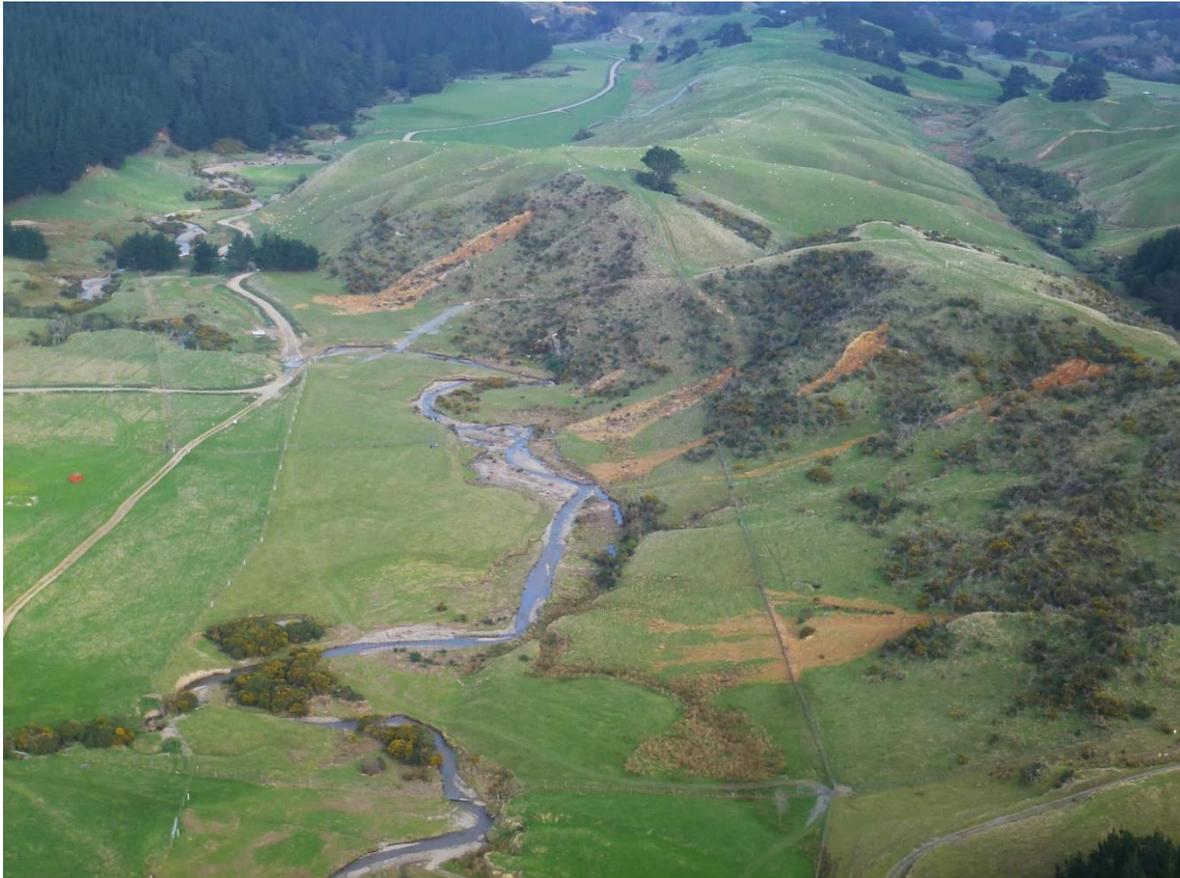
Figure 4.57 Landslides on undifferentiated, weathered gravels and silts. Looking south towards Battle Hill. (GNS Photo: BR_P1140502).

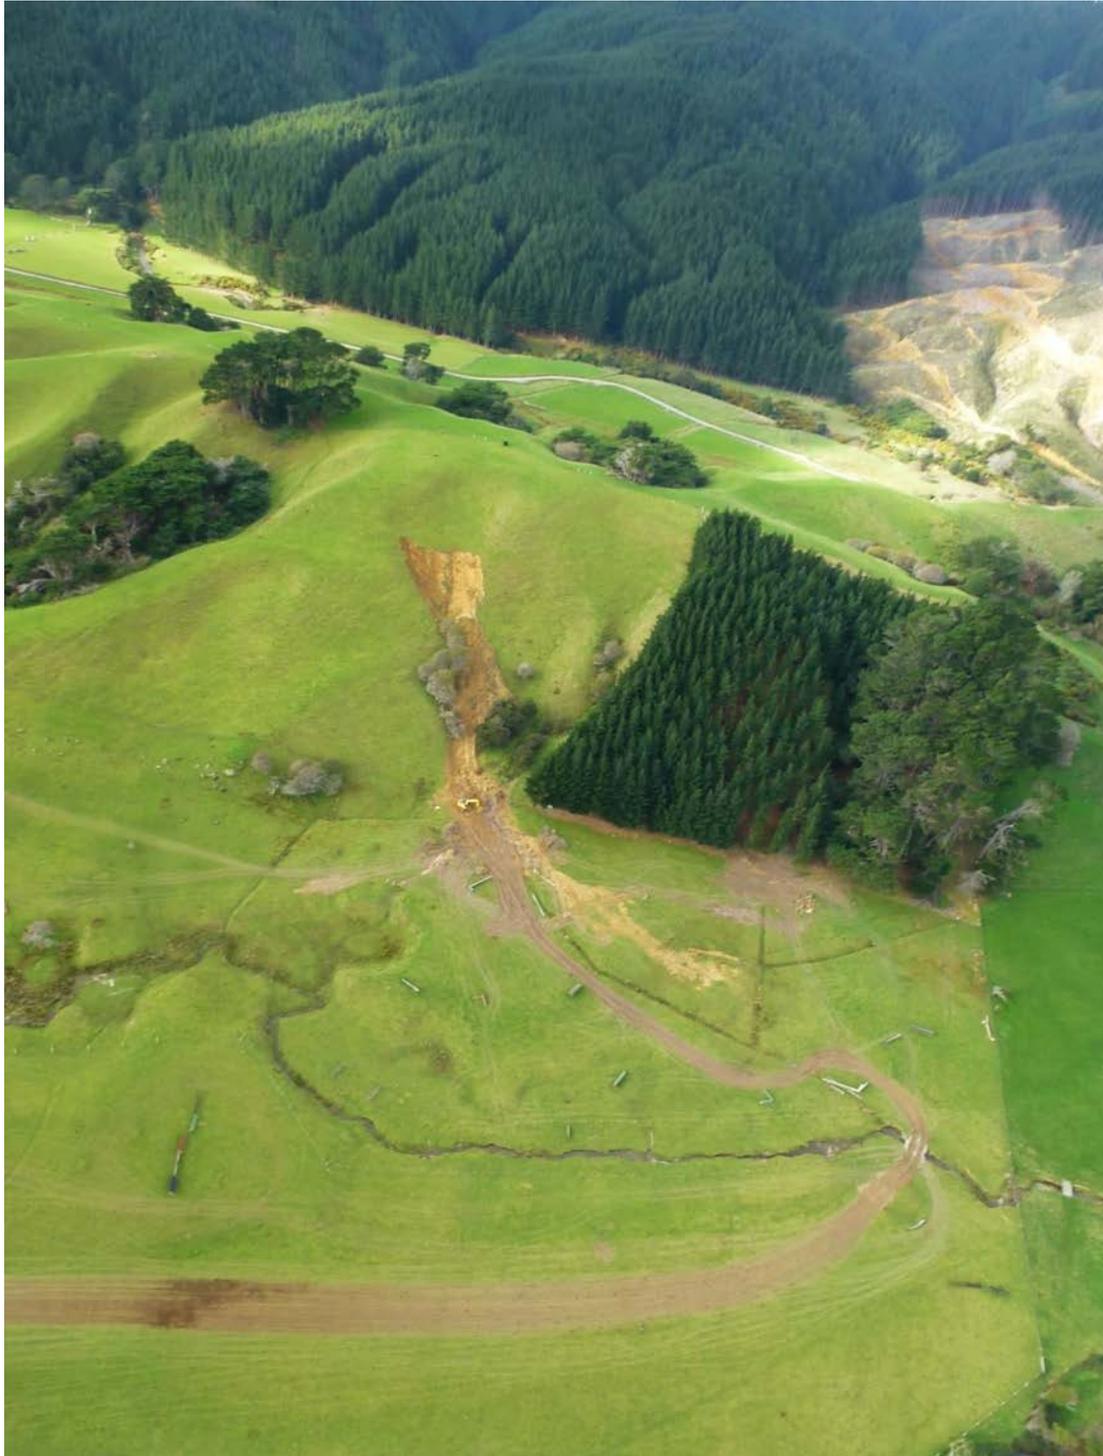
Figure 4.58 Battle Hill Farm Forest Park. Landslide on easy hill slope underlain by undifferentiated, weathered Pleistocene fan and alluvial gravels and lacustrine silts (eQa) mantled with loess. (GNS Photo: BR_P1140391).

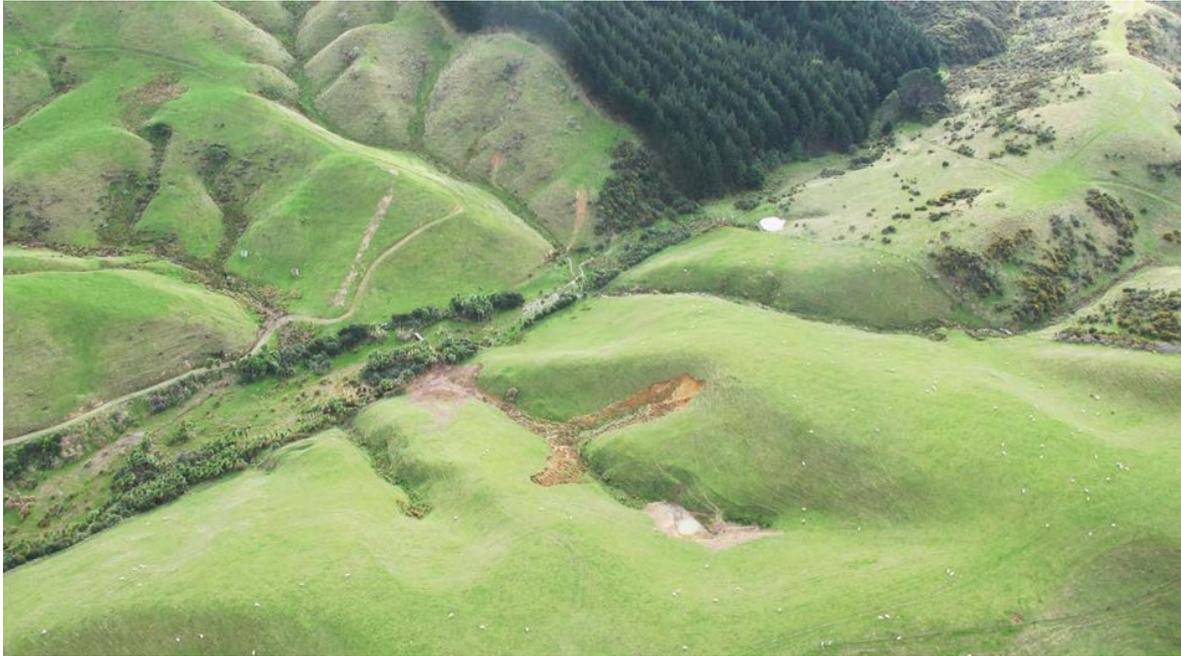
Figure 4.59 Landslides on undifferentiated, weathered gravels and silts (foreground), and on greywacke (background). (GNS Photo: MP_6442).
