Request for Information – Local Government Official Information and Meetings Act (LGOIMA) 1987

“...all information relating to slips, slip remediation and internal council correspondence relating to historical 2005 to the recent slips at 46 and 60 Holborn Drive or around that area facing the Eastern Hutt Road”

We have interpreted your request as applying to landslips occurring on or above Eastern Hutt Road, between the Stokes Valley roundabout and the intersection with High Street at Pomare. This covers properties at 46-92 Holborn Drive and 200-204 Eastern Hutt Road.

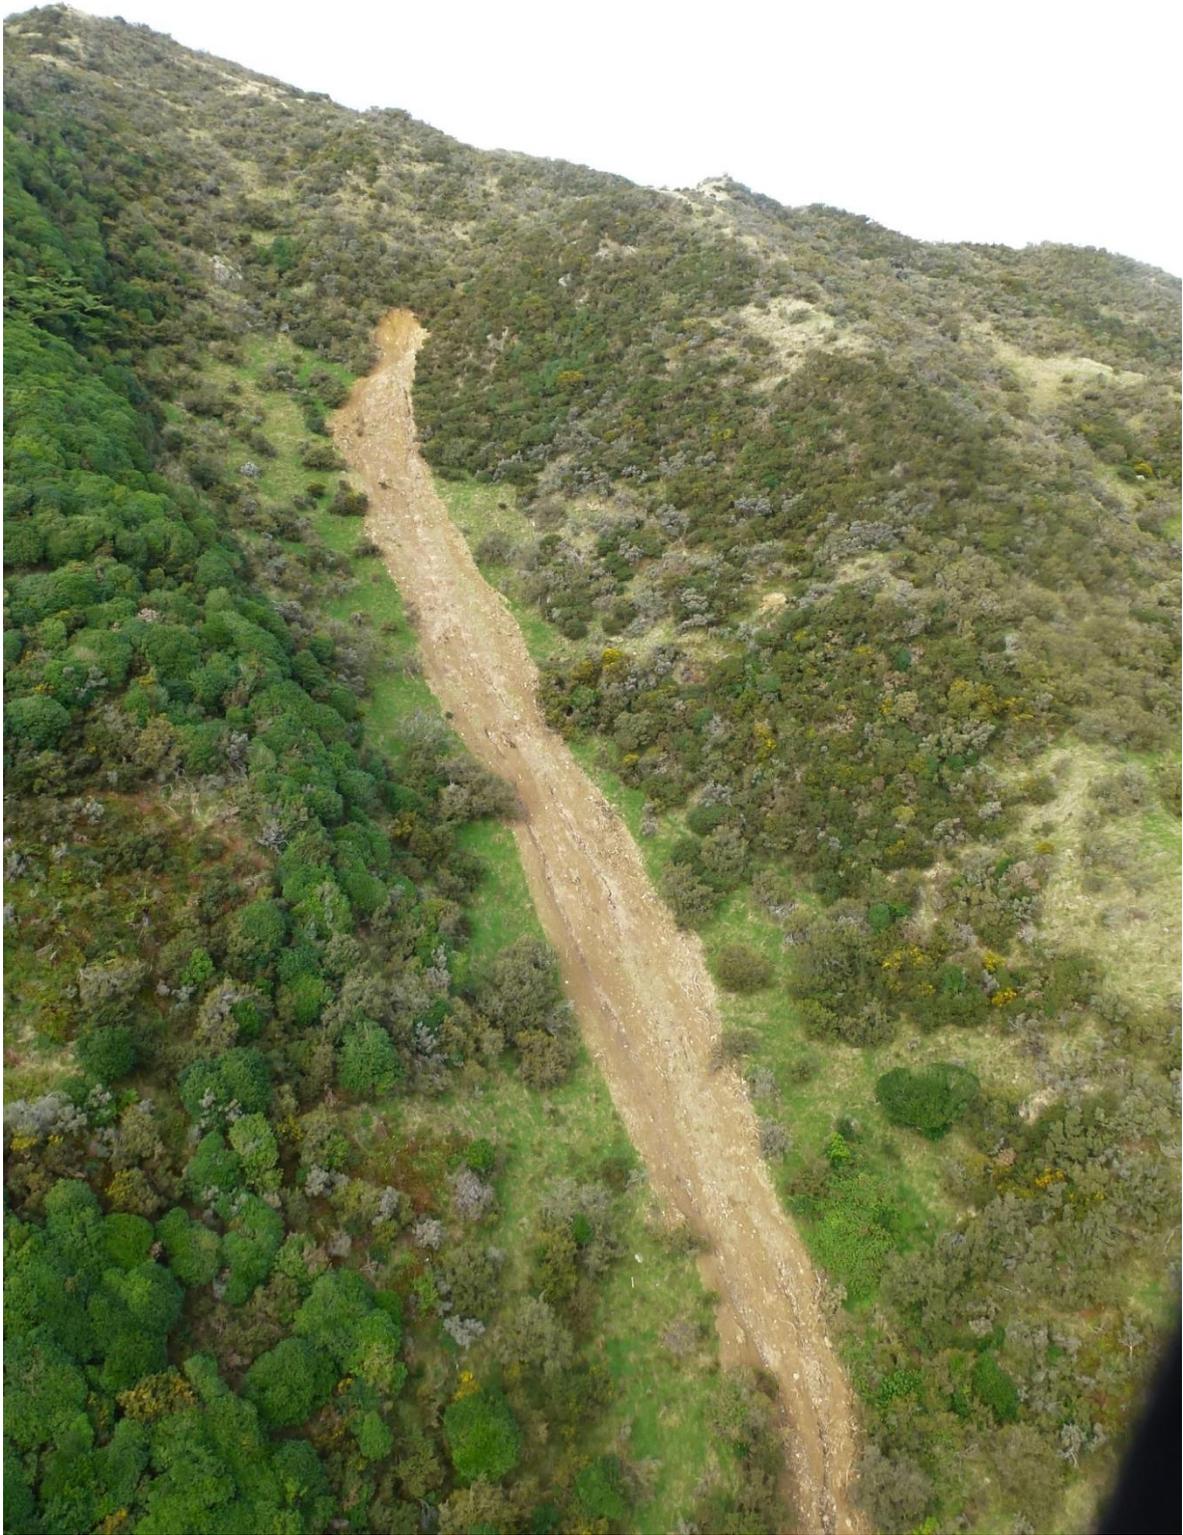
Figure 4.61 Debris avalanche on eastern slopes of Transmission Gully. (GNS Photo: BR_P1140511).

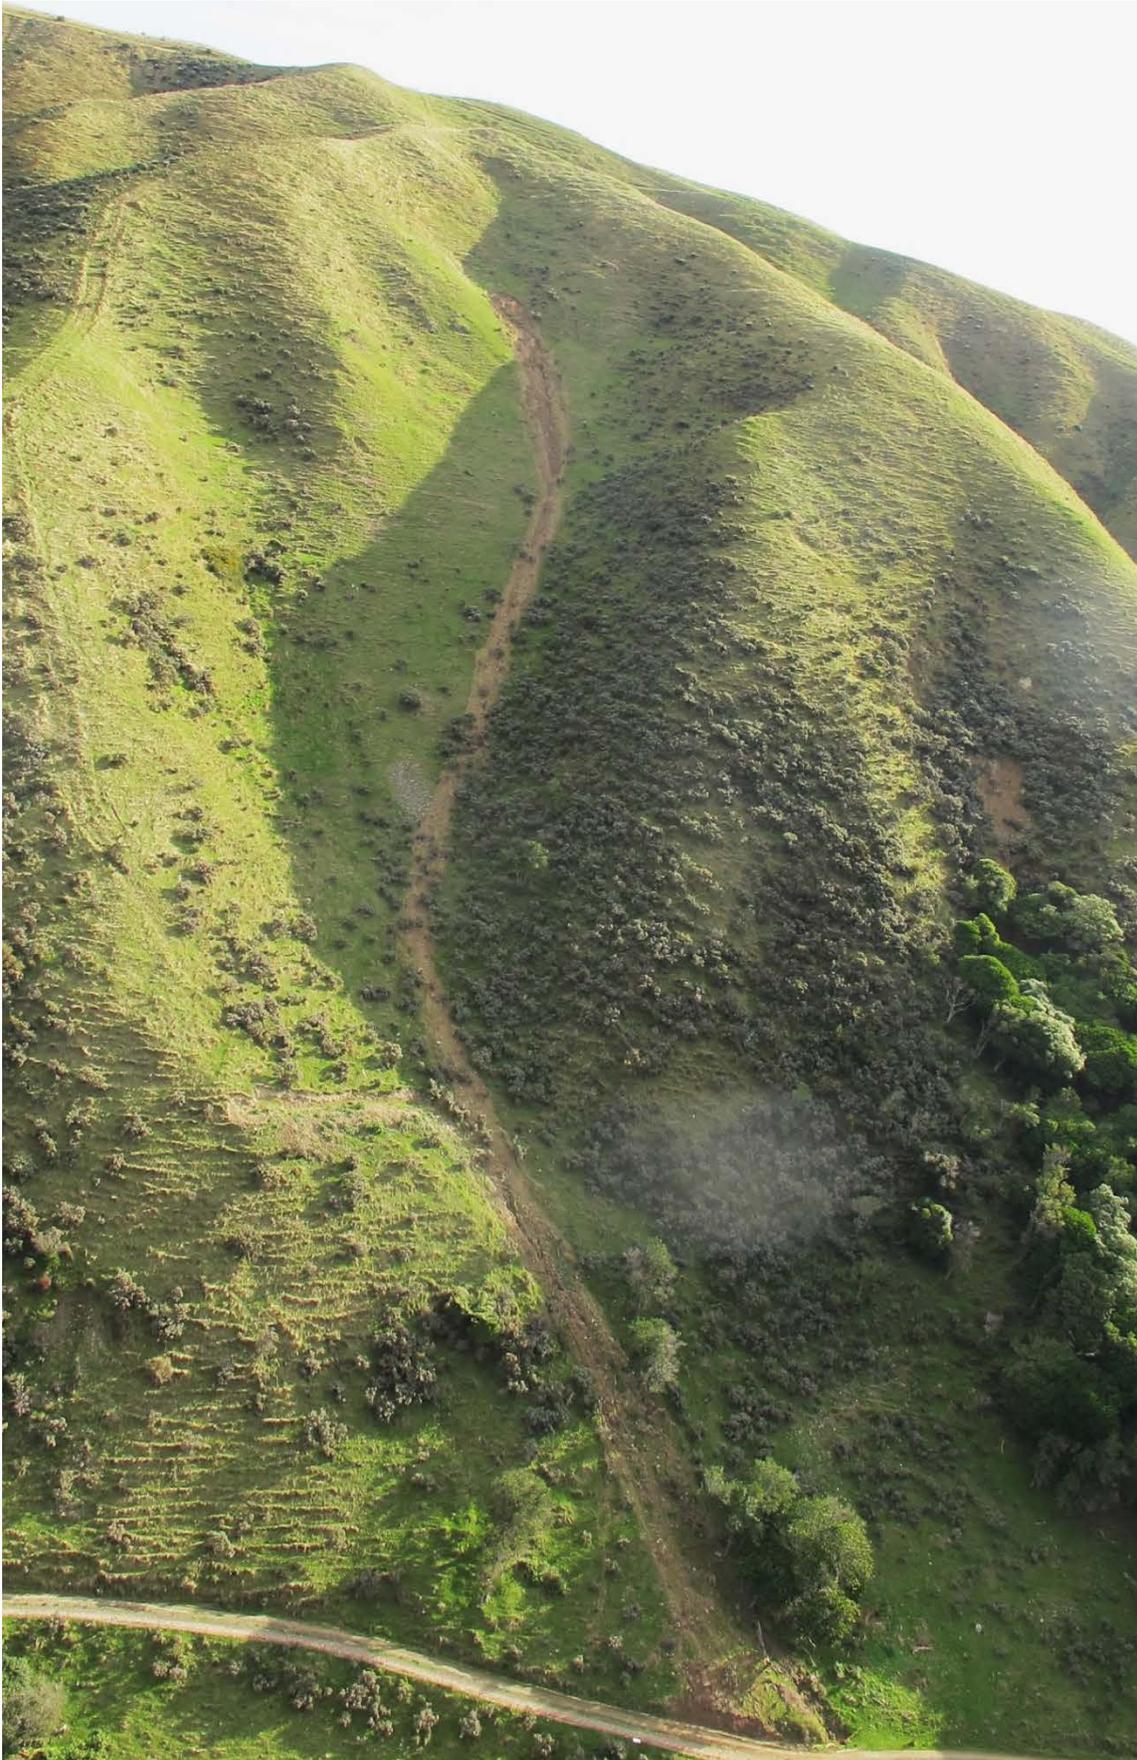
Figure 4.62 Debris avalanche on western slopes of Transmission Gully. (GNS Photo: MP_6461).

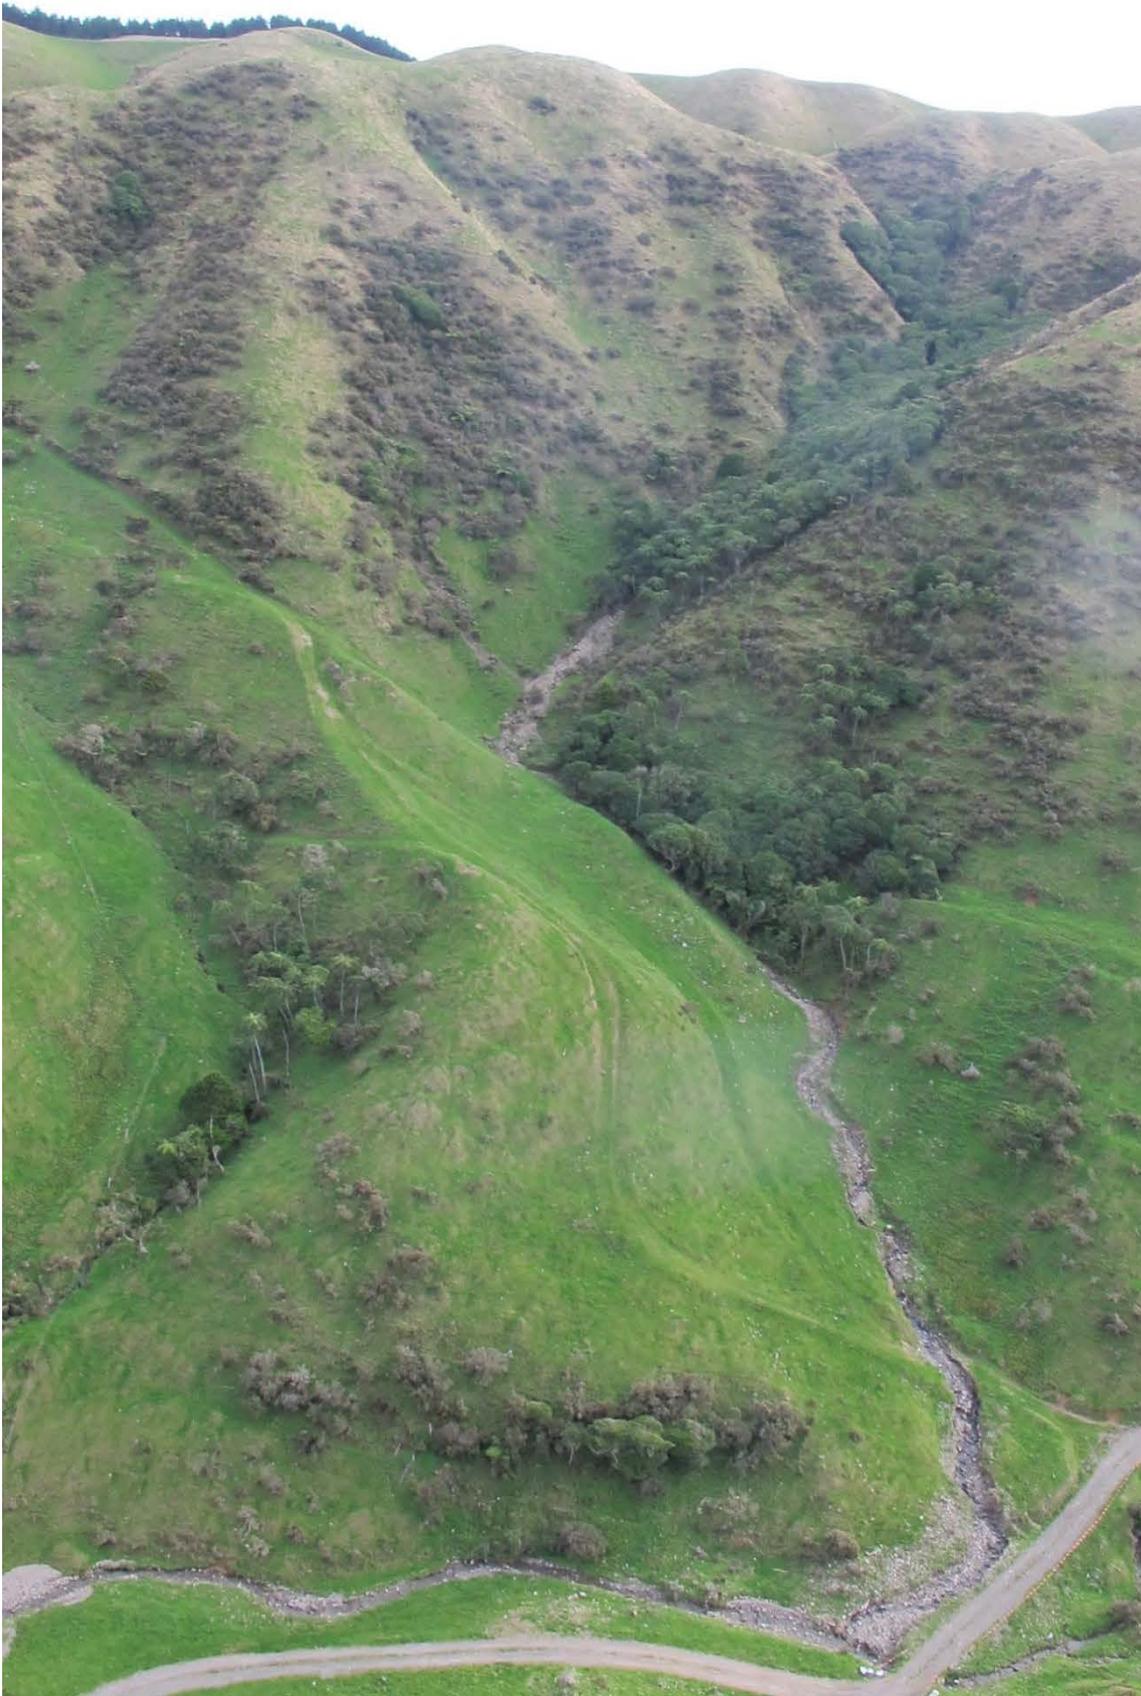
Figure 4.63 Sediment derived largely from in-channel sources. Western slopes of Transmission Gully. (GNS Photo: MP_6455).
