Request for Information – Local Government Official Information and Meetings Act (LGOIMA) 1987

Re: Hardwick Smith Lounge – Property Condition Report

Objective:

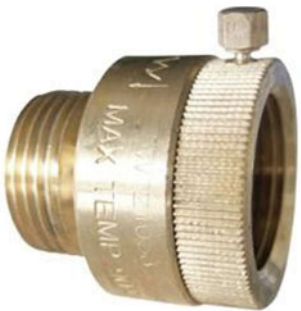
Debris entering gully trap (Right Image). It is assumed this is the main water feed to the premises. It would be advisable to have a 'vacuum break' (brass image directly left) fitting attached to this hose tap to prevent backflow into the facilities.
