Te Rangihaeata / Manor Park Development

Geotechnical Assessment Report

Prepared for
Rosco Ice Cream Ltd

Prepared by
Tonkin & Taylor Ltd

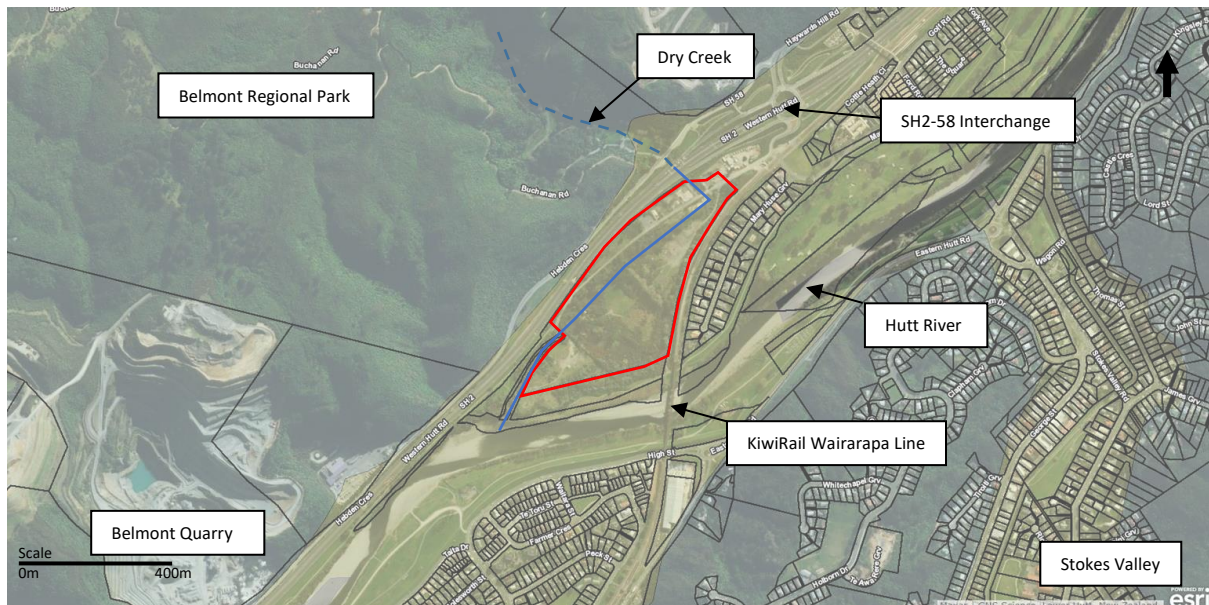
Figure 1.1: Plan of the proposed development site of Te Rangihaeata / Manor Park (highlighted red) located within the Hutt Valley flood plain between greywacke hills to the west and the Hutt River to the east.

Te Rangihaeata / Manor Park is located within the northeast-trending Hutt Valley flood plain and immediately between hills of Belmont Regional Park to the west, and KiwiRail's Wairarapa Line and the Hutt River to the east (refer Figure 1.1). At the base of the hills a steep linear escarpment (inferred to be the result of ongoing movement along the Wellington Fault) and State Highway 2 (SH2).

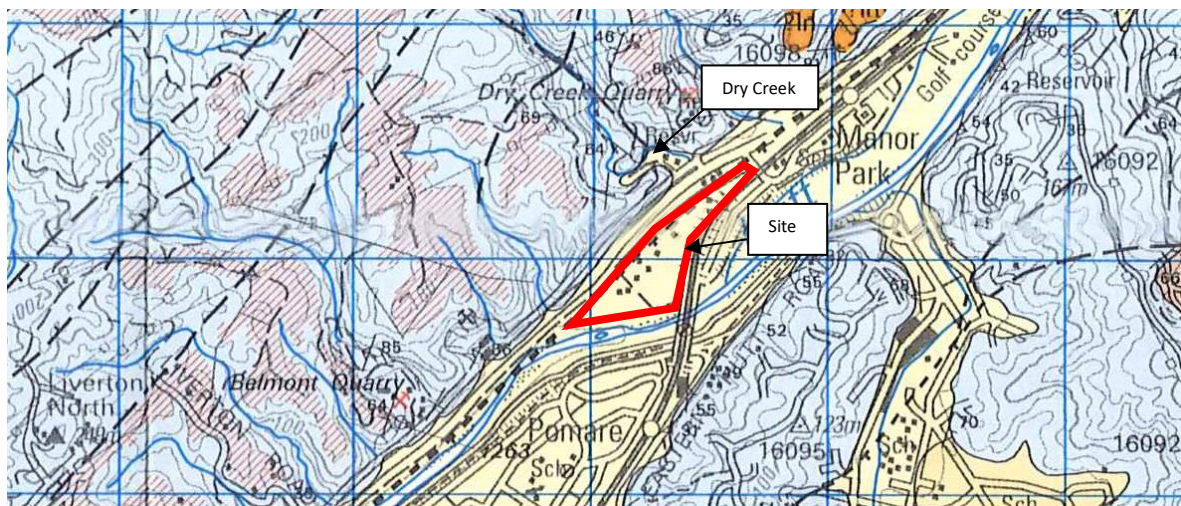
Figure 2.1: Published geological map (Begg & Mazengarb, 1996). Blue indicates Greywacke rock and cream indicates alluvium within the Hutt Valley. The approximate site extent is outlined in red and the black dashed line indicates the approximate location of the Wellington Fault.

The published geology⁵ of the area indicates that the site is directly underlain by Holocene alluvial deposits consisting of well sorted floodplain gravels. Triassic sandstone and mudstone of the Rakaia Terrane (Greywacke) form the adjacent valley sides and underly the alluvial deposits that fill the valley. The Wellington-Hutt Valley segment of the Wellington Fault is mapped within the western margin of the Hutt Valley and through the site.

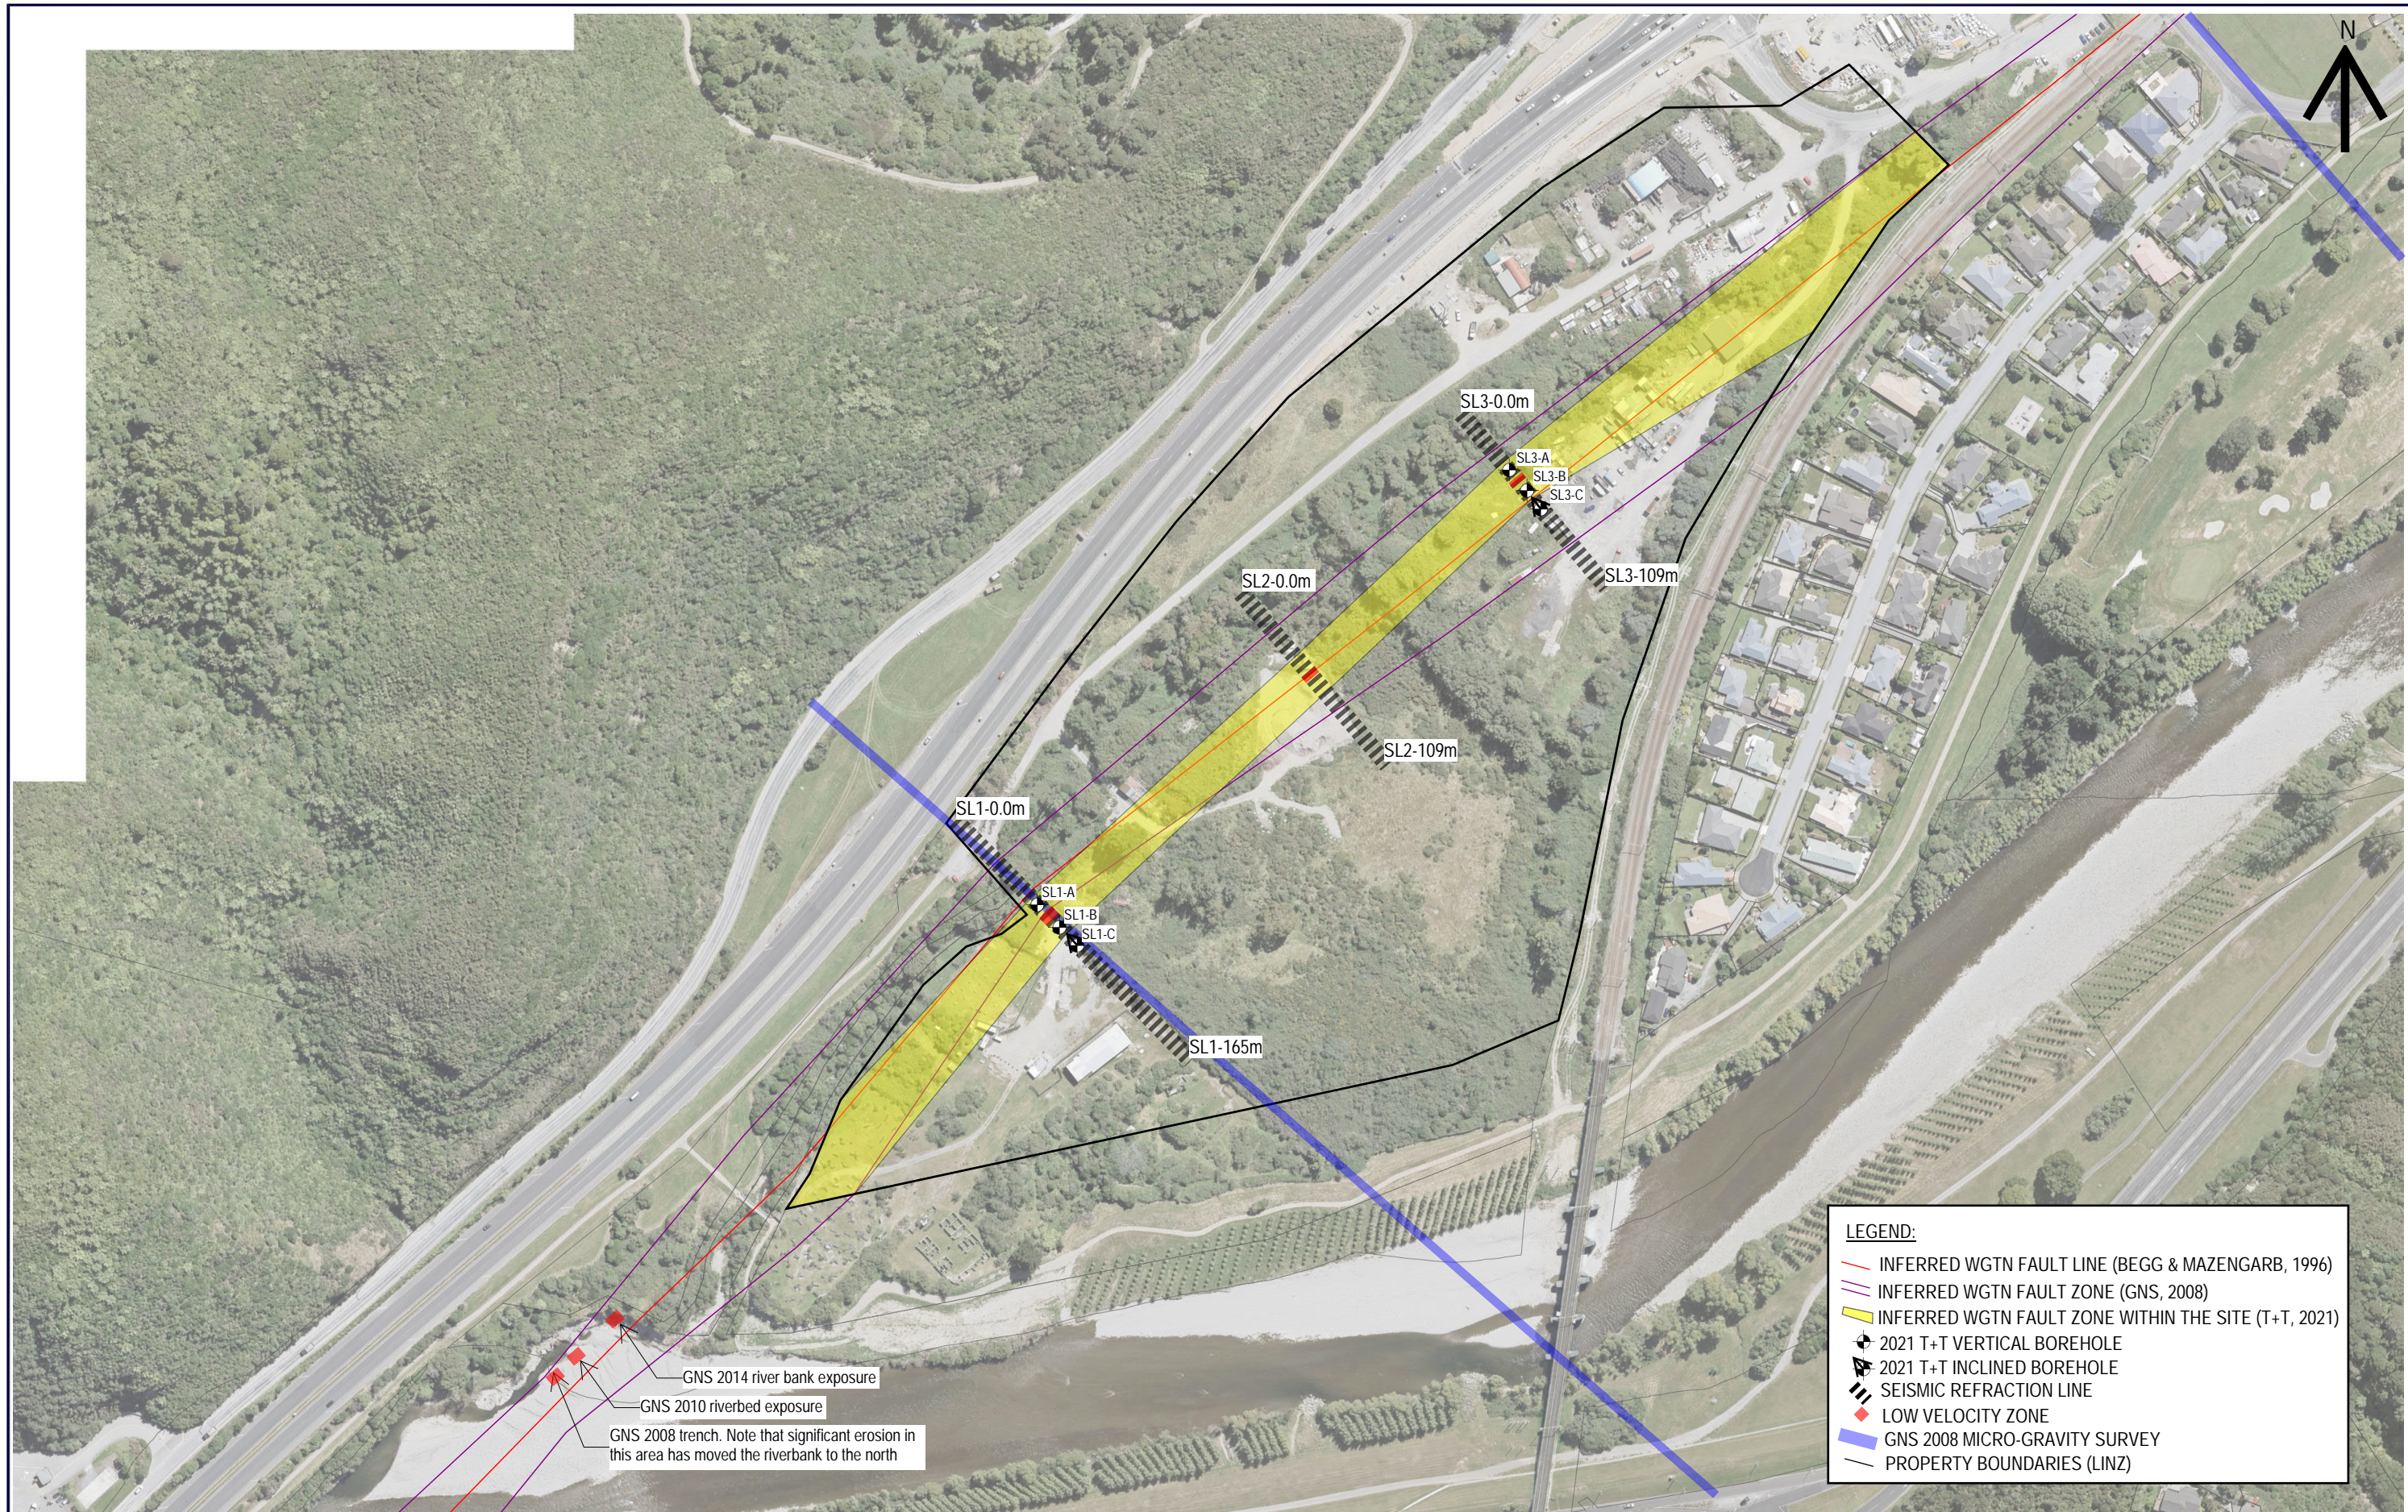
- **Figure A1 Wellington Fault investigation location plan**
- **Figure A2 Cross Section SL-1**
- **Figure A3 Cross Section SL-3**

A 5 m wide low velocity zone with a signal time loss of 4 and 6 milliseconds was observed in SL1 and SL2, respectively. We infer that the signal time loss is attributed to highly disintegrated material i.e., fault gouge of the Wellington Fault, which has a significantly reduced seismic velocity than the surrounding greywacke rock (which was measured between 2750 and 2900 m/s). Additionally, an attenuation of the maximum geophone signal amplitude at SL2 was observed within the low velocity zone.

When extrapolating the low velocity zones between the seismic refraction surveys and the exposures observed by Van Dissen to the south of the site, the inferred alignment of the fault is relatively consistent through the site (azimuth $\sim 048^\circ$).

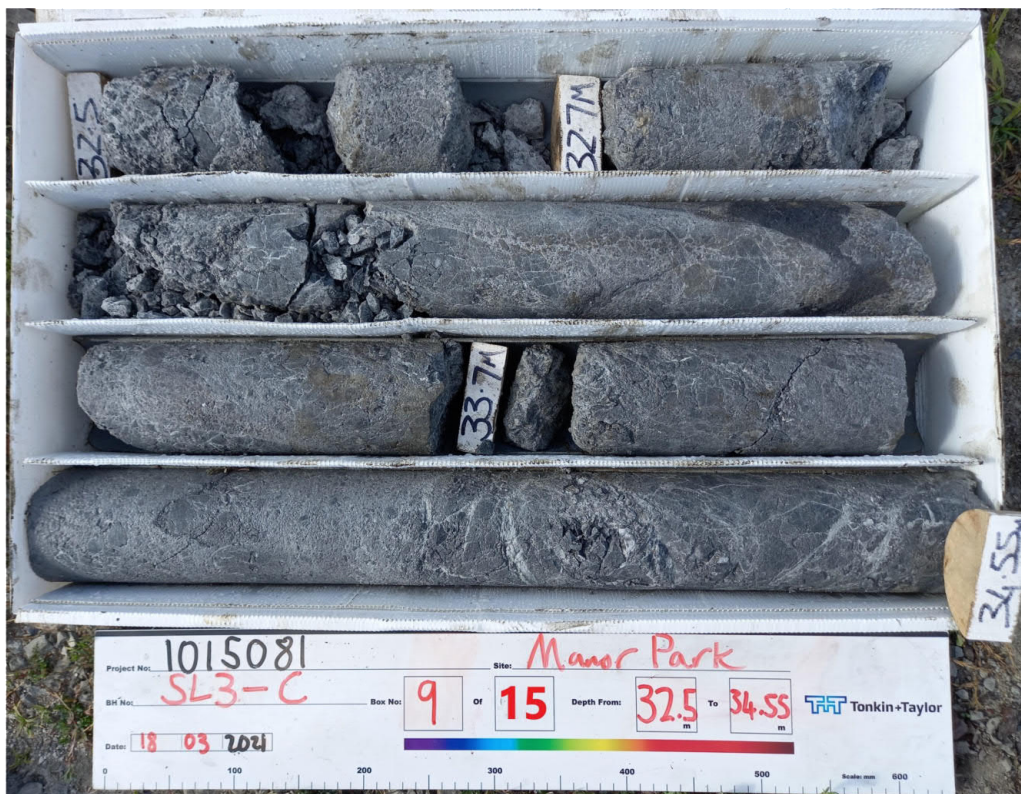
32.50-34.55m

CORE PHOTOS

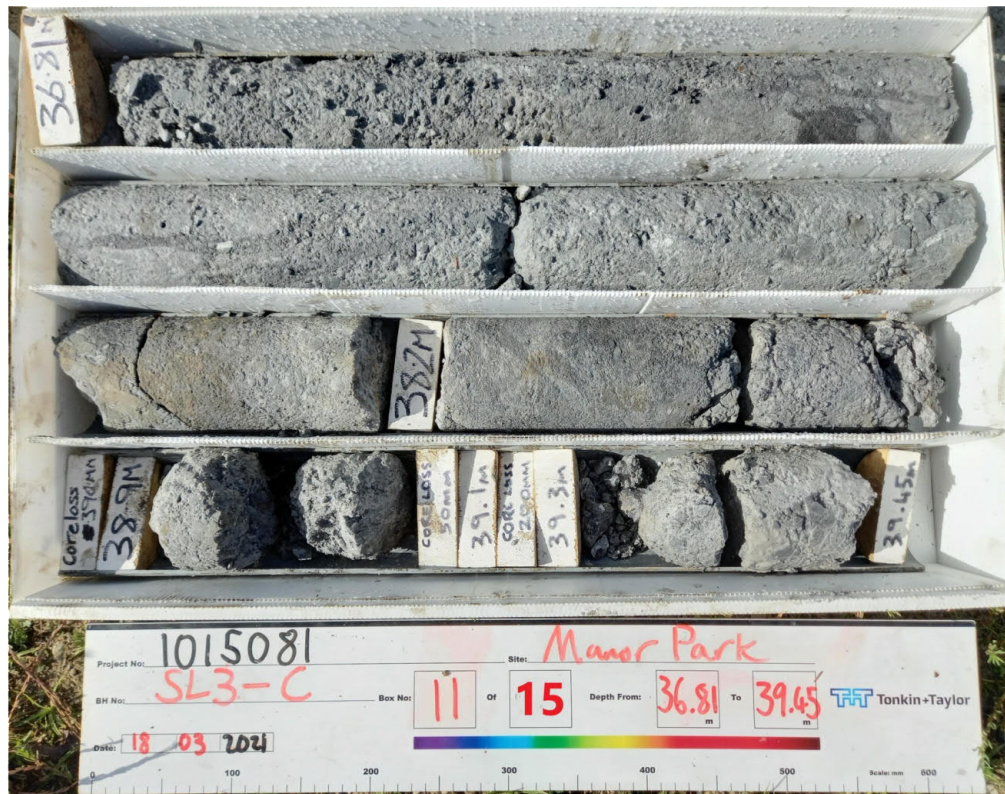
36.81-39.45m

CORE PHOTOS

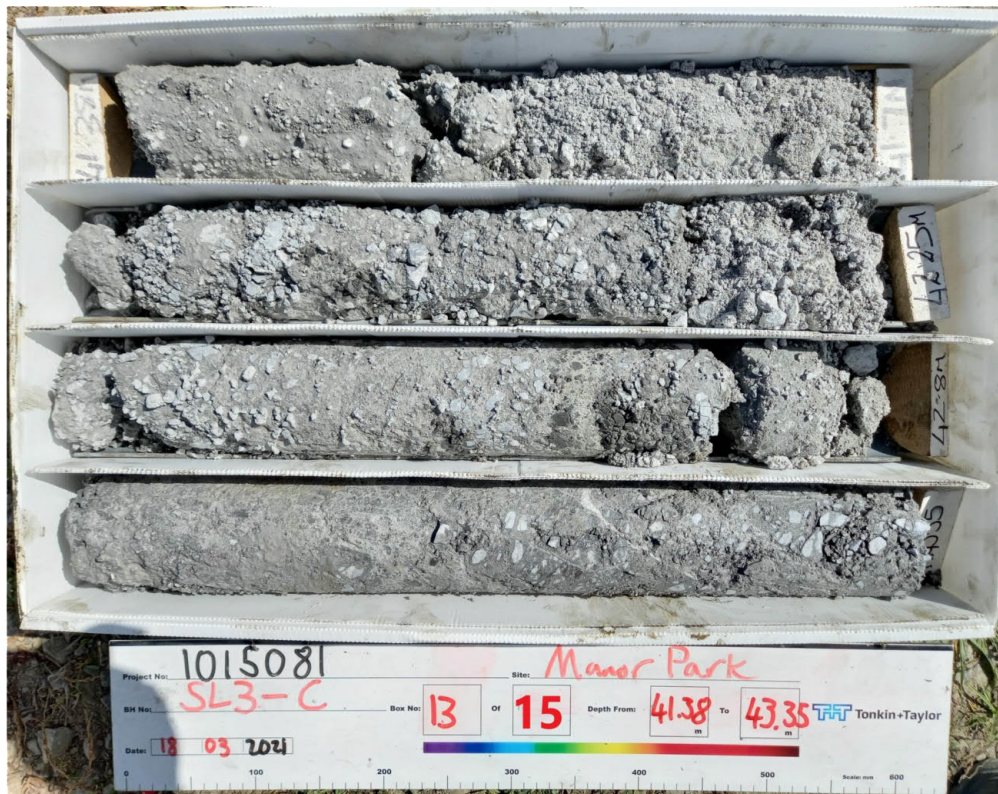
41.38-43.35m

CORE PHOTOS

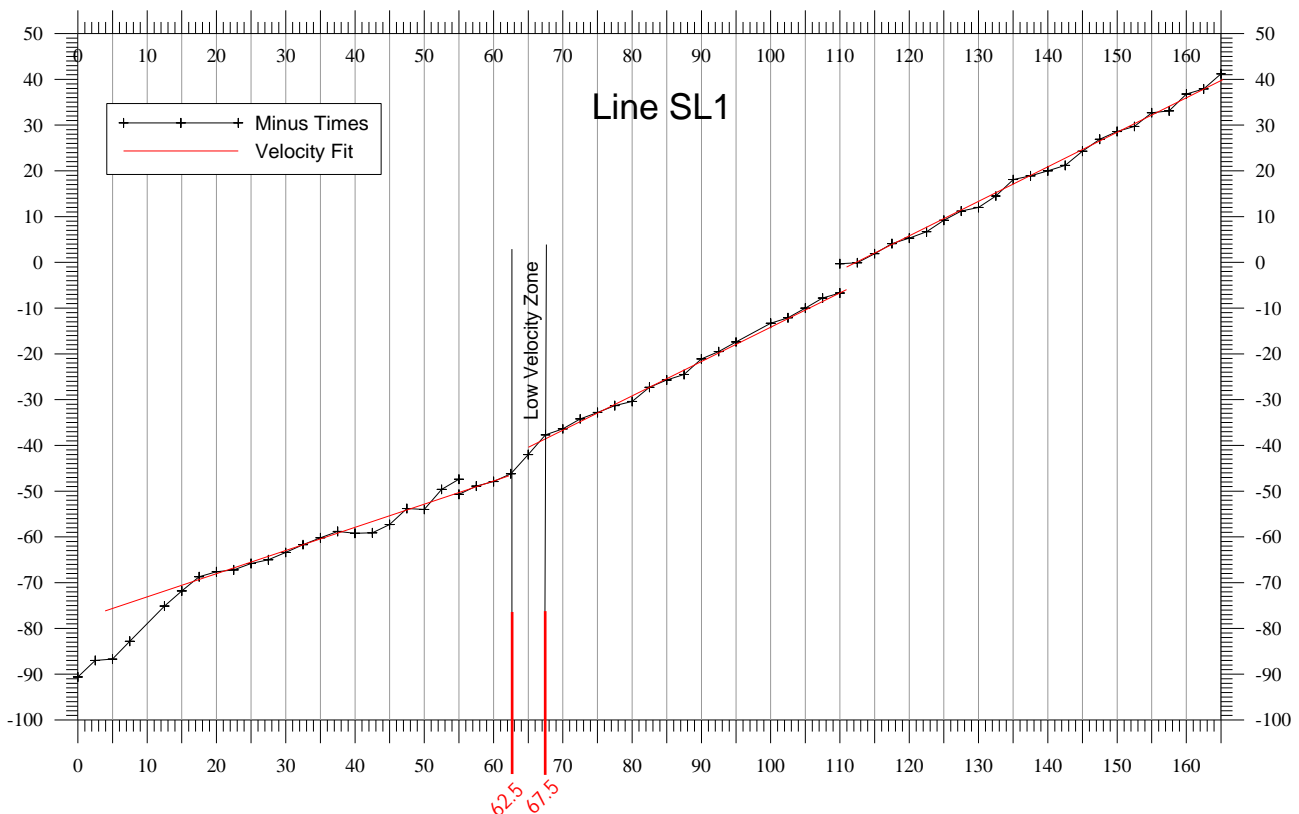
The plot below shows the times for the end shots at peg zero subtracted from the times for the offset shot at the far end of the line. The slope of the line is related to the velocity of the rock where the refraction is from the rock. A low velocity zone with a loss of 4 milliseconds was found between pegs 62.5 and 67.5m.

A surface layer of 300m/s is present along all of the line and an intermediate layer of 900m/s is also present. The rock layer has a velocity of 2750m/s along the eastern end of the line and 3900m/s at the western end of the line.

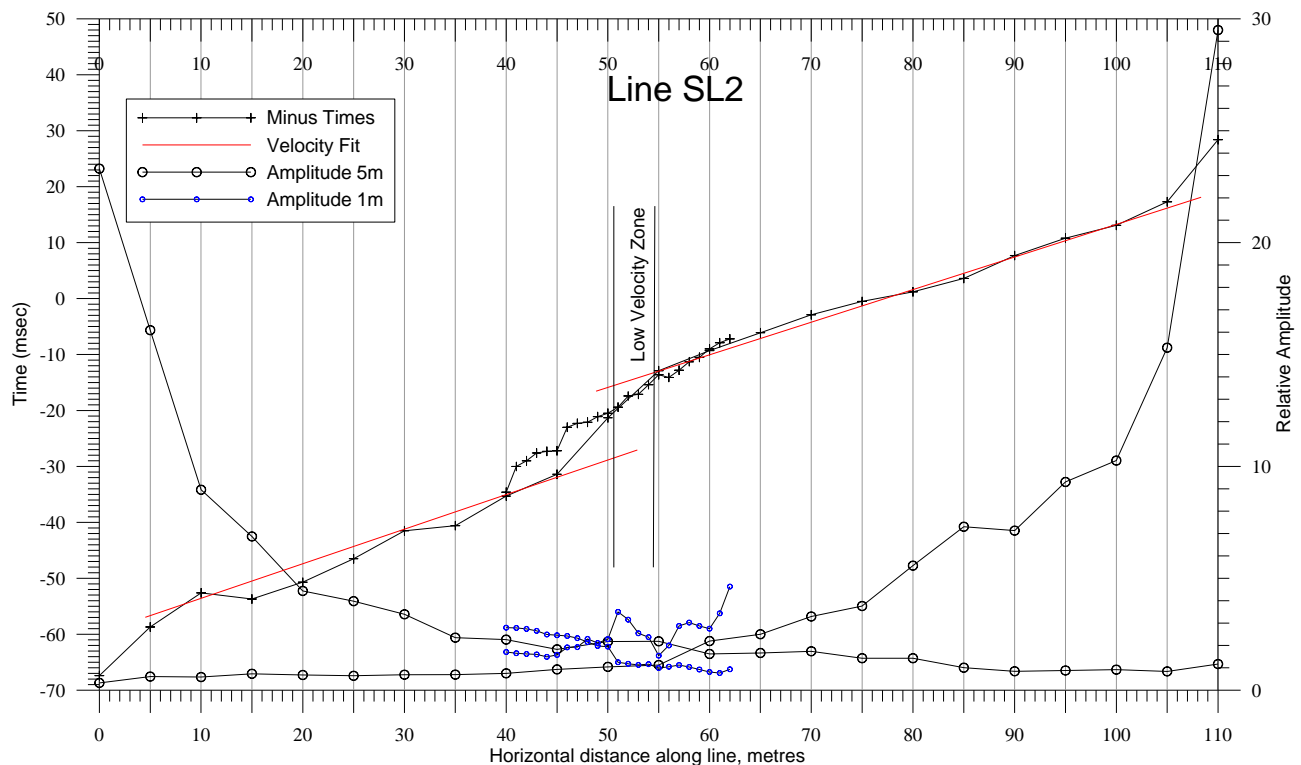
The plot below shows the times for the offset shots from peg zero subtracted from the times for the offset shot at the far end of the line. The slope of the line is related to the velocity of the rock where the refraction is from the rock. A low velocity zone with a loss of 6 milliseconds was found between pegs 45 and 55m. Additionally, the maximum amplitude of the signal at each geophone, for each offset shot is shown. The signal should be attenuated as it passes through the low velocity zone. The values of amplitude will be affected by background noise superimposed on the signal so may have some scatter in the values. The 1m spaced shot from the zero end of the shows a sudden step between 50 and 51m, with a relatively even attenuation either side.

Taking into account the velocity step and the amplitude changes the most likely position of the low velocity zone is between pegs 50 to 55m.

This line to the east of Benmore Crescent, beside the stream, North of SL1, then crossed the stream and ran up the slope to a flat area of fill. The total length of the line is 110 metres. The geophone spacing was 5m.

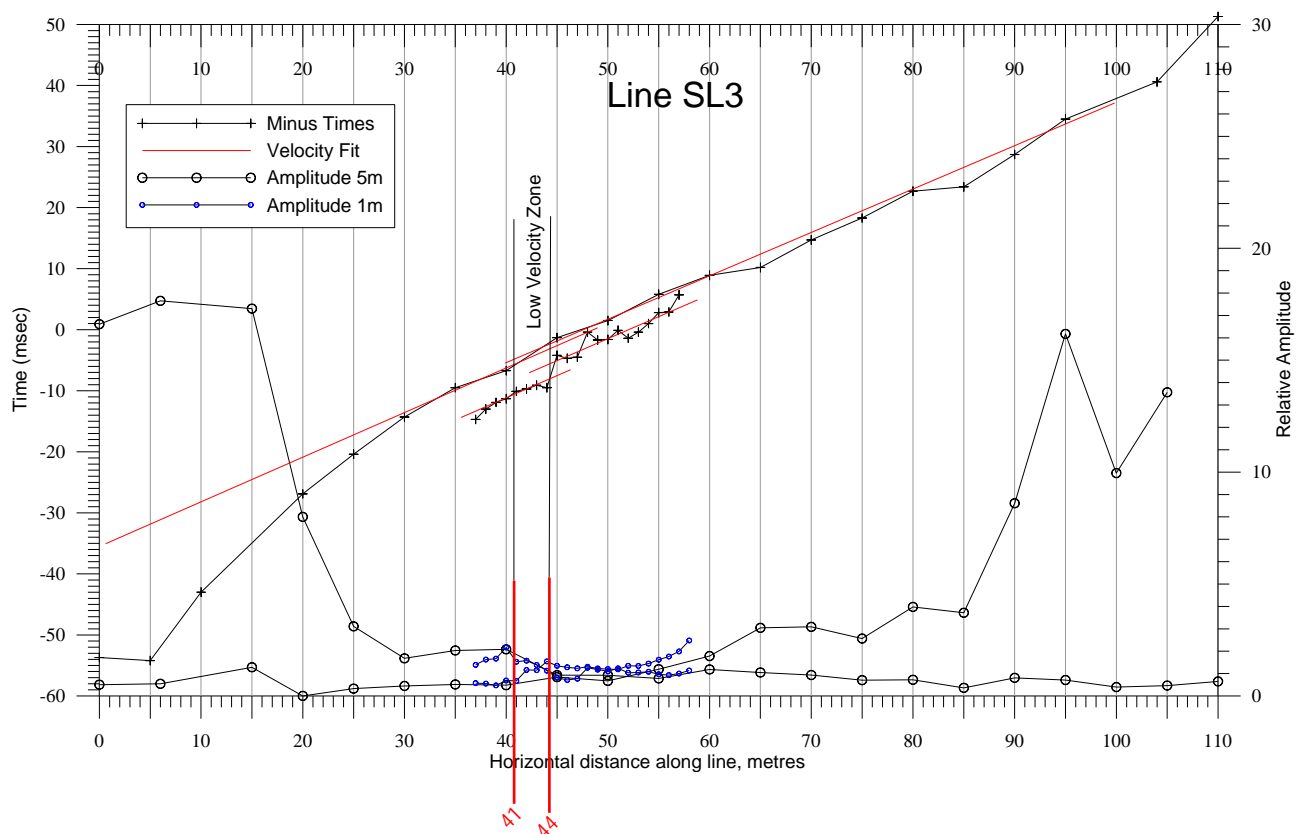
The plot below shows the times for the offset shots from peg zero subtracted from the times for the offset shot at the far end of the line. The slope of the line is related to the velocity of the rock where the refraction is from the rock. A low velocity zone with a loss less than 1 milliseconds was found between pegs 40 and 45m. Additionally the maximum amplitude of the signal at each geophone, for each offset shot is shown, as with line 2. Both of the 1m spaced shots and the 5m spaced offset from the zero end of the shows a step between 40 and 45m, which reinforces the small step seen on the velocity plot.

A surface layer of 300m/s is present along all of the line and an intermediate layer of 600 to 800m/s is also present. The rock layer has a velocity of 2900m/s along the length of the line.
