Petone Wharf

The Esplanade, Petone, Lower Hutt

Conservation Plan

Hutt City Council

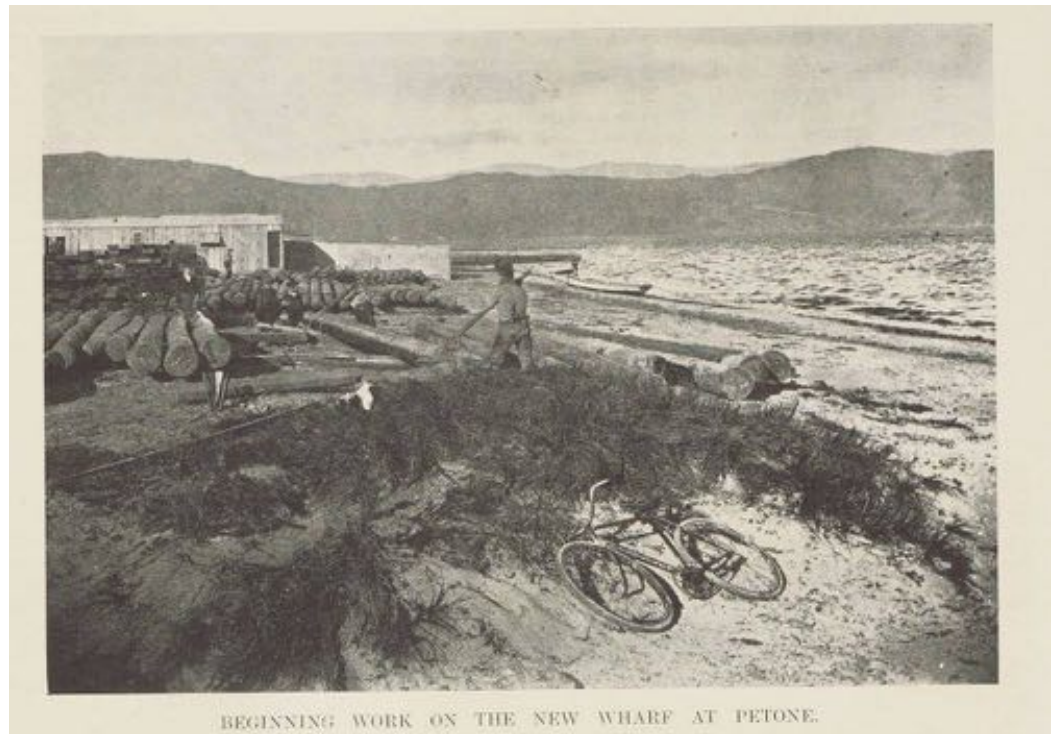
Figure 17. 1908 construction work on the Petone Wharf. Source: Sir George Grey Special Collections Auckland Libraries, NZG-19080624-37-1

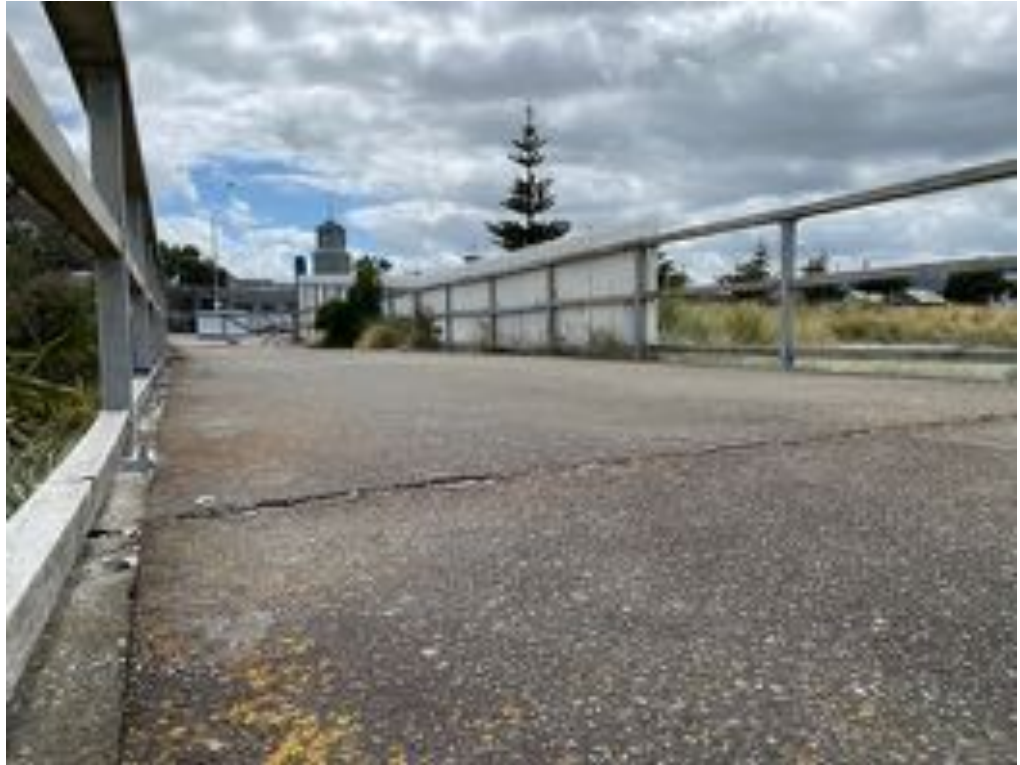
Figure 29. On the entrance looking north towards The Esplanade, January 2022

The entrance of the wharf consists of the first three bays that are directly accessible from The Esplanade. The entrance portion of the wharf is splayed in plan, with a width of approximately 10 metres at the widest end at The Esplanade, narrowing to 4.6 metres where it connects with the approach section of the wharf. The street edge of the wharf follows the angle of The Esplanade and so is not exactly perpendicular to the wharf.

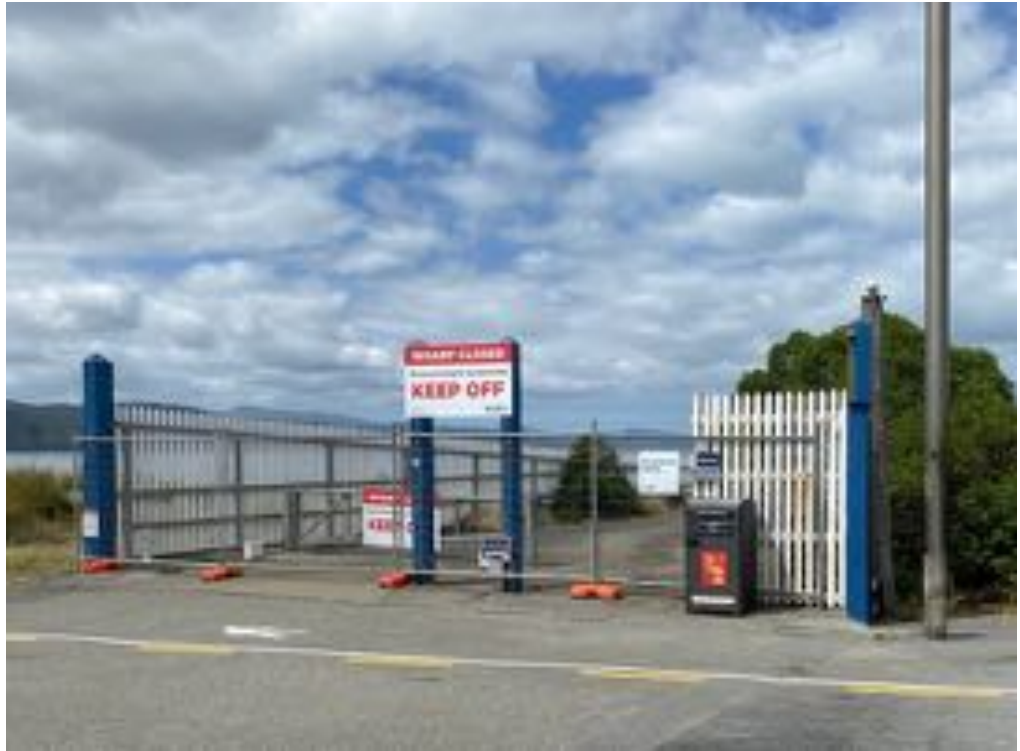
Figure 30. The entrance as seen from The Esplanade, January 2022

The entrance has a white painted timber picket-style fence, supported on a metal frame which is bolted into the wharf decking. This fence is relatively low, approximately 4' (1.2m) on either side of the wharf, but gradually increases in height as it approaches the street, to match the approximate 8' (2.4m) height of the gate portion at the street edge. Along the street edge are four large stop-chamfered posts, which are possibly original, however are not in original configuration. These posts are arranged in an uneven distribution to suit the recently removed non-original vehicle and pedestrian access gates. There is a small portion of picket fence remaining at the west of the entrance.

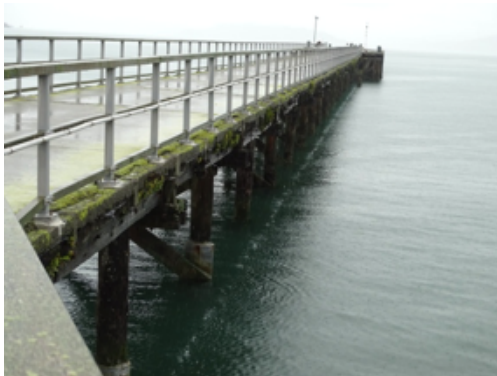
Figure 33. The structure below the approach as seen from the cart refuge

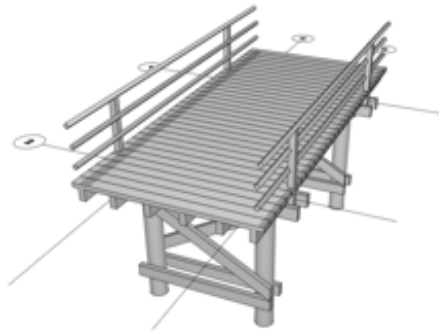
Figure 35. A representative bay of the approach portion of the wharf as built in 1908. Original fabric is grey.

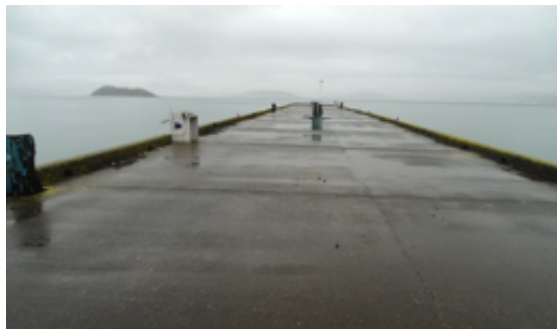
Figure 38. The head looking south towards Wellington

The head is constructed from ironbark and jarrah timber cross-braced piles and beams. The original timber decking was removed in 1960 and replaced with a reinforced concrete deck cast on steel sheeting.

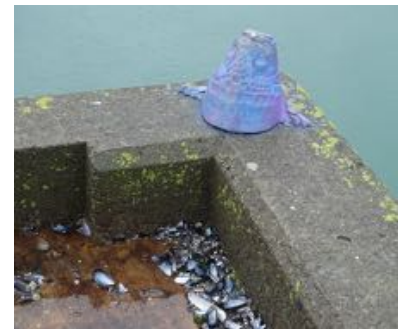
Figure 39. A fishing rod holder on a corner of the head

On the head are several non-original bench seats, rubbish bins, and fishing rod holders fixed to the concrete topping slab.

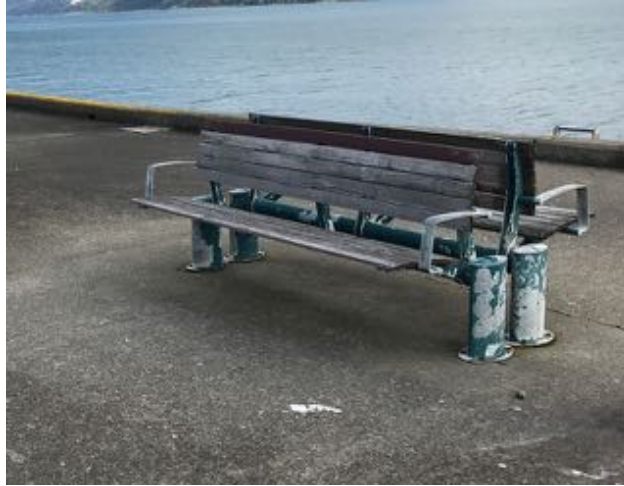
Figure 40. Bench seats on the head. Source: Calibre Consulting Ltd.

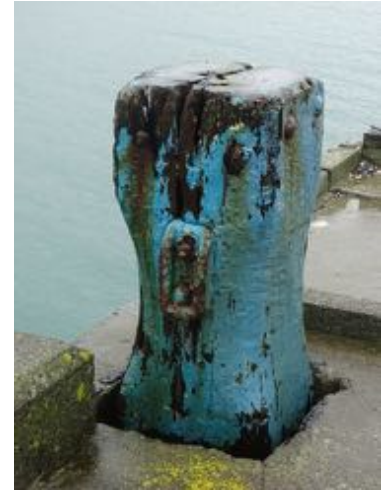
Figure 41. An original timber bollard on the head

Several original painted timber bollards remain around the perimeter of the wharf, these are generally in poor condition.

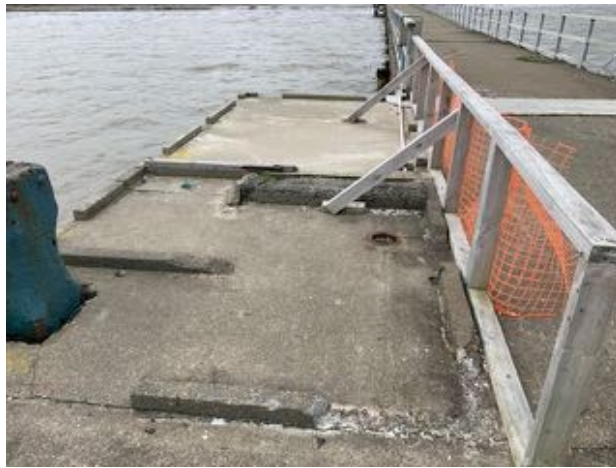
Figure 42. Remaining foundations on the wharf head. Source: Calibre Consulting Ltd.

The concrete foundation nib and slab of the most recent iteration of the building, and part of the foundation nib of an earlier iteration remain.

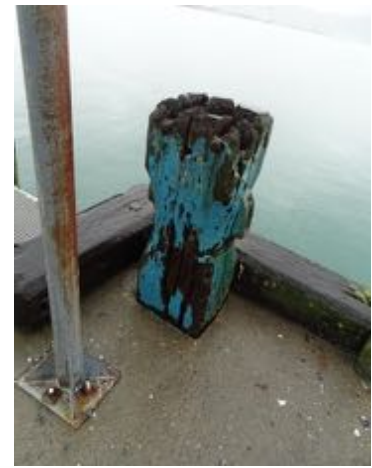
Figure 43. Timber kerbing at the north-east corner of the head

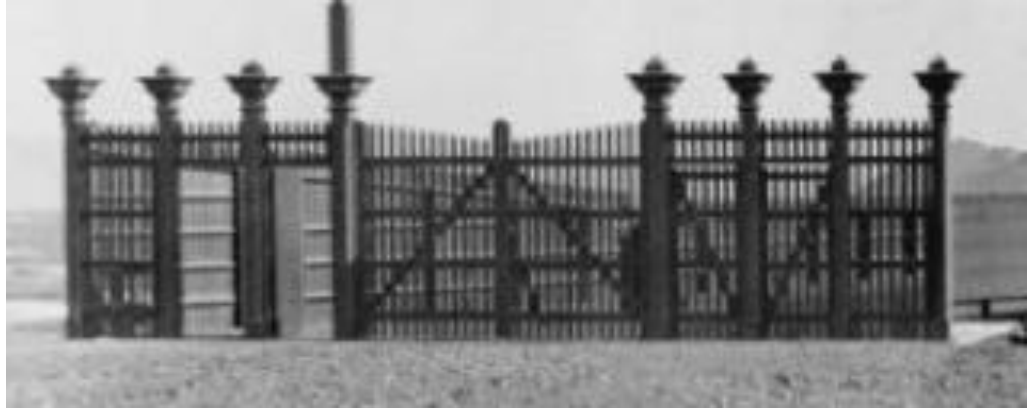
Figure 49. Detail view of The Petone Wharf, 1909, showing the original entrance gates and side fence down the wharf. This is consistent with the drawing, but the light is missing from the tallest post. Source: ATL 1/2-002541-F

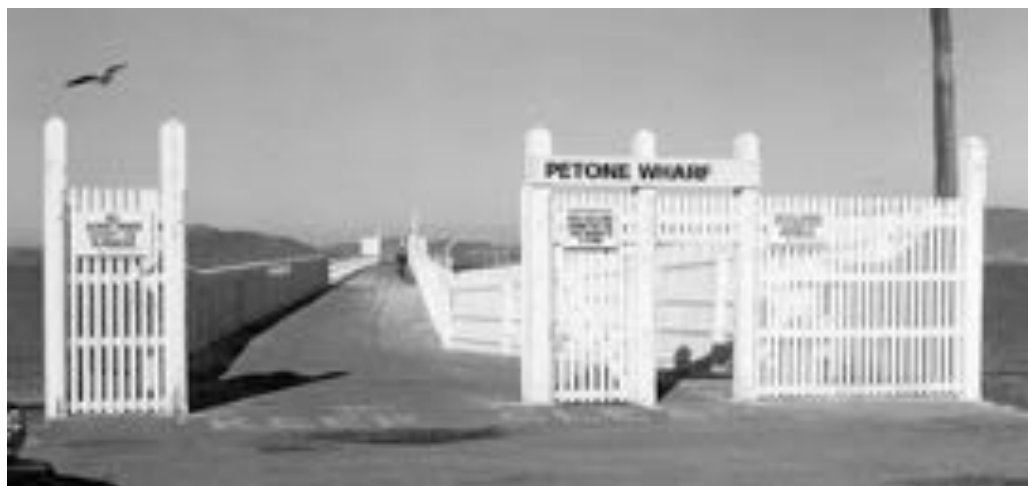
Figure 50. The Petone Wharf entrance, 1960's. Source: Unknown

The most recent entry gate, present since at least the 1960's until December 2021 was similar in design to the original, but had been extensively modified or completely replaced. It was still 2.5 metres tall, but the configuration of gates and posts had changed. The entry was asymmetrical with a wide vehicle entry to the east and two smaller pedestrian gates to the west.

A cut-out metal sign reading 'Petone Wharf' was present over the vehicle entrance and a solid sign board sat above the western gate and fence. This sign board was possibly installed in 2006 when the East-West ferry started running to Petone Wharf.

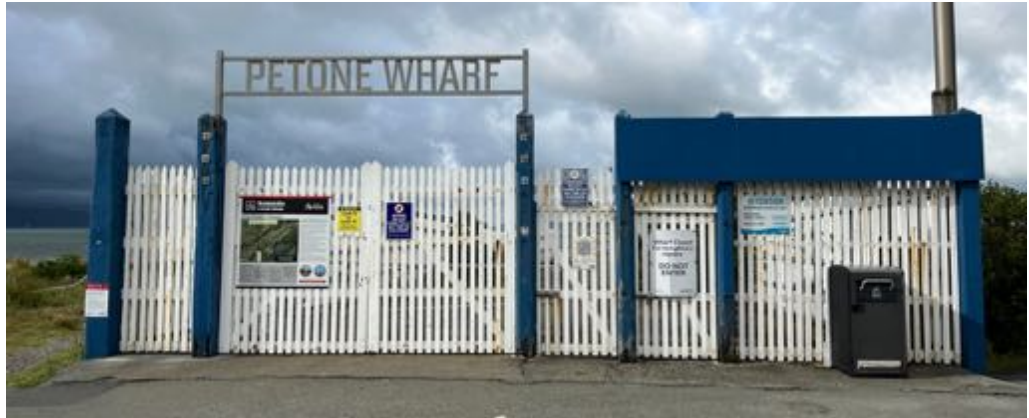
Figure 51. The Petone Wharf entrance in November 2021. Source: Calibre Consulting Ltd.

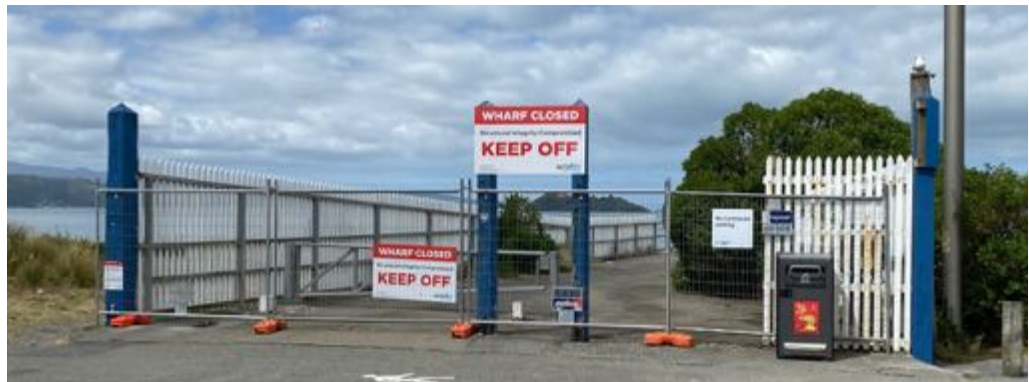
Figure 52. The Petone Wharf entrance, January 2022, with gates, fencing, and two posts removed

In December 2021 the vehicle and pedestrian entry gates, signs, two posts, and much of the fence along The Esplanade were removed due to the discovery of severe rot below ground-level in the posts. As of January 2022, only the two outer-most posts, two central posts, and a portion of fencing remain of the entry gates. The two central posts appear to be original, with stop chamfers and a shaped top, while the two outer-most posts appear more recent and are constructed of a rougher timber with less detailing.

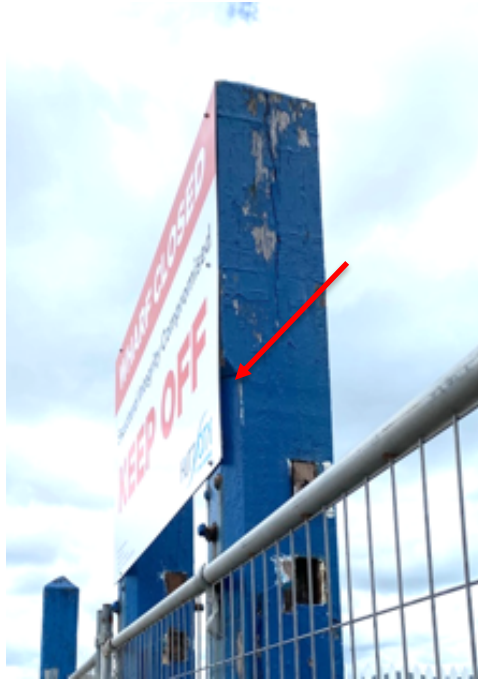
Figure 53. Possible original central post, note stop chamfer detail.

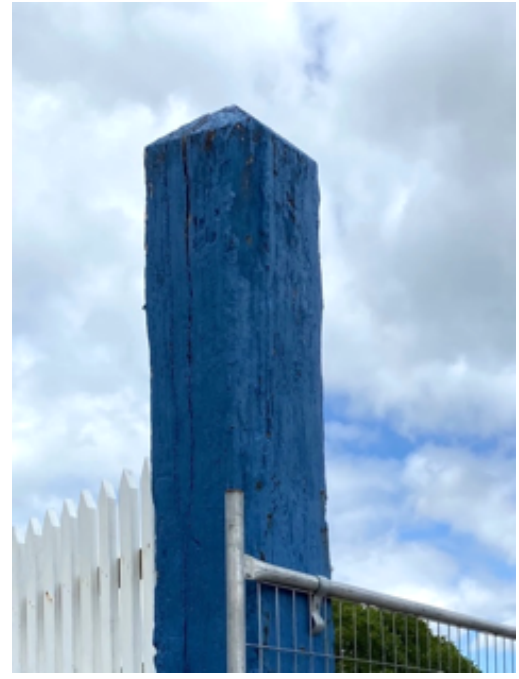
Figure 54. Likely non-original outer post, note rough timber

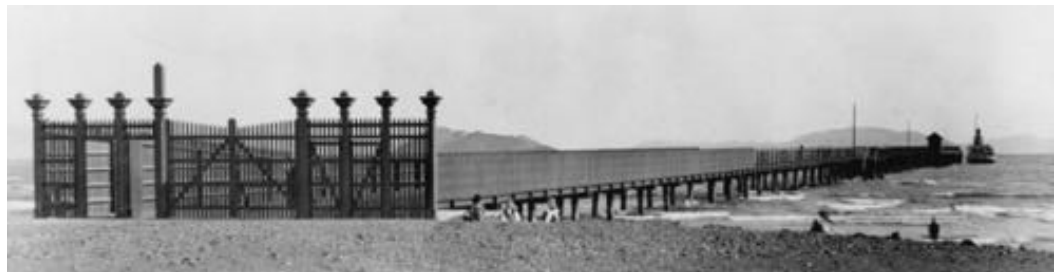
Figure 55. The Petone Wharf, 1909, showing the original entrance gates and side fence down the wharf. Source: ATL 1/2-002541-F

As detailed on the original drawings, and visible in photos shortly after construction, the original picket fences returned for a considerable distance down the sides of the wharf – for 12x 20-foot bays. This fence was a consistent height of approximately 6” (1.8m) for the length of the fences. The pickets were supported on the timber balustrades. It appears the original picket fences down the wharf were in place until at least 1990.

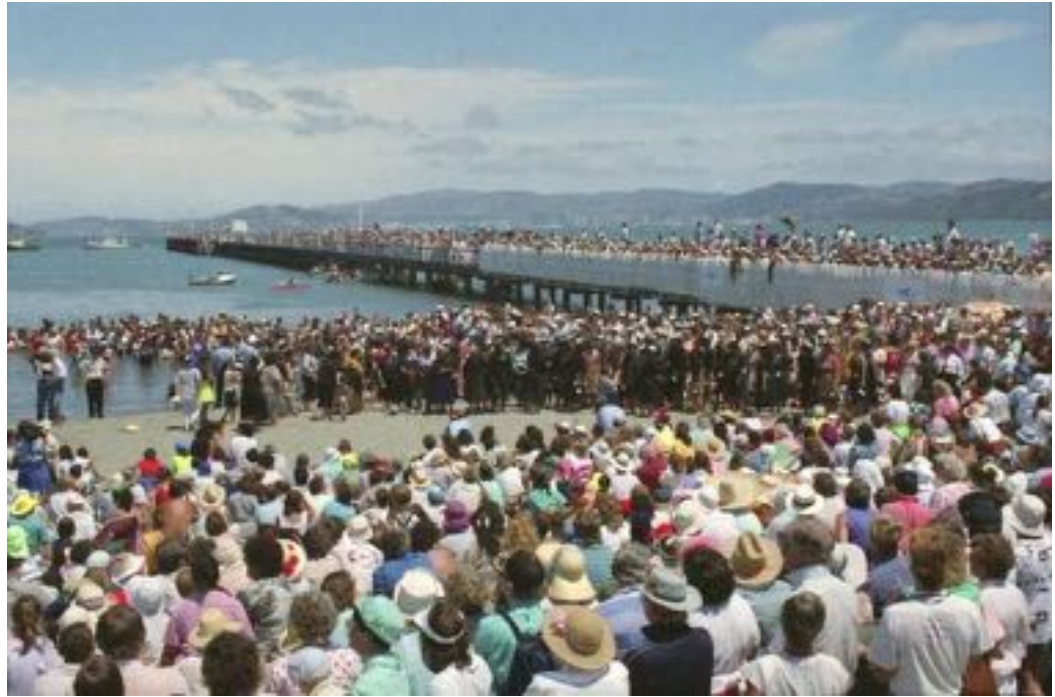
Figure 56. The Petone Wharf, 1990, Wellington Anniversary Day re-enactment of settlers arriving. Note: it appears the original side fence still in place. Source: Memelink, Alfred, Petone Settlers Museum < <https://petonesettlers.org.nz/2014/01/17/happy-anniversary-wellington/amp/>>

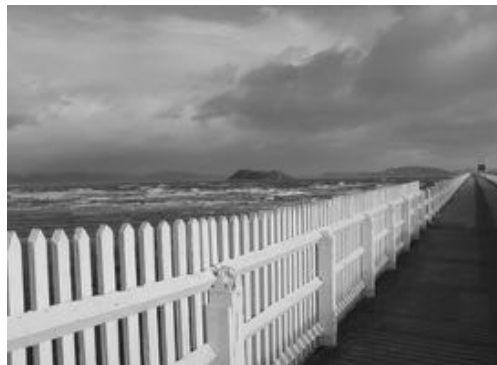
Figure 57. The Petone Wharf 2002 with the balustrade original structure. Note the arris rails. Source: Whaka, "Storm Wellington Harbour", 2002, Photograph. Accessed 09-11-2021 https://commons.wikimedia.org/wiki/File:Storm_Wellington_Harbour.JPG?fbclid=IwAR0KGchDL-7VH9s-ucMYzhx5WAizfXo5Jlg1dxJDe_n3NjIOHmcR9Bzbe94

The original balustrade had horizontal base, mid, and top rails constructed from arris cut 4"x4" timber rails set on the diagonal between 6"x6" posts. The drawings show it as 4'6" (1.370m) high. A timber balustrade – likely the original – was in place until at least 2012, after which it was replaced. horizontal timber rails made by arris cutting a 4"x4" timber and setting it on the diagonal between 6"x6" posts.

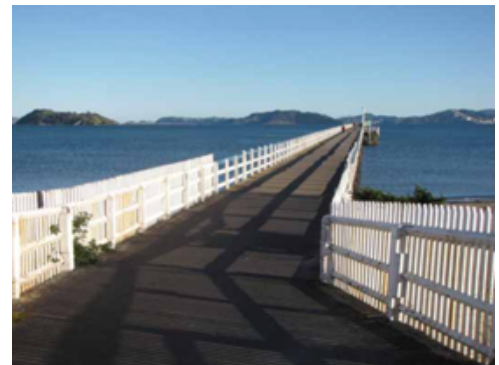
Figure 58. The timber balustrade and fence, possibly original c.2011. Source: Cochran and Murray Conservation Architects, Historic Heritage of the Wellington Region

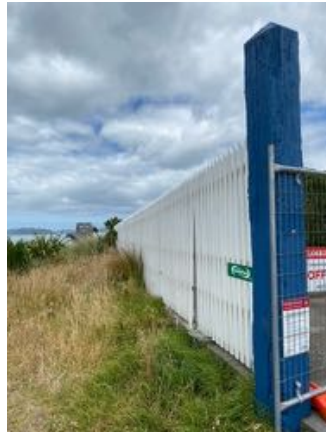
Figure 59. The current fence as seen from outside the wharf

In the 1990's, and again around 2016, the pickets were replaced in a slightly different configuration, which remains today. The pickets only extend approximately 20 metres down the sides of the wharf and varied in height. The pickets are approximately 2.5m at the entrance, matching the height of the gates on The Espalanade, and gradually decrease to approximately 1.2m in height for the last 7 metres along each side of the wharf. It is not known if the pickets are the originals reused, or new fabric. Until approximately 2012 the pickets were supported on the timber balustrade when this was replaced with the current steel and timber design.

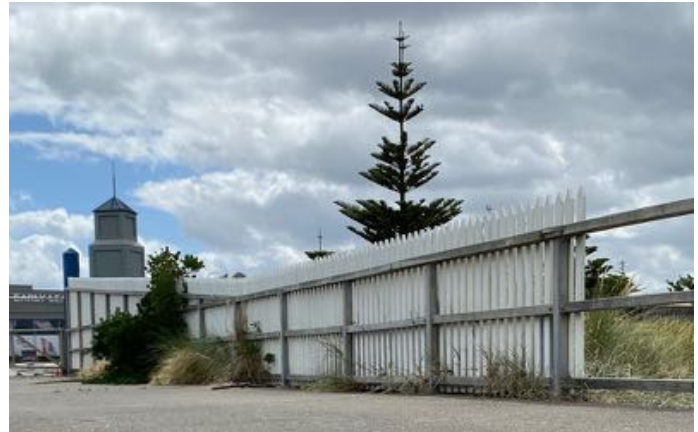
Figure 60. The current fence as viewed from on the wharf. Note the palings decrease in height from The Esplanade in the first few bays.

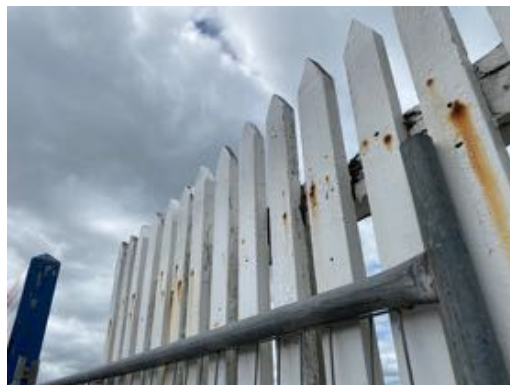
Figure 61. The current fence palings. These are of the same dimensions (not height) of the original, but it is unclear if they are original

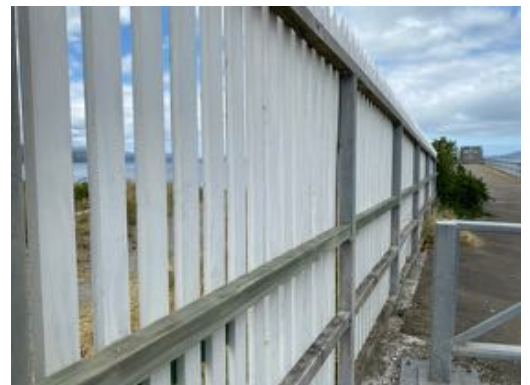
Figure 62. The current fence structure with metal stanchions and timber horizontals to match the current balustrade

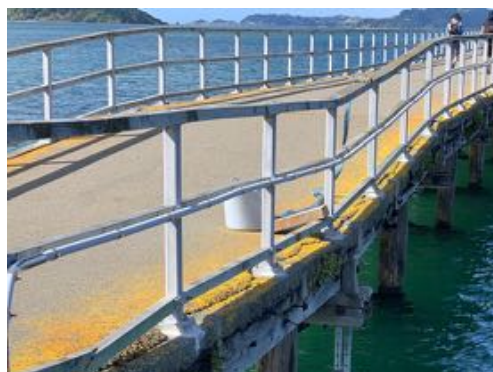
Figure 63. Current metal and timber balustrade over slumped portion of the approach. Source: Calibre Consulting Ltd.

The current balustrade which runs down either side of the approach portion of the wharf is constructed from galvanised steel posts with timber base, mid, and top rails. The balustrade is bolt-fixed into the concrete decking at its base.

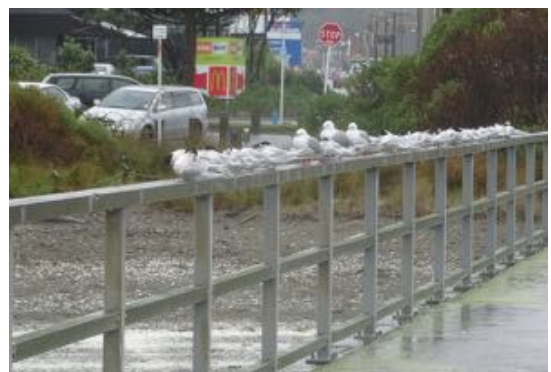
Figure 64. Current metal and timber balustrade, 2021

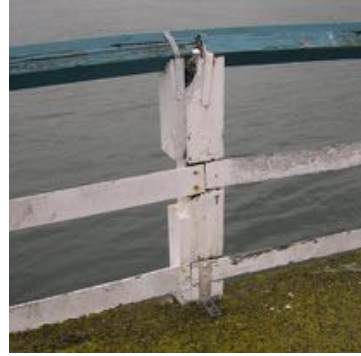
Figure 66. The handrail as of 2021 with multiple repairs. The toprail and post are as per the original specification, however the base and mid rails may have been replaced. Source: Calibre Consulting Ltd.

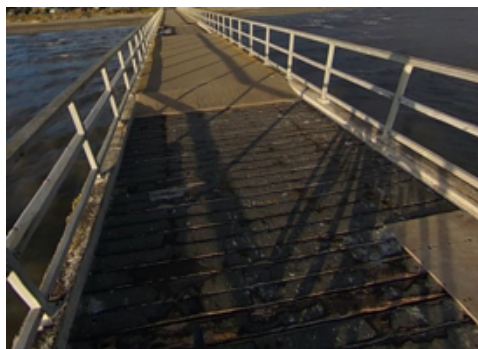
Figure 67. Test portion of concrete decking removed showing original decking, 2018. Source: Google Street View, December 2021

In 2018 on the approach two large portions of the concrete decking and asphalt were removed, exposing the original timber decking. These have since been infilled with a lighter concrete and so are identifiable.

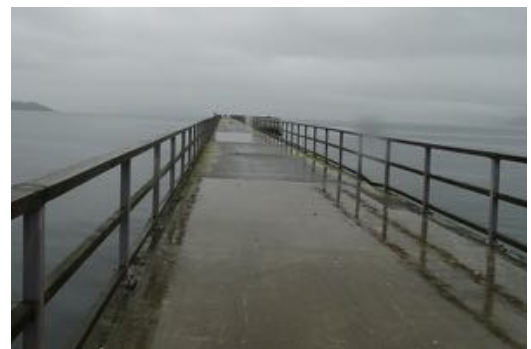
Figure 68. Concrete and asphalt decking on the approach of the wharf, 2021

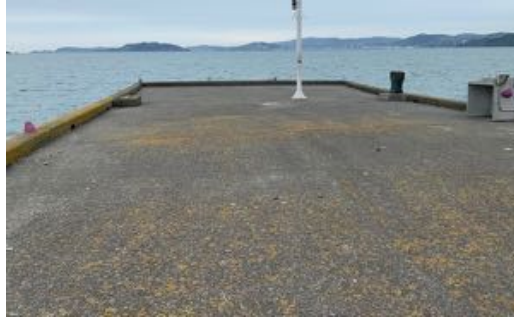
Figure 69. The concrete decking on the wharf head. Source: Calibre Consulting Ltd.

As part of the 1960 work a concrete topping slab was added to the entire wharf. On the entry and approach portions of the wharf, the concrete deck was cast directly onto the timber decking. On the head, the decking was removed, and a reinforced concrete deck was cast over flat steel sheeting which sits on the sub-structure. At some point an asphalt topping was laid over the entrance and approach portions of the wharf. This asphalt does not extend to either side of the wharf, with a border left at each edge, so the balustrade is bolted directly to the concrete decking.

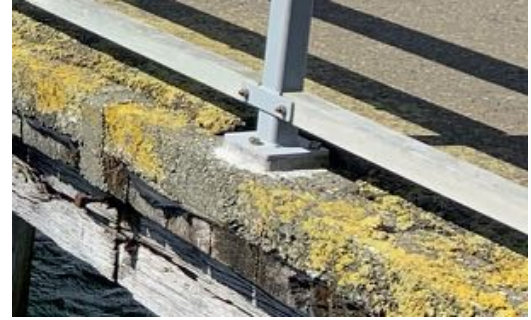
Figure 70. Side view of the concrete decking on the approach over the original timber decking. Source: Calibre Consulting Ltd

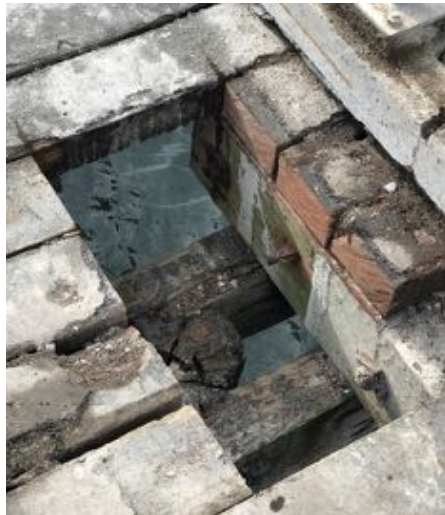
Figure 71. The timber decking below the concrete topping on the approach exposed during a test. Source: Calibre Consulting Ltd.

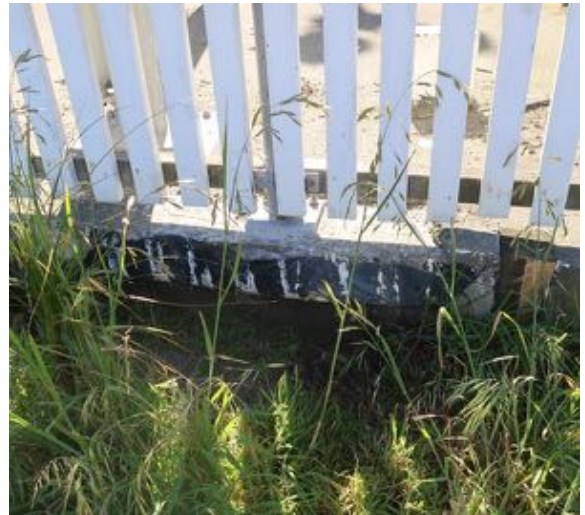
Figure 72. The edge of the concrete wharf deck on the entrance above the sand dunes. Source: Calibre Consulting Ltd.

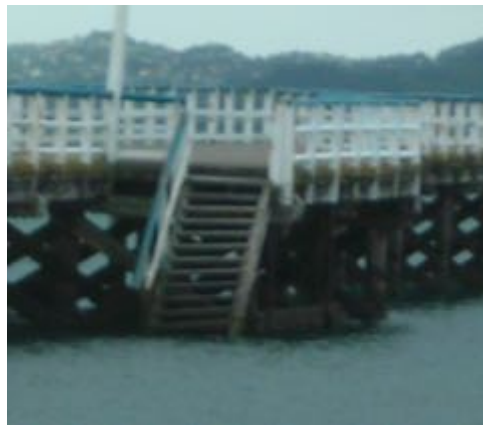
Figure 74. View of the cart refuge with stairs present, 2009. Source: Calibre Consulting Ltd., 2009

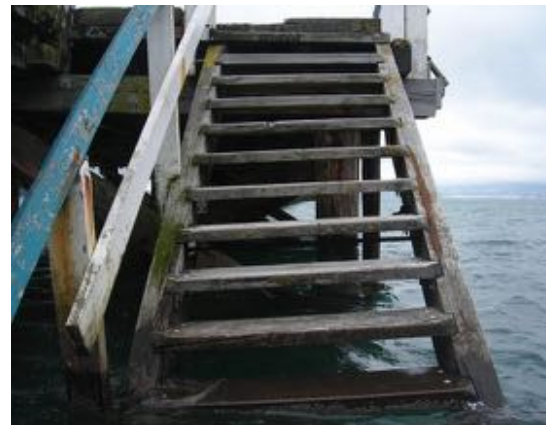
Figure 75. The stairs from the cart refuge, 2009. Source: Calibre Consulting Ltd., 2009

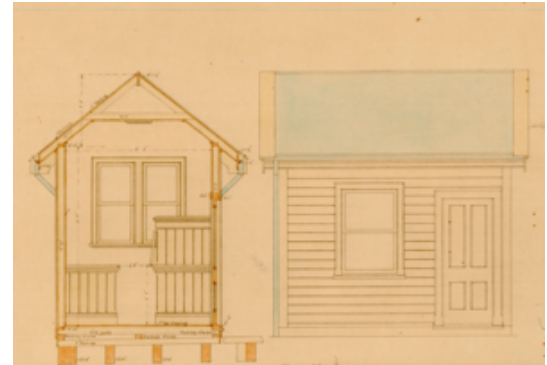
Figure 77. Original Drawing of the Office at Petone Wharf. Source William Fergusson, Petone Wharf Contract No. 146, 21 May 1907

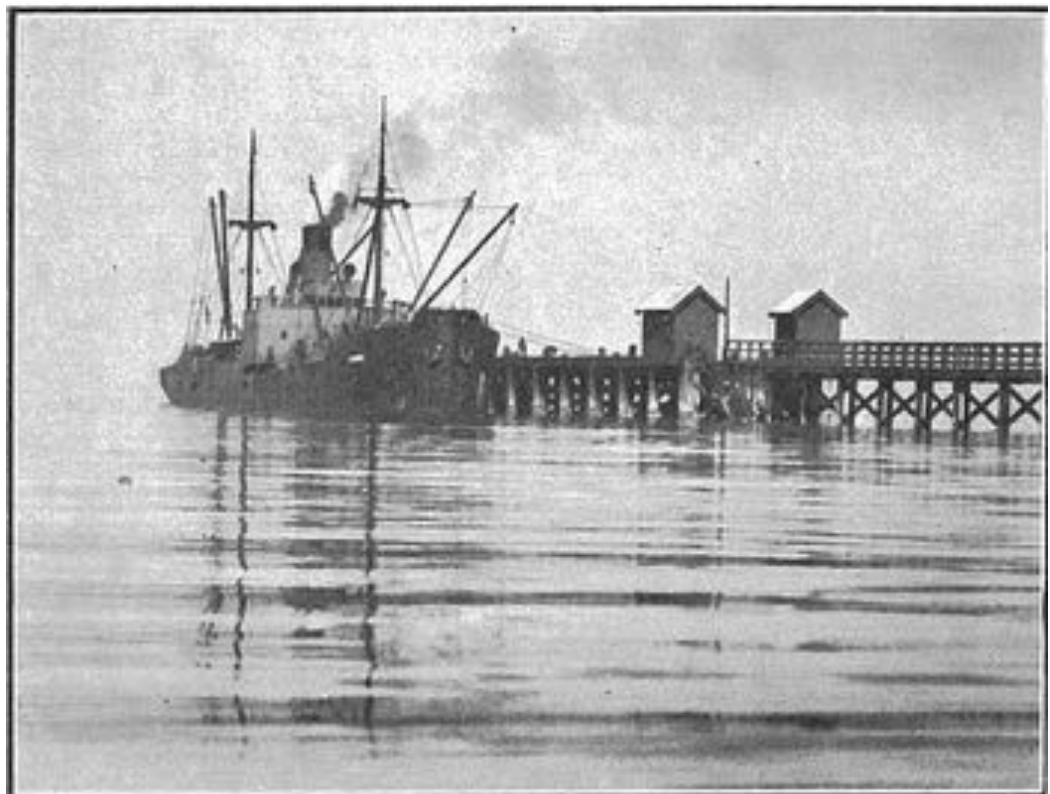
THE WHARF, PETONE.

Figure 78. The Petone Wharf showing two office buildings, undated photo. This appears to show the original documented building to the west (right), and the additional building of the same general form to the east (left). Note that there are no visible windows on the western building. Source: A. Barnett, "Petone Wharf", Petone's First 100 Years, 1940, LT. Watkins Ltd. Accessed 09-11-2021 <<https://library.huttcity.mebooks.co.nz/text/Petone100/t1-body-d55.html>>

At some point soon after construction, a second office building was built directly opposite the first, on the east side of the wharf. This may also be the time much of the joinery and detailing appears to have been removed from the original building. The second building appears to have matched the design of the original. The 1953 painting specification refers to the two buildings as the 'office building' and the 'mess building'. The original drawings refer to the documented western building as the 'office building', so it is likely the second building was the 'mess building'.

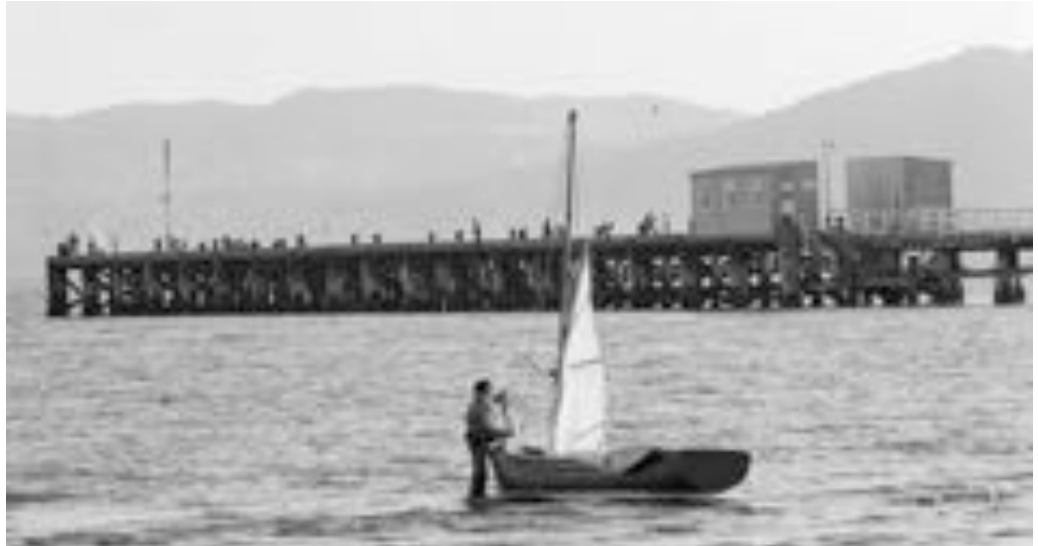
Figure 80. The Petone Wharf, 1974, showing two modified office buildings. Source: ATL AW-1058

By 1974 both office buildings had again been extensively modified or replaced with new weatherboard buildings. This likely occurred in 1960 with the installation of the concrete slab and removal of decking from the head, which would have required the removal of both buildings. The new design had a monopitch roof and was longer in plan. The entry door on the western building was still located in the same position. It is possible some original fabric, such as window joinery was reused in the new buildings. These two buildings were present on the wharf at least until 1989.

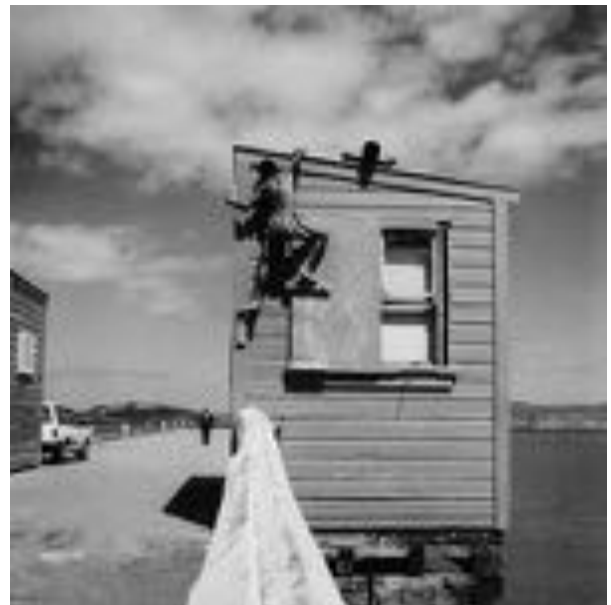
Figure 83. The Petone Wharf, 1989, looking towards Wellington, showing both modified buildings. The north-facing window appears to match that of the original building in dimensions and style. Source: Ans Westra, Petone Wharf, 1989. Accessed 13-01-2022 <https://issuu.com/capitalmag/docs/capital_46_-_online_version/34>

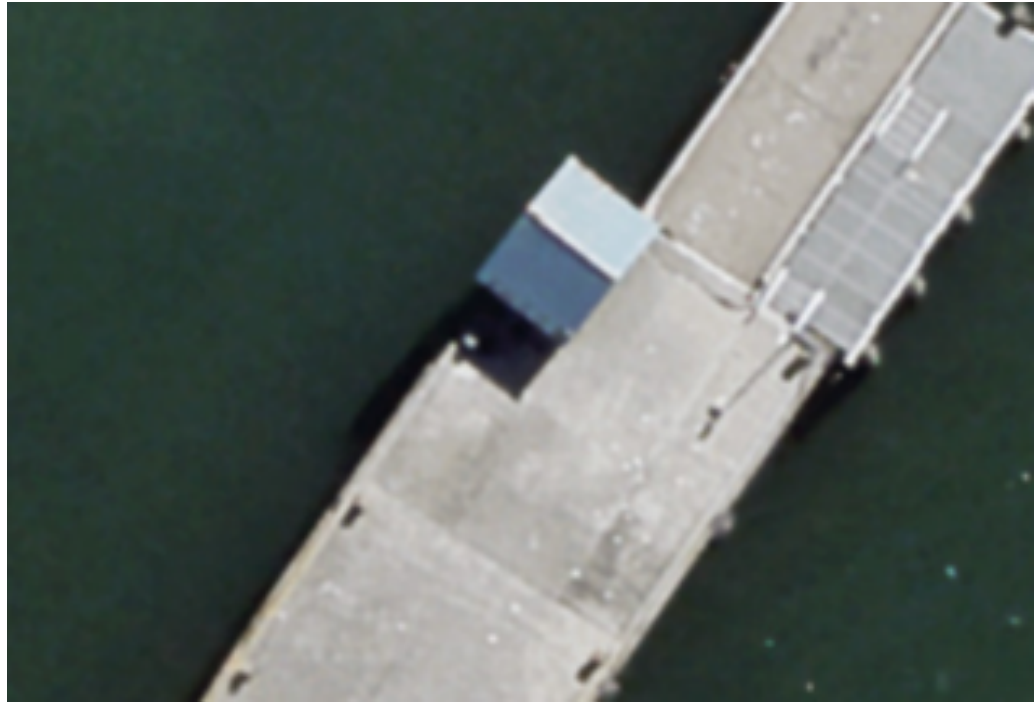
Figure 84. 2017 aerial view of the most recent wharf building. Source: Hutt City Council Historic Aerials

By 1990 the eastern office building had been removed, and the western building extensively modified again. The building now had a steep gable roof running perpendicular to the wharf, and no windows. The door onto the wharf was still located in the same position as the original design. The building appears to have returned to the original dimensions, and the extended portion of the foundations possibly dating from the slab construction in 1960 were visible beyond the building. This building was damaged in the 2016 Kaikōura earthquake and demolished by the Hutt City Council in 2017. The walls, suspended timber floor, and roof trusses have been placed in storage.

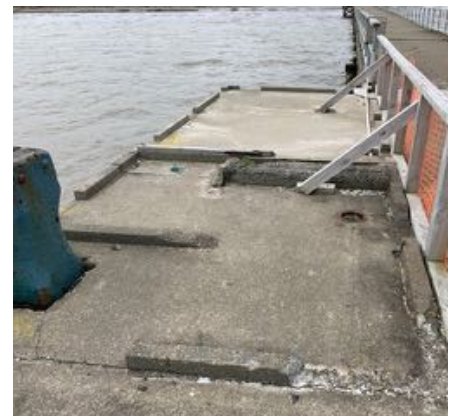
Figure 86. The Petone Wharf, November 2021, with the building removed and concrete foundations visible. Source: Calibre Consulting Ltd.

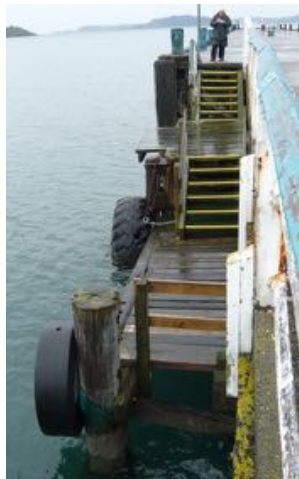
Figure 89. The previous timber access platform in 2012 prior to demolition. Source: Calibre Consulting Ltd.

Around 2013 this timber access platform was noted as being in poor condition and was demolished and replaced with the current steel access platform. This access platform is constructed from steel grate flooring with painted metal balustrades, and consists of two levels sitting below current wharf level accessed by steps from the head. The platform is supported on five new piles.

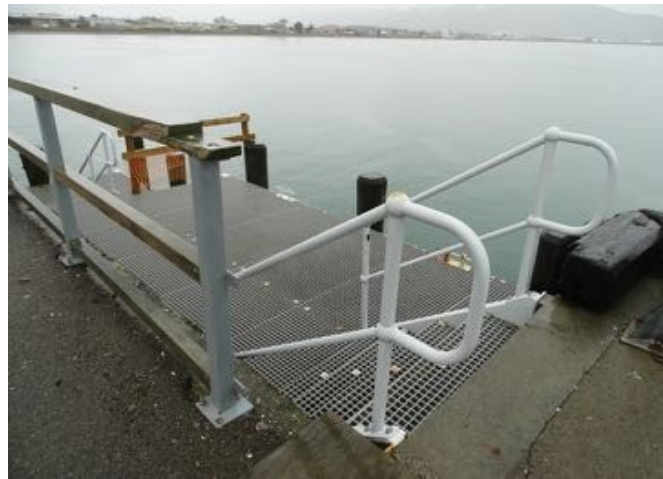
Figure 90. The current steel mesh access platform

The steel access platform (jetty) is in moderate condition, with deformation of steel beams and rust. The structure is vulnerable to earthquakes as it straddles the wharf head and approach, which move differently during an earthquake. It

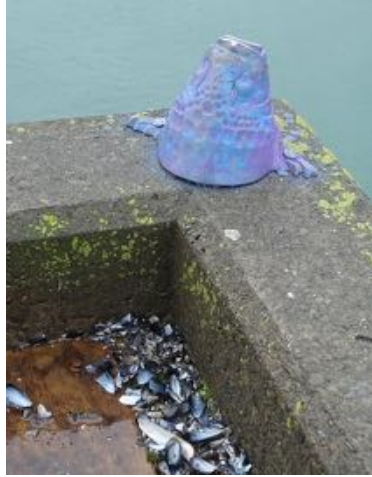
Figure 91. One of the painted fishing rod holders fixed to the wharf head

On the head portion of the wharf several timber and metal bench seats and rubbish bins were installed between 2000 and 2005. Around the perimeter of the wharf, colourful painted fishing-rod holders have been fixed to the concrete perimeter nib. These were manufactured by Morris Metal Products in Nelson St, Petone, and were not intended to be painted – this was done at a later date by an unknown party.

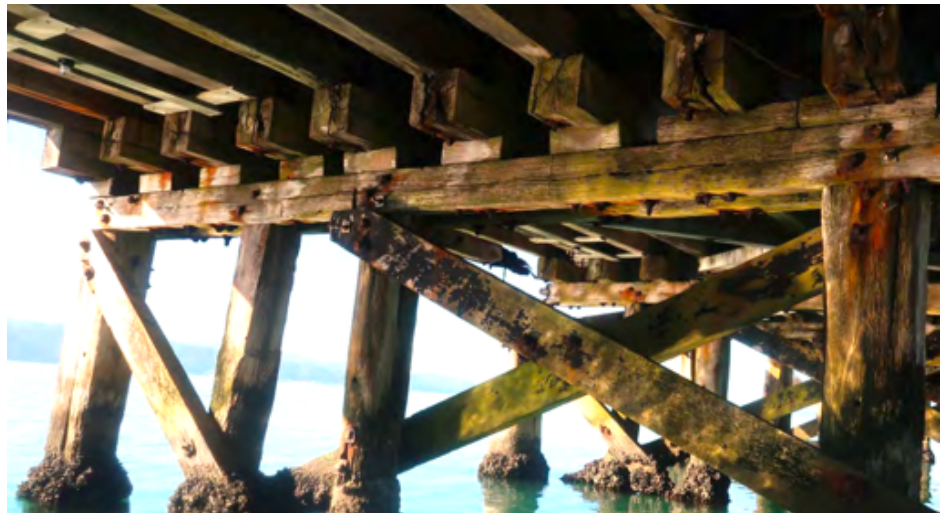
Figure 93. Timber packing between lowered cap beam and stringers. Source: Tom Arthur, Calibre Consulting Ltd., 2021 Wharf Condition Report, 25 June 2021.

- On the head, the cap beams on most bents have been lowered or replaced due to rot in the top of the piles, or the piles sinking. This work involved cutting down the top of the piles where rotten and installing a cap beam at the new lower height. Timber packing and corbels have been added between the lowered cap beams and stringers.

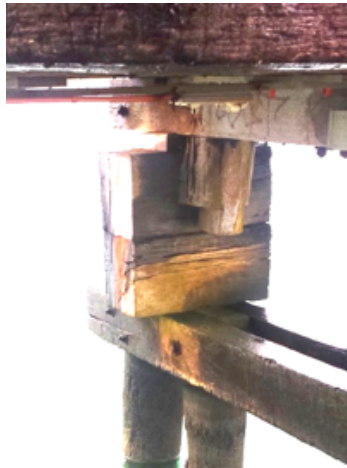
Figure 94. Timber blocks between upper and lower pile caps on bent 45. Photo by Calibre Engineering.

- On bents 45 and 46, presumably due to rot in the top of the piles, the top portion of the piles have been removed and a second lower cap beam added, while the original cap beams have remained in place. The removed portion of the piles have been replaced with two large timber blocks stacked vertically.

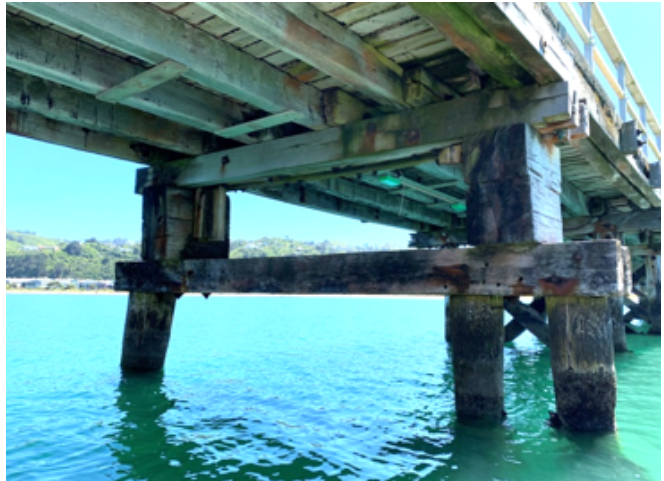
Figure 95. Bent 46 with timber blocking between upper and lower pile caps. Note the missing original pile on the left-hand side with the top of the original pile still in place.

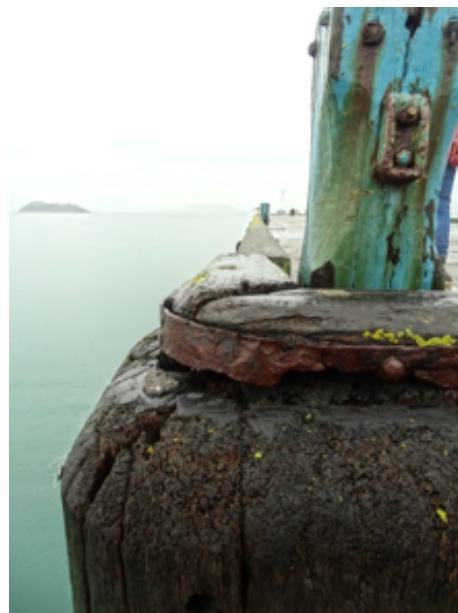
Figure 96. Existing timber corner fender and metal kerbing on the head.

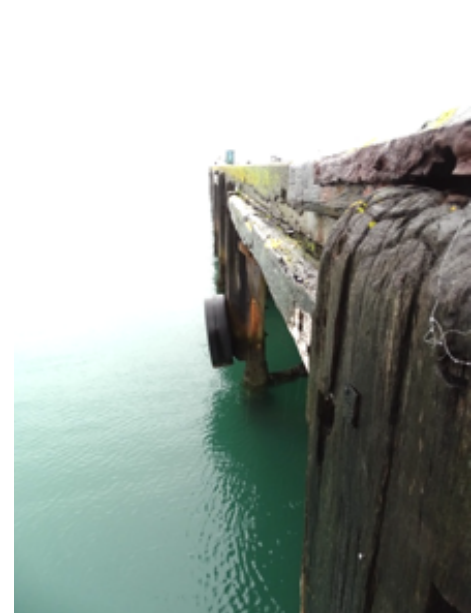
Figure 97. Existing timber fender on the head.

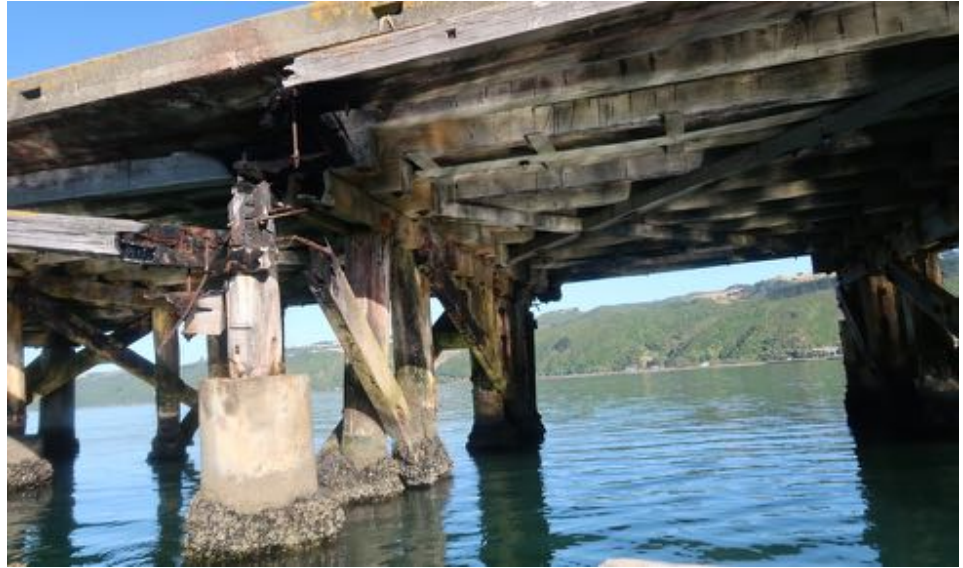
Figure 98. Fire damage to bent 63 on the head. Source: Calibre Consulting Ltd.

- In 2017 a fire beneath the head damaged the east end of bent 63, resulting in a section of the pile, brace, and cap beam being destroyed. As a result of this the stringer collapsed and the concrete decking above this area is now relying on support from the inner stringer.

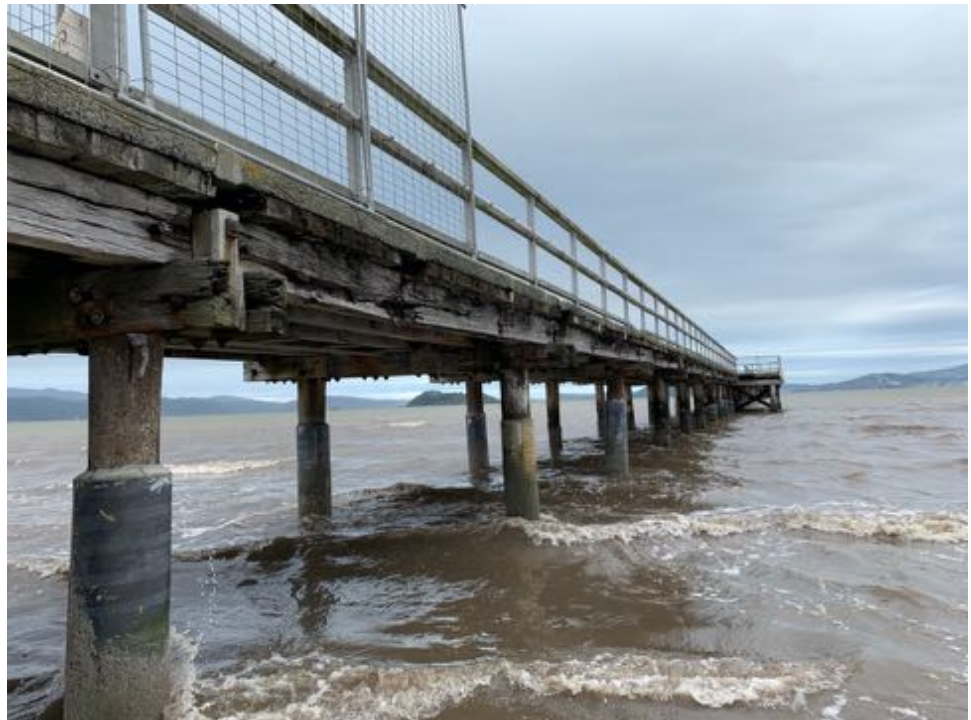
Figure 99. FRP Repairs on piles below the approach section of the wharf. Source: Calibre Consulting Ltd.

- In 2017 and 2018 FRP repairs were undertaken on many piles in the approach.
- In 2018 on the head portion of the wharf, splice repairs were made to several cap beams.
- In 2021 several waler beams on the approach portion of the wharf were removed to allow for the inspection of the piles. Also, from bent 24 to 30 (excluding 26) both walers and cross bracing (where present) were removed for pile inspections.
- In 2021 a stump and FRP repair was undertaken on many of the piles of the approach portion of the wharf.

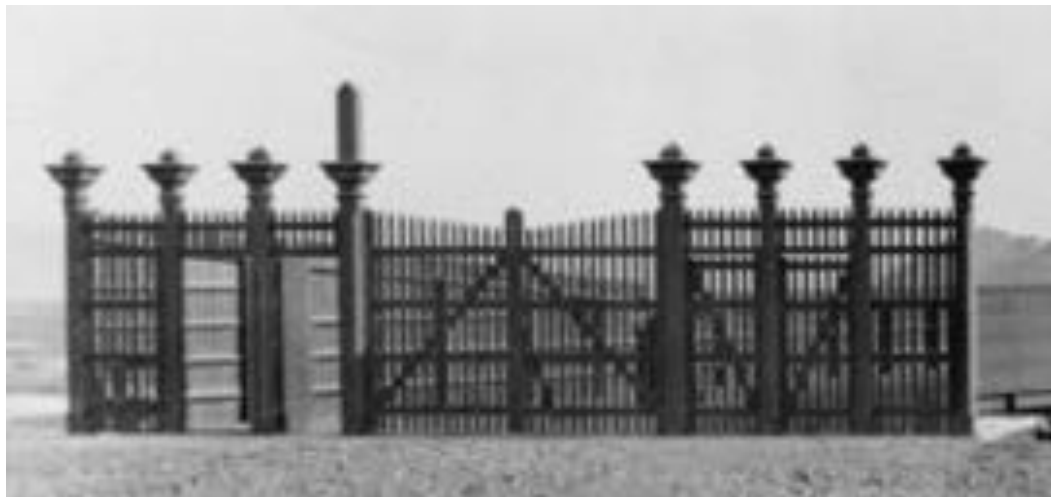
Figure 100. The original gates as built, 1909. Source: ATL 1/2-002541-F

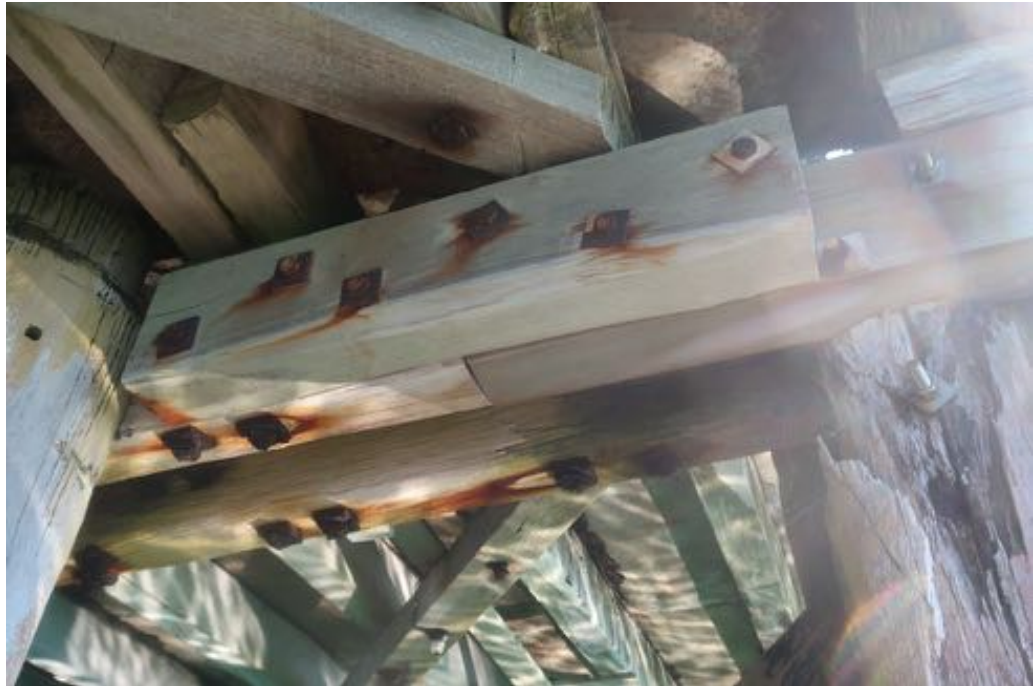
Figure 101. Repaired/replaced cap beam below the head constructed largely from new timber in original configuration. Source: Calibre Consulting Ltd.

The original pile caps, waler beams, cross-bracing, beams, and fenders were ironbark. Since construction the timber structural members have been repaired and replaced extensively with new timber. Refer to table below.
