Petone Wharf

The Esplanade, Petone, Lower Hutt

Conservation Plan

Hutt City Council

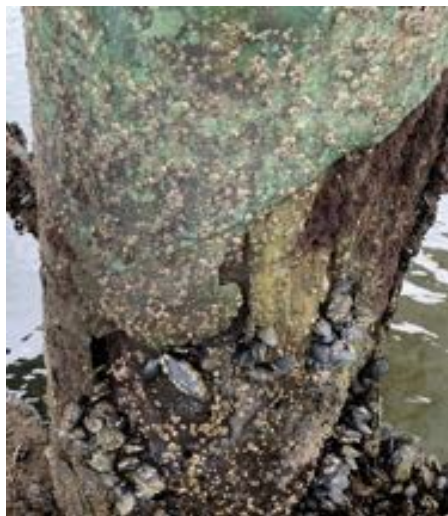
Figure 102. Some remaining copper sheathing on a pile. Source: Calibre Consulting Ltd.

Where timber structural members had exposed ends or connections sitting below the median high-water line they were sheathed in copper. The copper sheathing was to protect the timber from attack by marine organisms such as teredo worm. Much of this copper sheathing is missing and the remainder is in poor condition.

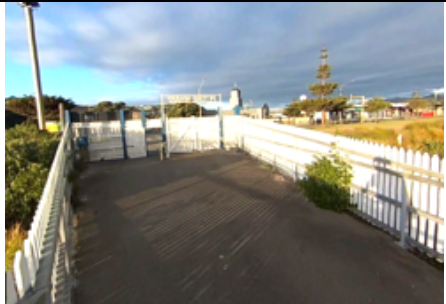
<p data-bbox="427 651 874 725"><i>Figure 104: The wharf entrance. Source: Google Street View February 2018, accessed January 2022</i></p>	Exceptional	Timber Entry Posts (OF tbc) Splayed plan (OF)
	Considerable	Picket fence palings along The Esplanade (LF)
	Some	Vehicle and pedestrian entry gates (LF) Picket fence palings down the sides of the wharf (RF) Concrete decking (LF)
	Not relevant	Low steel vehicle gate (RF?) Services installed on inside fence (RF?)
	Intrusive	Metal 'Petone Wharf' Sign (RF) Metal and timber balustrade frame to fencing (RF) Timber signboard over western gates (RF) Plastic signs (smoking, dogs, warning) on the fence along The Esplanade (RF) Concrete decking to wharf (LF) Lighting column (RF)

THE ENTRANCE	CONSIDERABLE	
The entrance (bents 1 to 4) is the first portion of the wharf, accessible directly from The Esplanade, and displays features that represent the Victorian style of the original design. It has an overall rating of considerable significance.		
ABOVE DECK

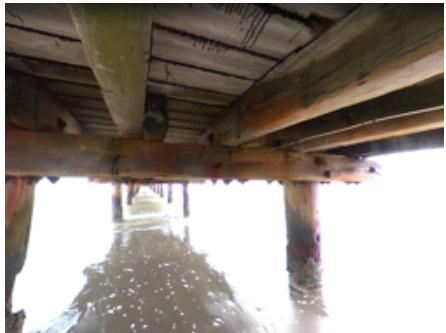
<p data-bbox="427 1368 874 1442"><i>Figure 105. Below the wharf entrance deck. Source: Google Street View November 2018, accessed January 2022</i></p>	Exceptional	
	Considerable	Concrete foundation wall at street edge (assumed OF) Original timber decking (OF) Original timber stringers and inner beams (OF) Original timber piles (OF)
	Some	
	Not relevant	
	Intrusive

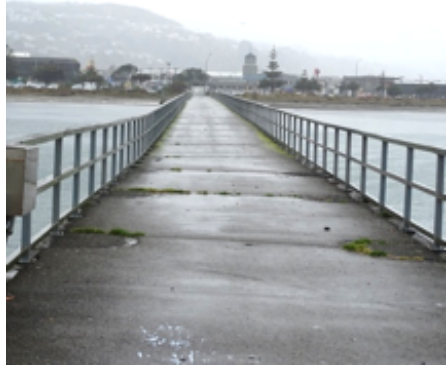
<p data-bbox="427 763 735 790">Figure 106. The wharf approach</p>	Exceptional	The extreme length of the wharf (OF) The form of the wharf including the cart refuge (OF)
	Considerable	Timber decking (OF)
	Some	
	Not relevant	Wind speed and weather monitoring rods (RF)
	Intrusive	Metal and balustrade frame to fencing (RF) Concrete decking (LF) and asphalt (RF) to wharf
BELOW DECK

THE APPROACH	CONSIDERABLE	
The approach (bents 4 to 48) is longest portion of the wharf, spanning from the entrance to the head, and has considerable significance.		
ABOVE DECK

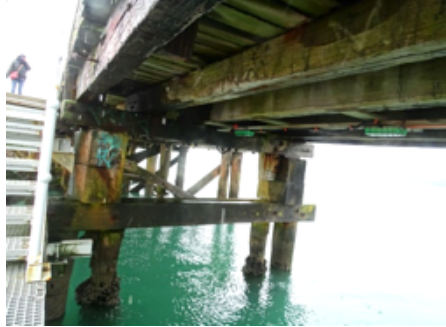
<p data-bbox="427 1205 847 1232">Figure 107. Below the wharf approach deck</p>	Exceptional	Form of timber bents (OF)
	Considerable	Original timber piles (OF) Original timber waler beams (OF) Original timber cap beams (OF) Original timber cross bracing (OF) Original timber stringers and (OF) Copper sheathing to structural elements in tidal zone (OF/EF)

Some	Lower cap beam and packing (LF) Additional support piles (LF)
	Not relevant	FRP jacket repairs to several piles (RF) Stump repairs to several piles (RF) Steel access platform (RF) Water quality testing plant (RF)
	Intrusive	Lights and cabling (RF)

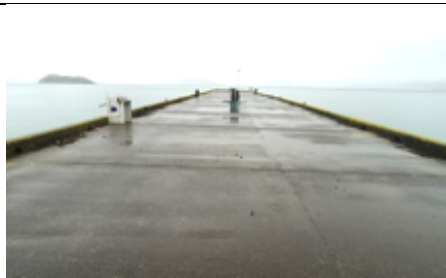
<p>Figure 108. The wharf head</p>	Exceptional	Form of the head (OF)
	Considerable	Timber fenders (OF) Metal kerbing to corner fenders (OF) Timber bollards (OF)
	Some	Foundation wall of shed (LF) Timber portions of nib balustrade (LF)
	Not relevant	FRP jacket repairs to several piles (RF) Stump repairs to several piles (RF) Steel access platform (RF) Water quality testing plant (RF) Wind speed and weather monitoring rods (RF) Bench seats and rubbish bins (RF) Fishing rod holders on kerb (RF)
	Intrusive	Temporary construction fencing (RF) Concrete decking to wharf (LF) Concrete kerb (LF)
BELOW DECK

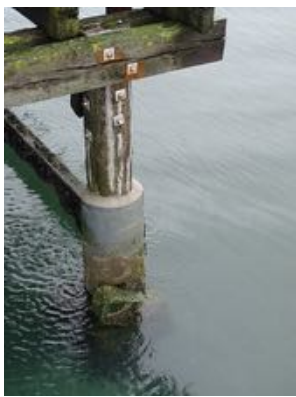
<p>Figure 110. Example of pile repair.</p>	Exceptional	Original timber piles (OF) Original timber waler beams (OF) Original timber cap beams (OF) Original timber cross bracing (OF) Original timber stringers and inner beams (OF).

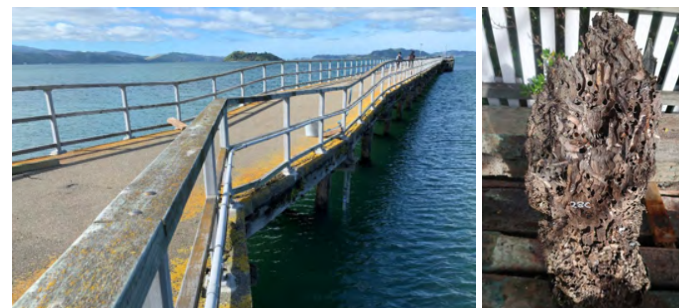
Figure 4 Dip in wharf deck over grid 28, and a length of the removed pile from this location showing severe deterioration from teredo worm

The condition of the piles has declined significantly since the last dive inspection was completed in 2018. Nine piles had failed around the cart refuge and were repaired in February – March 2021, the failed piles were found to have severe loss of section due to teredo worm. It is likely that other piles on the wharf will have similar hidden deterioration. The dive inspection noted the piles on the wharf head to be in poor condition, the piles located along the western edge and outer half of the wharf head are generally in poor or very poor condition.
