**Initial Evaluation Procedure (IEP) Assessment - Completed for Hutt City Council**

| Street Number & Name: | <b>38 Mitchell Street</b> | Job No.: | <b>5-C3957.00</b> |
| Name of building: | <b>Epuni Community Hall</b> | Date: | <b>28/08/2019</b> |

**Table IEP-1 Initial Evaluation Procedure Step 1**

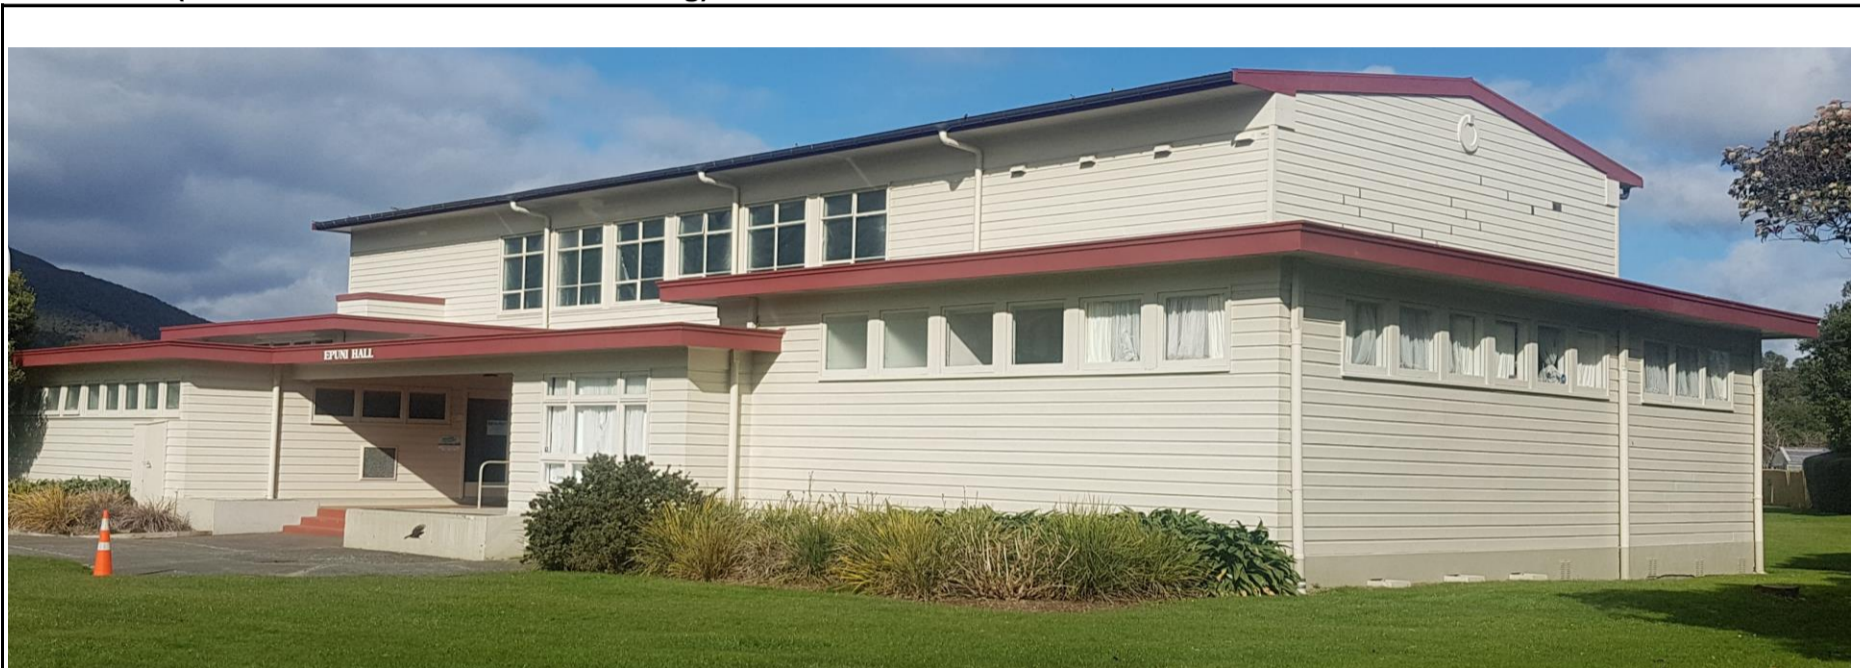
**1.1 Photos (attach sufficient to describe building)**

Structure: Portal frames, lined timber framed walls with let in braces  
 Foundations: Piled foundations with pads under the portal frames and foundation walls.  
 Roof: Portals and timber frames support timber framing  
 Subsoil: D soft or deep soils - assumed based on location  
 Construction Date: 1953
