Initial Evaluation Procedure (IEP) Assessment - Completed for Hutt City Council

Street Number & Name:	33 Parkway	Job No.:	5-C3957.00
AKA:		By:	GSF
Name of building:	Parkway House	Date:	11/12/2019
City:	Wainuiomata, Hutt City	Revision No.:	0

Table IEP-1 Initial Evaluation Procedure Step 1

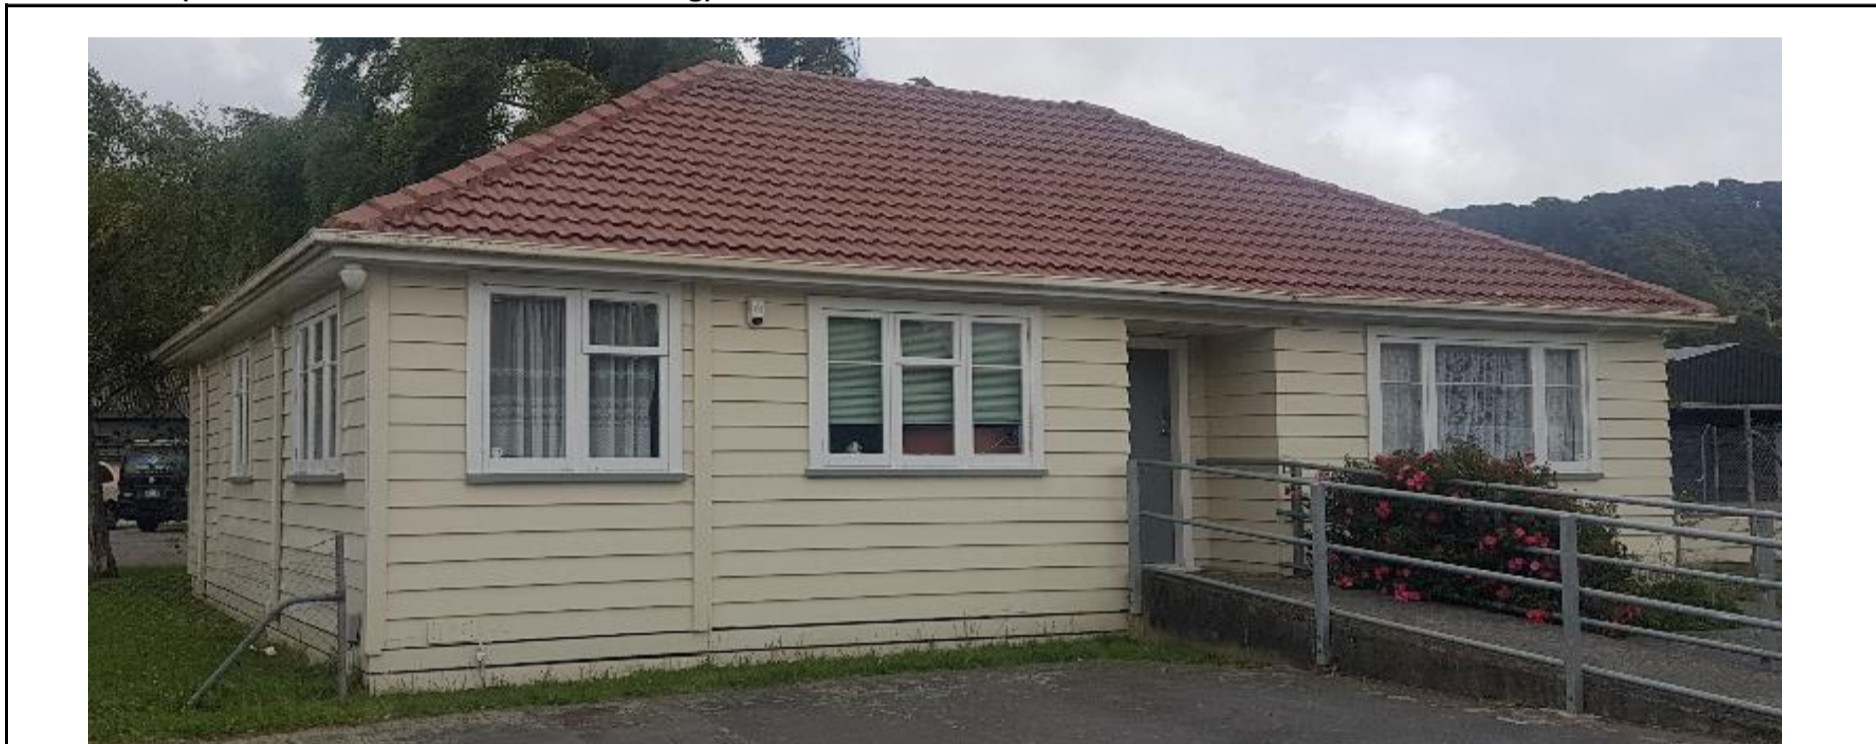
1.1 Photos (attach sufficient to describe building)

Structure: Timber framed with lined walls and weatherboard cladding, letin 1 inch bracing for all walls + linings
 Foundations: Relocated from 5 Wainuiomata Drive and re-piled 1983
 Roof: Lightweight timber truss with heavy cladding
 Subsoil: D soft or deep soils assumed
 Construction Date: 1955 to 1960, relocated and re-piled 1983
