Initial Evaluation Procedure (IEP) Assessment - Completed for Hutt City Council

Street Number & Name:	135 Dowse Drive	Job No.:	5-C3957.00
AKA:		By:	GSF
Name of building:	Maungaraki Hall and Community Centre	Date:	4/09/2019
City:	Maungaraki, Hutt City	Revision No.:	0

Table IEP-1 Initial Evaluation Procedure Step 1

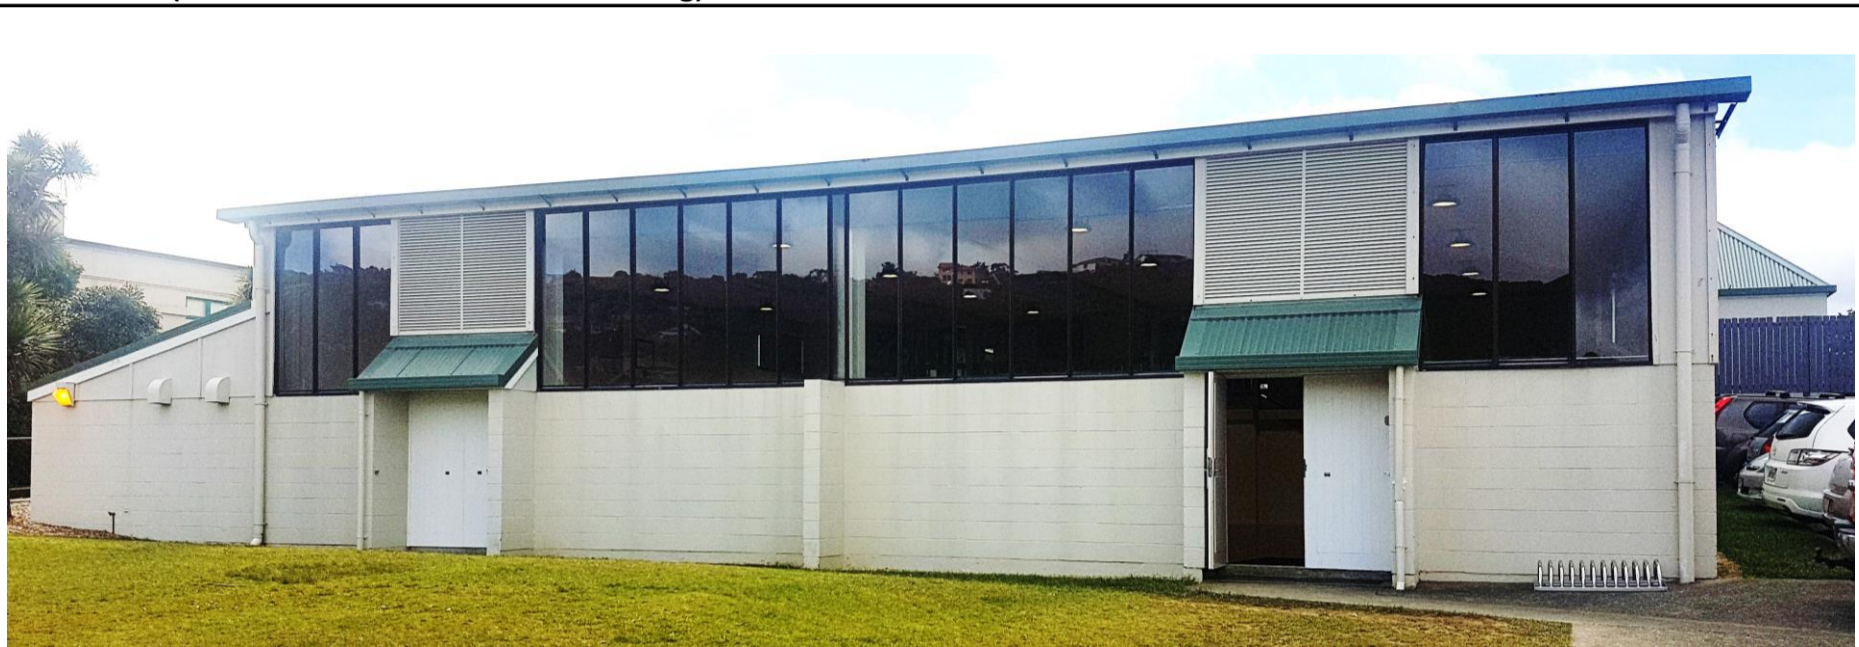
1.1 Photos (attach sufficient to describe building)

Structure: Mixed system. Steel portal frame Hall, Upper level 12mm particle braced walls with lightweight timber roof and cladding (12mm particle board diaphragm), RC Masonry walls D12@400 vertical and 2x D10@ 2nd course bondbeams horizontal at lower level.

Foundations: Concrete slab on grade and reinforced foundation walls and tie beams, pads under portal frames

Roof: Steel framed with ply and other bracings
