Project:	Eastern Hills Reservoir
Client:	Wellington Water Ltd
Compiled by:	Dr Wendy Hoddinott, Principal Landscape Architect, NZILA (Registered)
Verified by:	David McKenzie, Technical Principal: Landscape Architecture, FNZILA (Registered)
Date:	16 July 2024
Status:	Final

Landscape and Visual Assessment – Supplementary Information

2. Viewpoint 5: View from Balgownie Grove looking southwest towards the Proposed Site

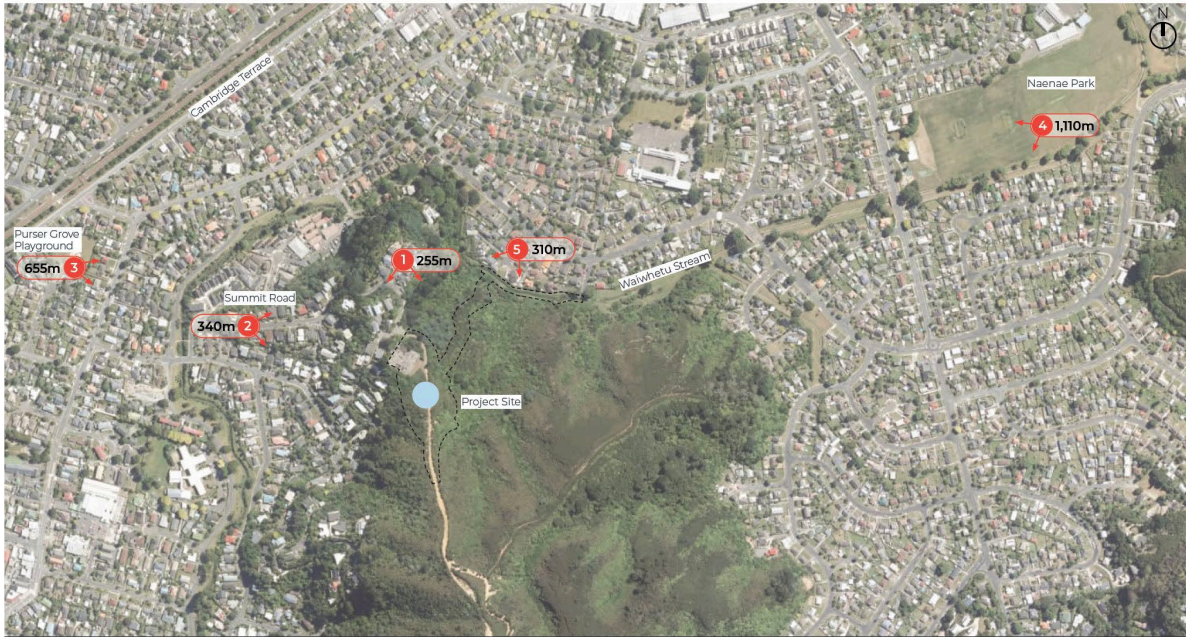
Viewpoint Plan

Figure 1: Viewpoint Reference Plan with Viewpoint 5 (from Balgownie Grove) identified (see *Appendix B* for A3 plan).

Figure 1 shows Viewpoint 5 which is the subject of this assessment alongside Viewpoints 1 to 4 which were evaluated as part of the 2023 LVA.

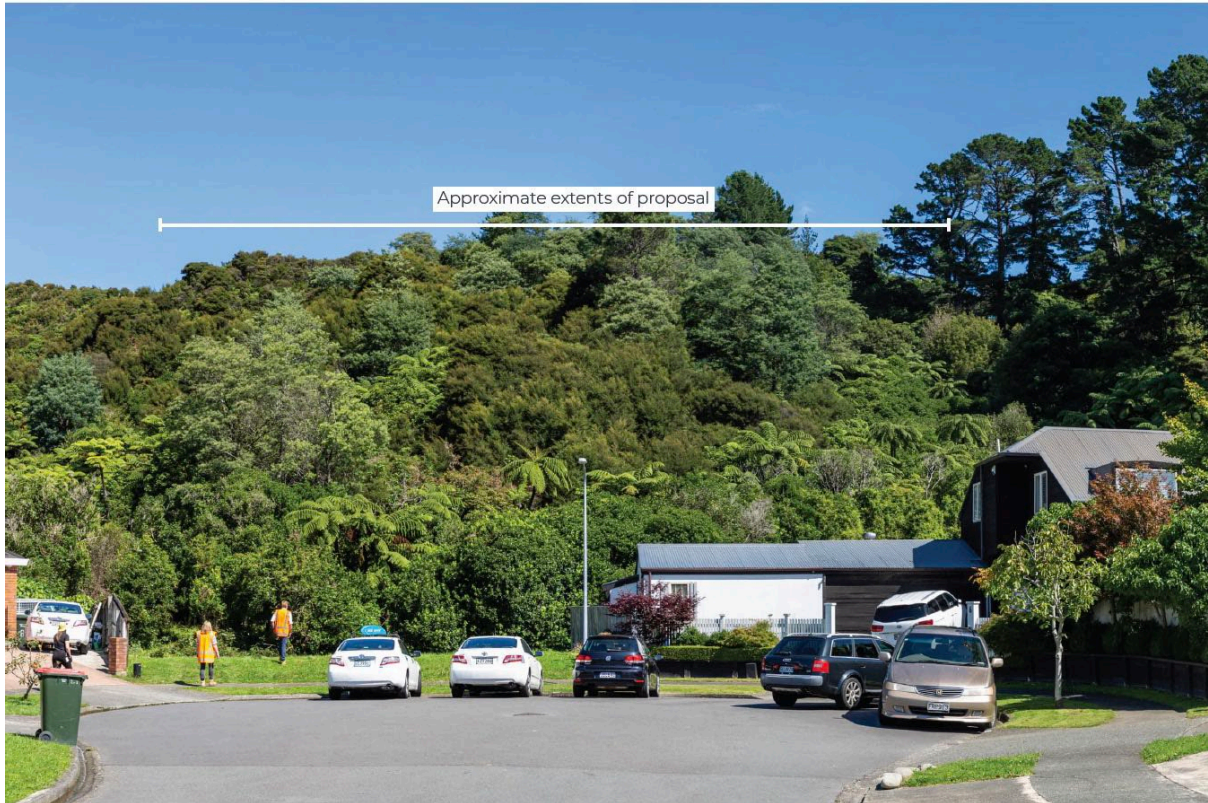
Figure 2 shows the existing condition of Viewpoint 5 taken from the road between 2 and 11 Balgownie Grove looking southwest towards the Project. Viewpoint 5 illustrates the visibility that residents (fixed viewers) currently have from these properties. Transient viewers will consist of people travelling along Balgownie Grove either by vehicle, bike, scooter or foot. Views will also be available for pedestrians at the foot of the hill travelling along a walkway beside Waiwhetū Stream.

The foreground of the image comprises the end of the Balgownie Grove cul-de-sac, including the footpath. A vacant grassed area between residential properties either side of this gap can be observed in the mid-ground and streamside vegetation can be seen at the foot of the hill behind. A single storey residence stands to the left of the image (5 Balgownie Grove) and a one and two storey standalone house to the right (6 Balgownie Grove). Residential fencing borders the vacant lot (5A Balgownie Grove) which provides access to the streamside walkway and the residence either side. Above the streamside vegetation, regenerating native bush covers the hillside and tree ferns stand out as a distinctive natural element.

Figure 2: View towards the Project illustrating the existing view from Balgownie Grove.

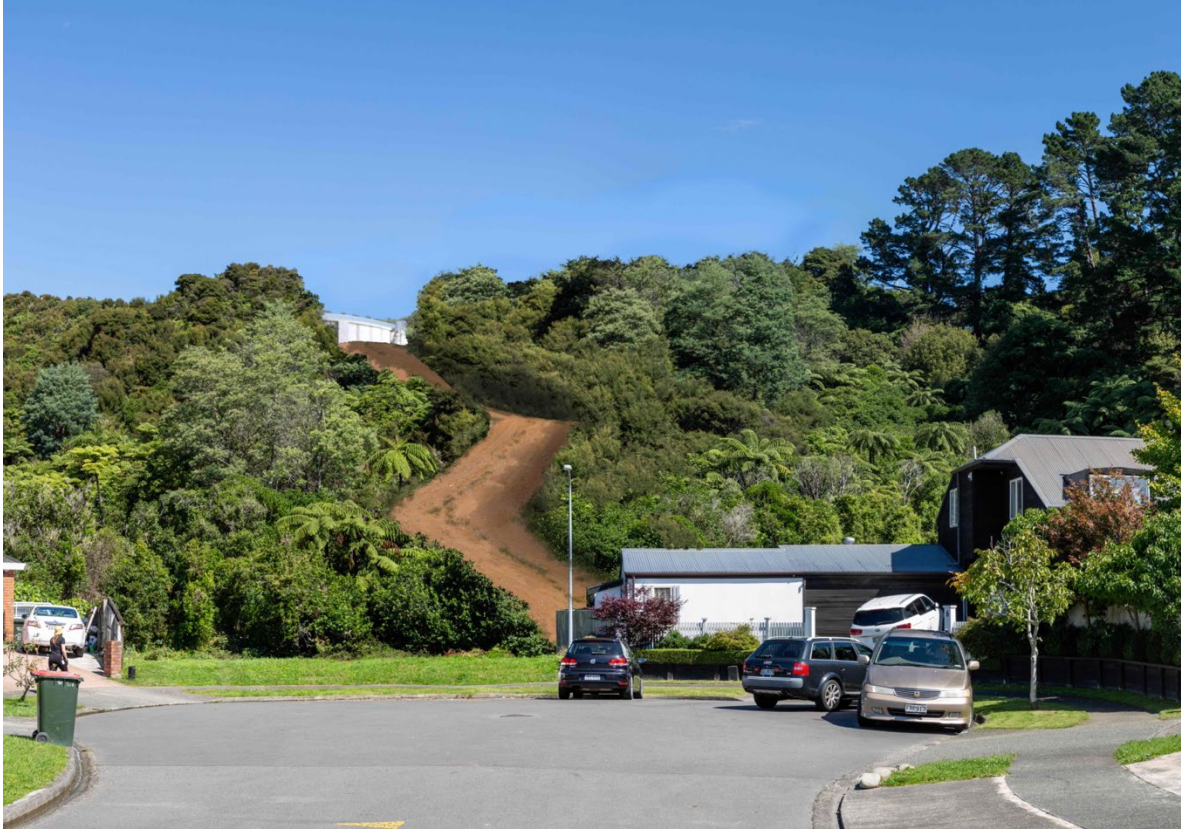
A close view of the Project will be available from Viewpoint 5 (Figure 3). A 14 m wide corridor of vegetation will be removed along the proposed pipeline corridor to allow for both the pipeline and a working area that will accommodate construction vehicles and material laydown or stockpiling.² Vegetation removal will follow the ridgeline from the reservoir platform towards Waiwhetū Stream and Balgownie Grove. With vegetation cleared, the proposed concrete reservoir will also be visible from Viewpoint 5. Crane-lifting equipment, temporary structures and other construction vehicles will be visible temporarily at the end of Balgownie Grove while the vacant lot is used as a staging area to lift equipment across the stream.

Figure 3: Simulated view towards the reservoir project from Balgownie Grove after construction with no mitigation.

Viewpoint 5 offers a clear vantage point from which the Project is clearly visible. While there will be minimal adjacent cut slopes, the large band of removed vegetation will be obvious. The concrete reservoir at the top of the hill will also be visible from this viewpoint. The amount of vegetation clearance required and introduction of a built structure (concrete reservoir) from Balgownie Grove are at variance with the existing predominantly natural landscape. However, well managed mitigation measures will reduce this effect substantially.

From VP5, the Project *without* mitigation has been assessed as having **High Adverse** visual effects. *With* mitigation measures, the Project has been assessed as having **Low Adverse** visual effects.

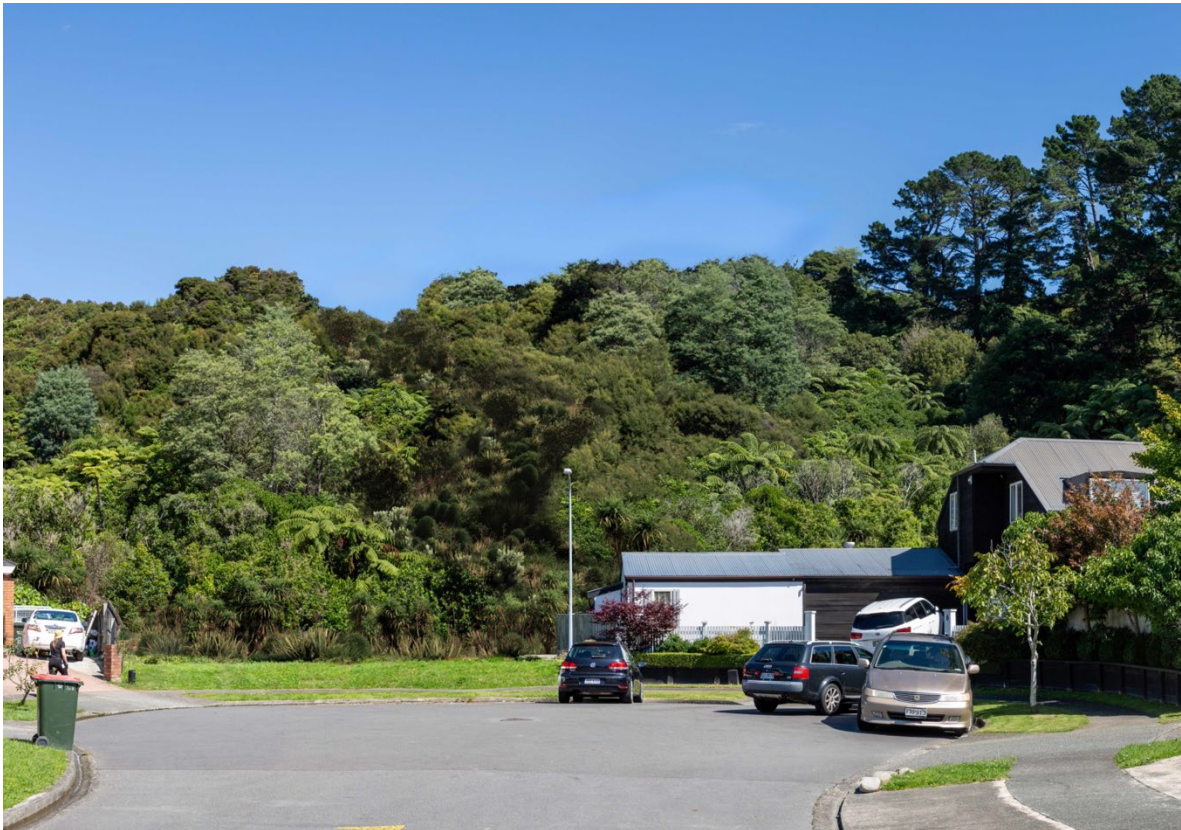
Mitigation measures have been identified in the Eastern Hills LVA³ and include revegetation of the clearance area with eco-sourced native vegetation (Figure 3). Taller trees such as manuka (*Leptospermum scoparium*) will be located at the outer edges of the pipeline corridor and lower shrubs in the central 5 m area above the pipe trench, due to maintenance requirements along the pipeline. While during the initial phases of plant growth, this newly planted area will be obvious, over time natural seed dispersal and successional growth will produce a mix of species which will blend with the surrounding vegetation.

Figure 4: Simulated view towards the reservoir project from Balgownie Grove after mitigation and remediation (5 – 10 years).

The visual effects of the Project without mitigation from Viewpoint 5 are High Adverse. This is primarily due to the removal of a wide band of vegetation on a wholly vegetated hillside and the visibility of a new built structure. With mitigation, this rating will drop to Low Adverse. Management and maintenance of mitigation planting will be critical to ensure that the revegetation planting has every opportunity to develop dense vegetation cover replicating the current situation, and to screen the Project.

During construction and before mitigation, the potential visual effects have been assessed as **High Adverse** due to removal of a wide band of vegetation and visibility of the new reservoir. With mitigation and remediation the rating will change to **Low Adverse**, due to revegetation of the clearance area with eco-sourced native vegetation.
